Application to amend licence

| Licence number | L6989/1997/13 |
| Licence holder | Shire of Augusta Margaret River |
| Premises | Davis Road Putrescible Landfill Davis Road FOREST GROVE WA 6286 Legal description Lot 5011 on Deposited Plan 192309 Certificate of Title Volume LR3093 Folio 152 |

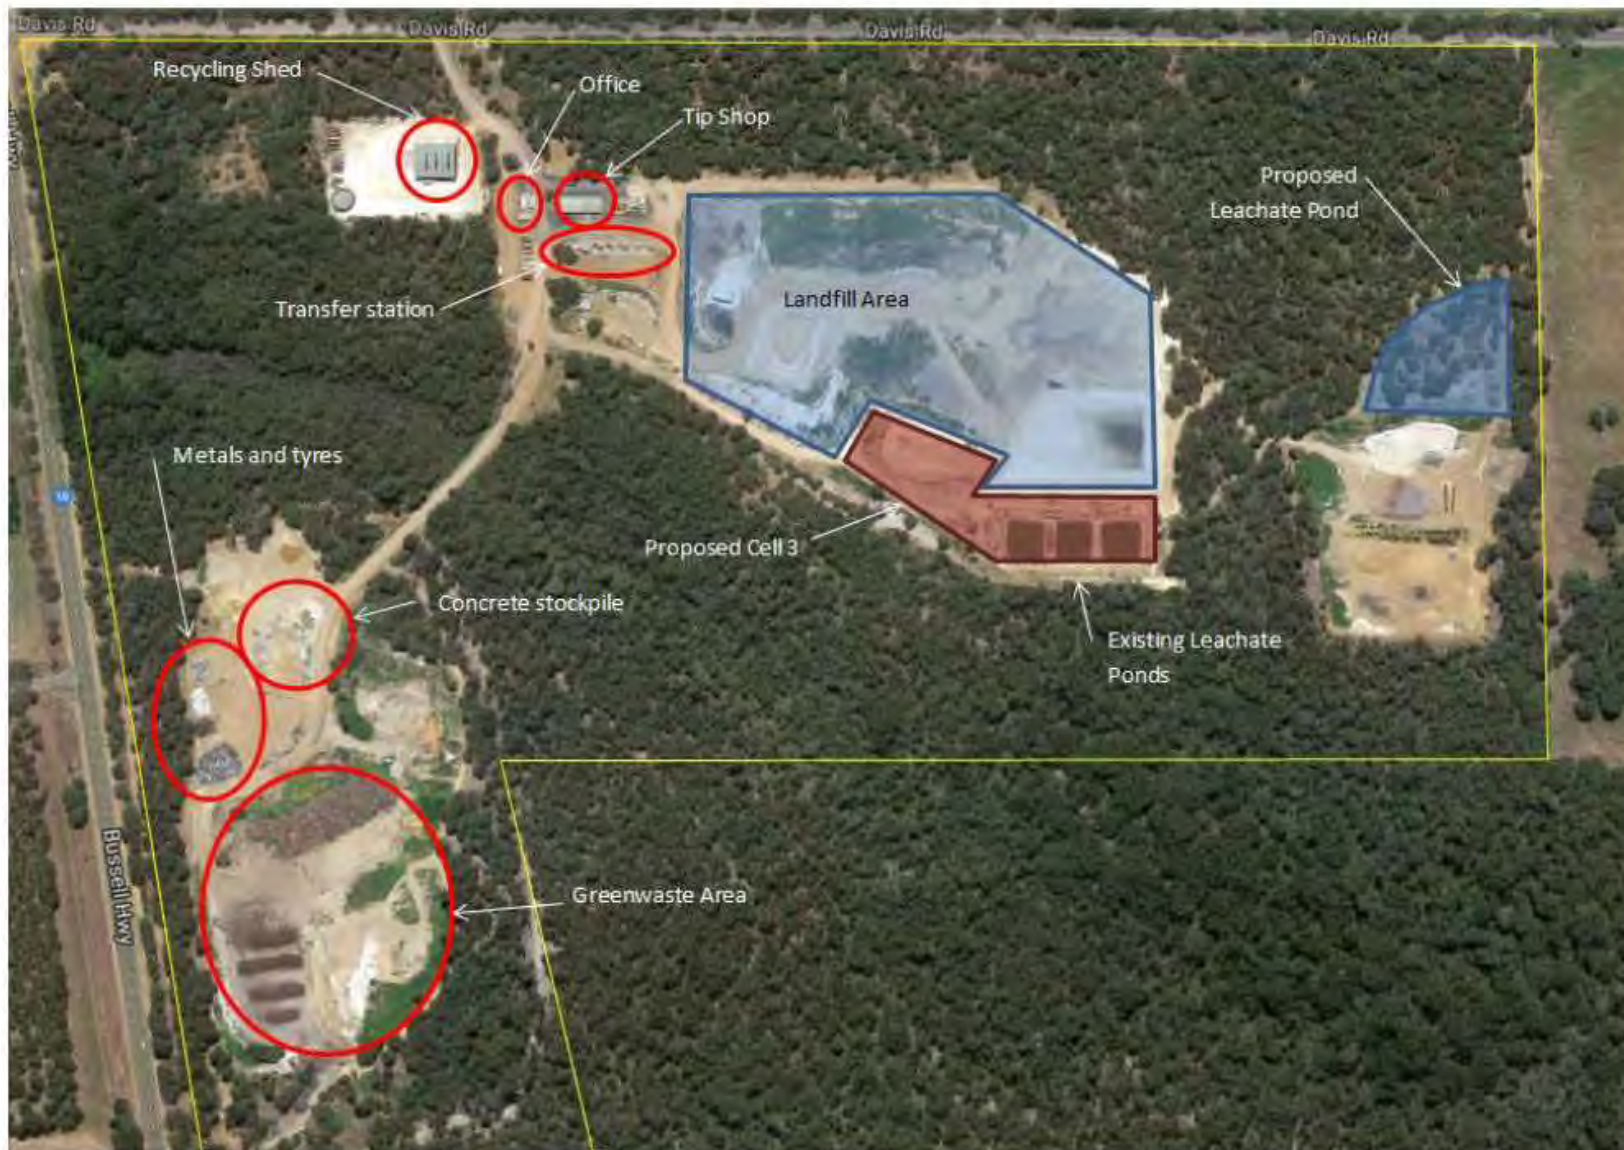
Figure 1: Site Layout Plan including proposed Cell 3 and new leachate pond (excerpt from the Application)

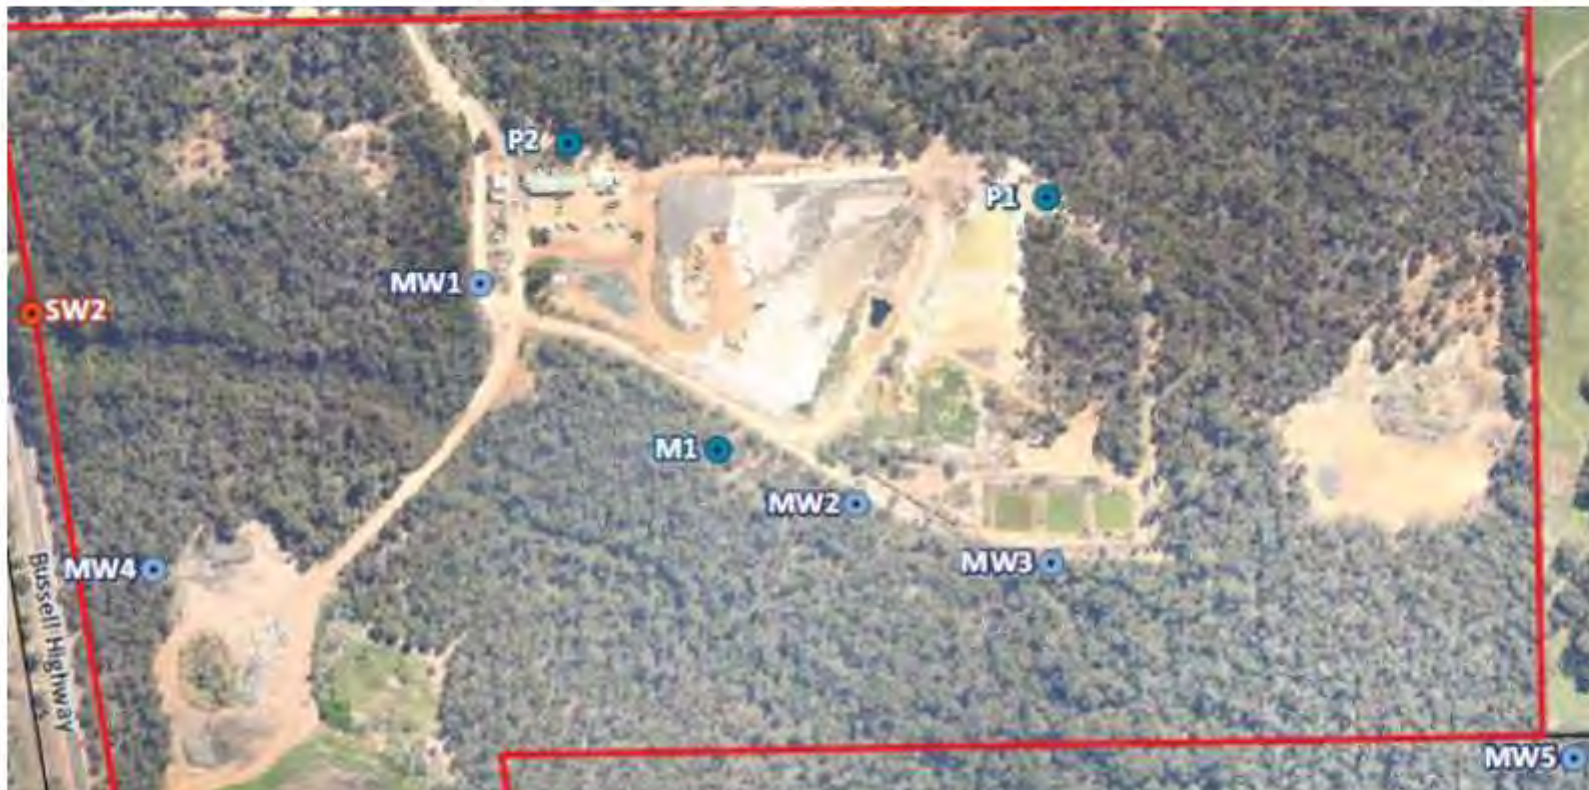
Figure 2: Location of existing groundwater monitoring bores on the Premises (excerpt from the Application)

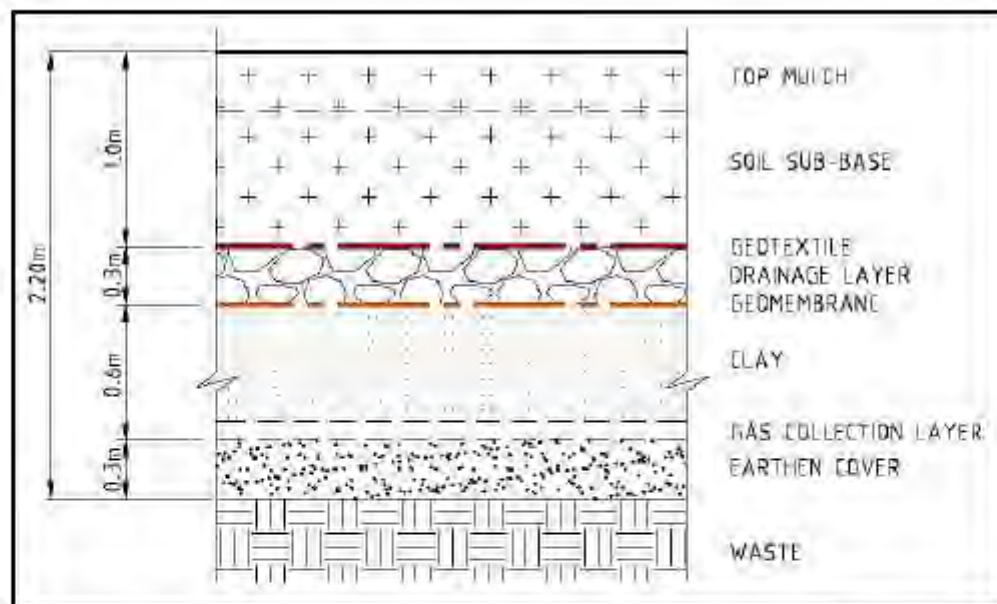
The capping will be installed at a gradient of no greater than 1V:5H. Rehabilitation with suitable vegetation is also intended to provide the cap with some protection against erosion.

Figure 3: Cell 3 landfill cap design

The capping and rehabilitation of Cell 3 is proposed to be undertaken following completion of landfilling within the cell. The design of the capping is intended to reduce rainfall infiltration into the waste body of the cell to ensure that the volume of water passing through the capping into the waste body is less than the rate of leachate generation and recovery from the cell.

The proposed design of the Cell 3 cap is shown in Figure 3 below.

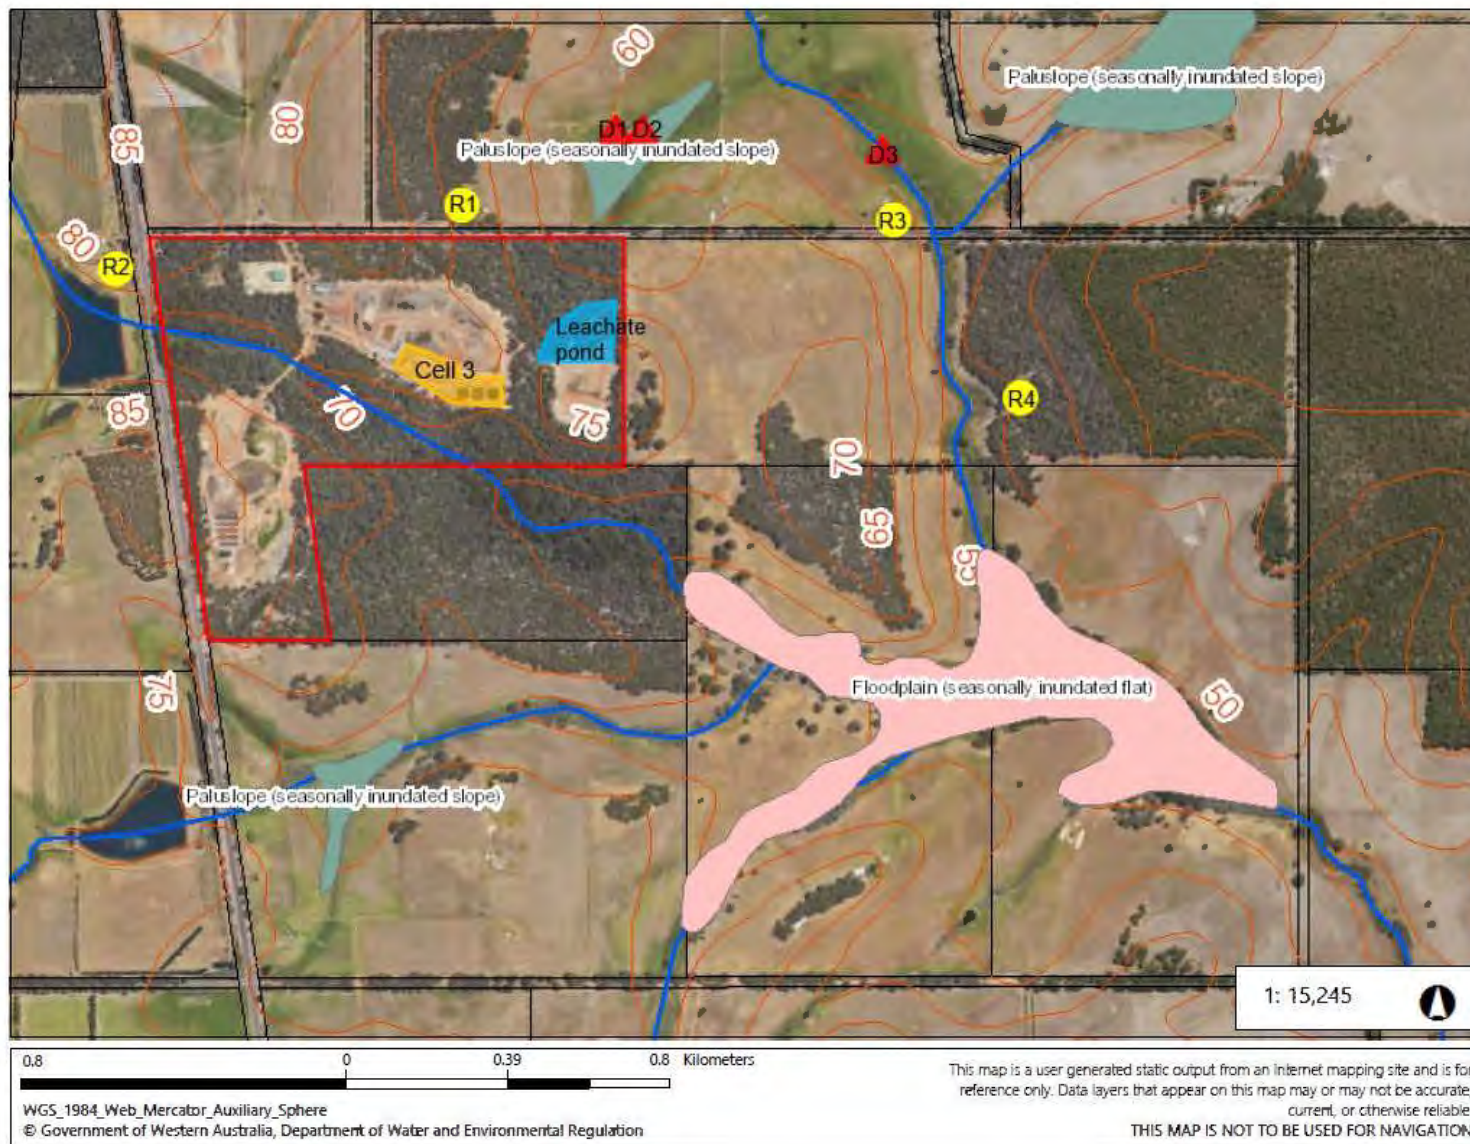
Figure 4: Map of nearby receptors (indicating approximate location of Cell 3 and new leachate pond)

| Minor watercourse/seasonally inundated slope | <p>Approximately 130 m north (downgradient) of the new leachate pond area</p> <p>Approximately 350 m north-east (potentially downgradient) of the Cell 3 area</p> |
| Floodplain (seasonally inundated flat) | Approximately 500 m south-east of the Cell 3 area |

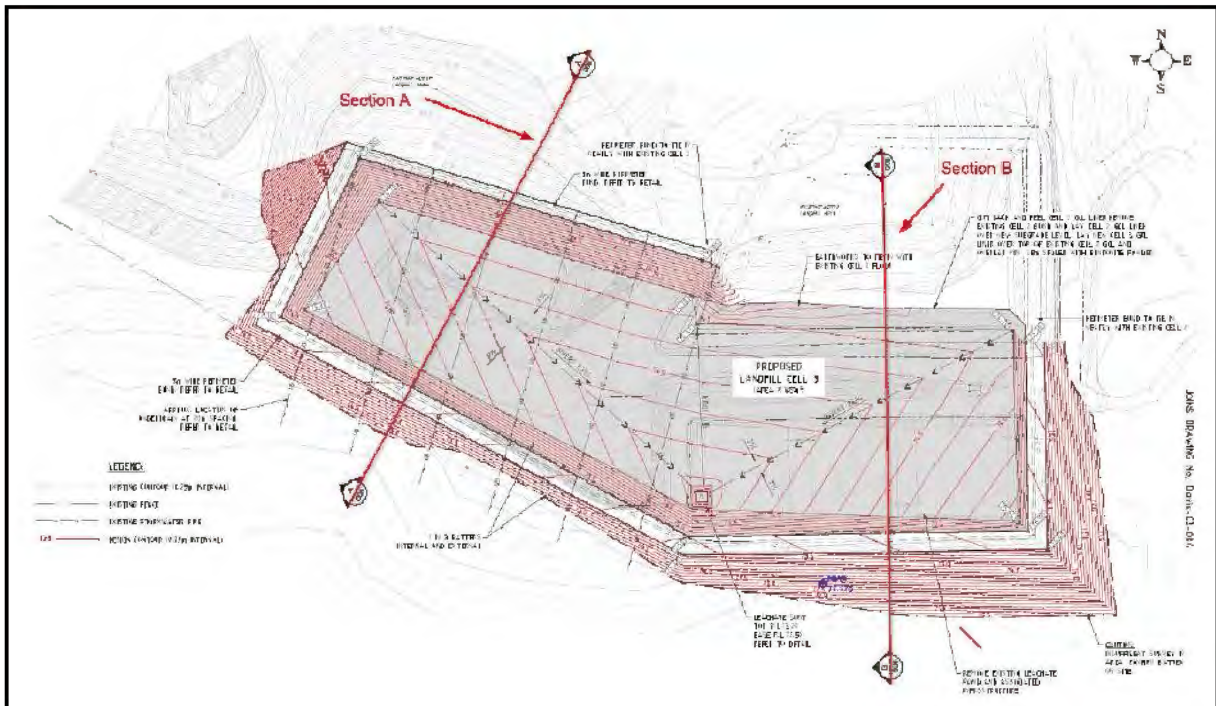
Figure 8: Critical sections within the landfill (excerpt from Application)

Modelling was undertaken for the critical sections of the landfill shown as Sections A and B in Figure 8, Figure 9 and Figure 10. These sections have the highest embankments and were therefore considered to have the highest risk of instability.

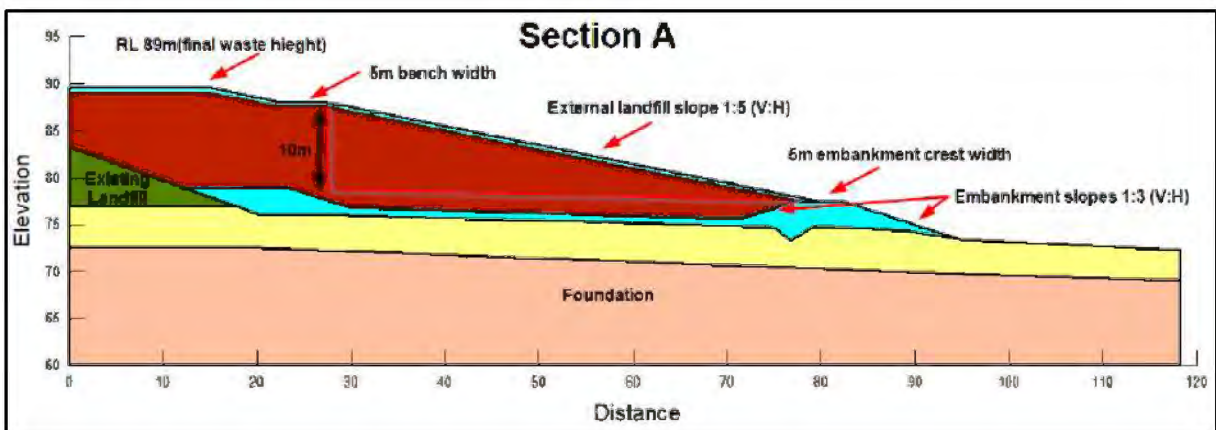
Figure 9: Section A (excerpt from Application)

The modelling results for the existing landfill slope (Cell 2) indicate a factor of safety (FoS) of 2.7 and 4.3 for Section A and Section B respectively which are both above the recommended minimum FoS.

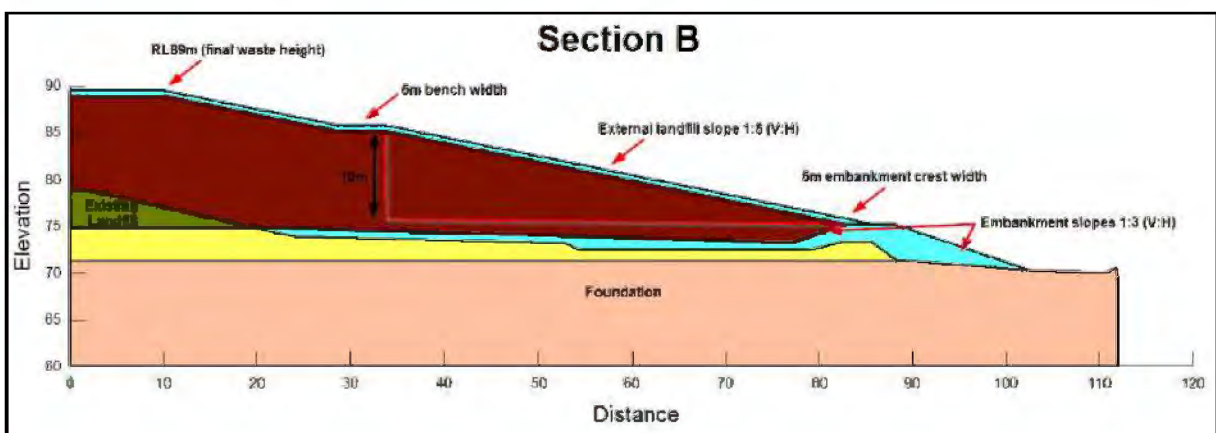
Figure 10: Section B (excerpt from Application)

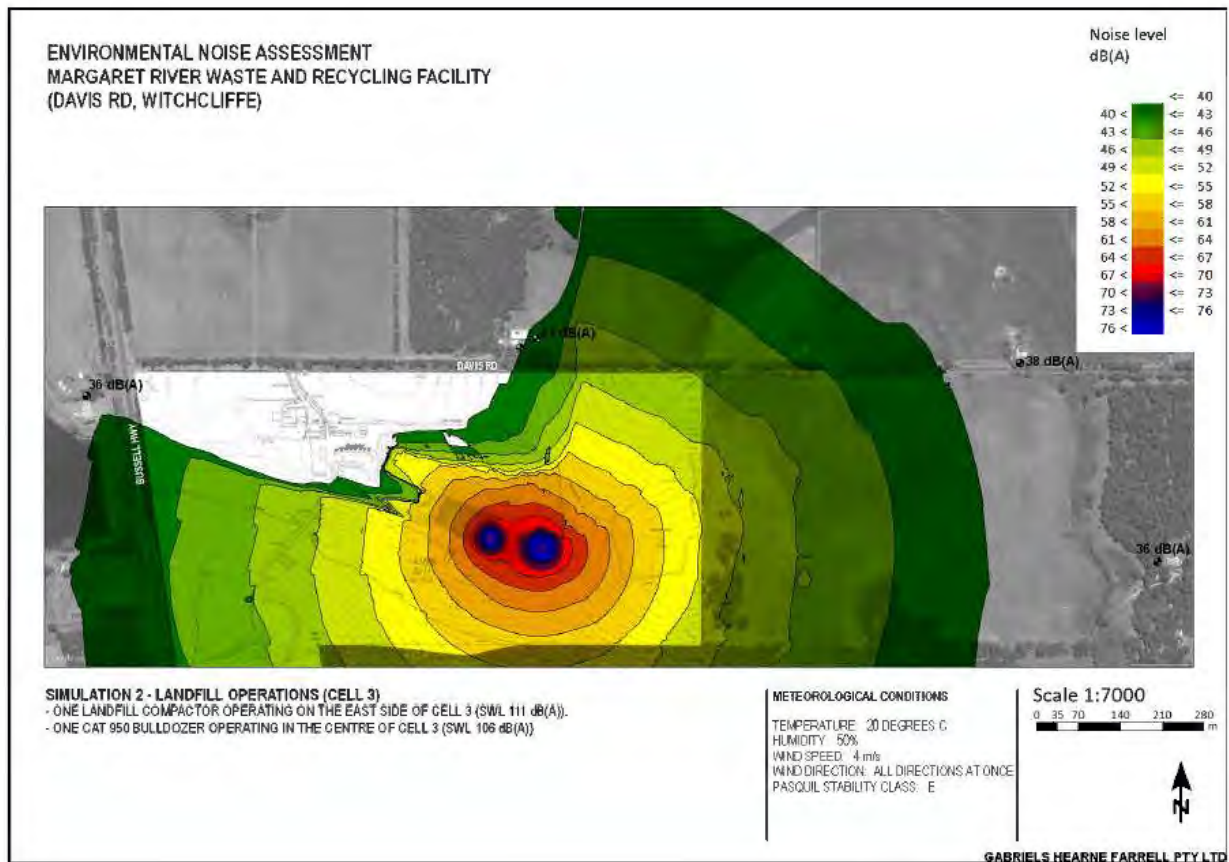
Figure 15: Landfill operation noise simulation

The acoustic assessment concludes that the noise emissions associated with the operation of Cell 3 have been calculated to comply with the assigned noise levels, given the proposed hours of operation. However, as the calculated and adjusted noise level was not provided for receptor R3, DWER has inferred from the simulation output shown in Figure 15 that the noise

emissions during operation are expected to comply with the assigned levels at R3 (indicated by the labelling of 38 dB(A) within the figure).

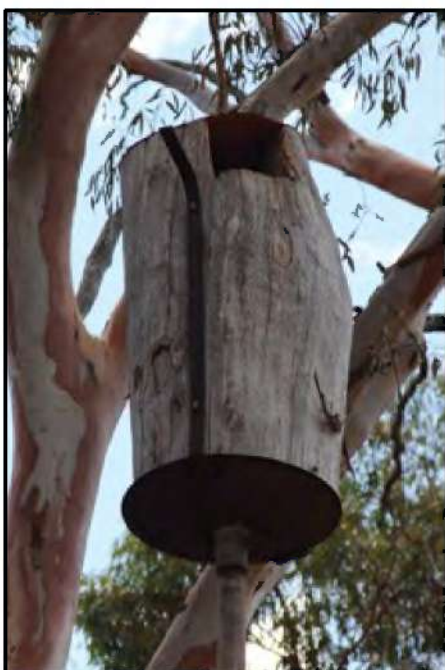
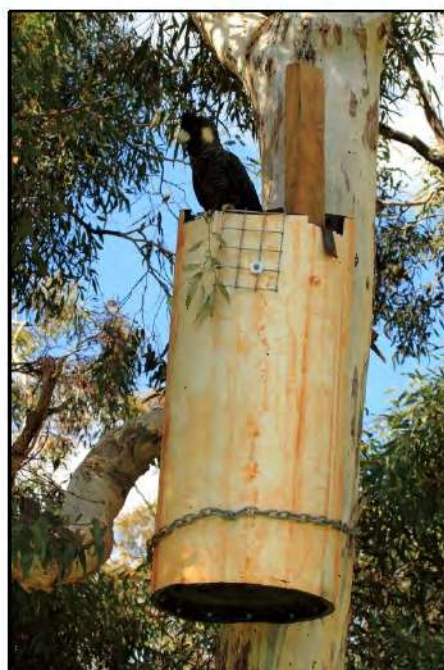
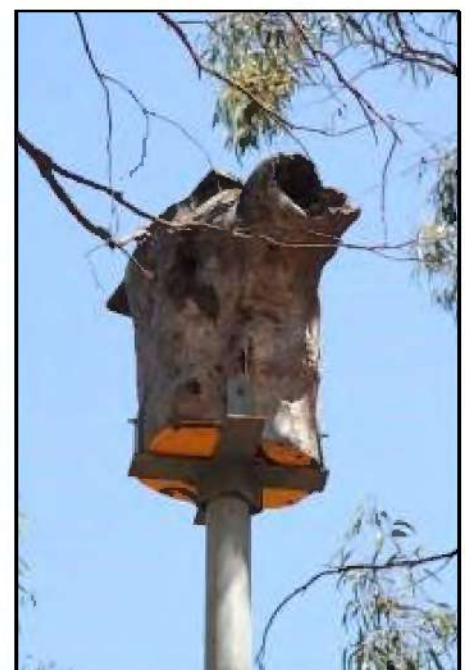
Below are three examples of successful artificial hollows used by Carnaby's cockatoo for nesting. Artificial hollows made from a natural log with cut side entrance (left), white industrial pipe with top entrance (centre) and natural log with natural side entrance (right).

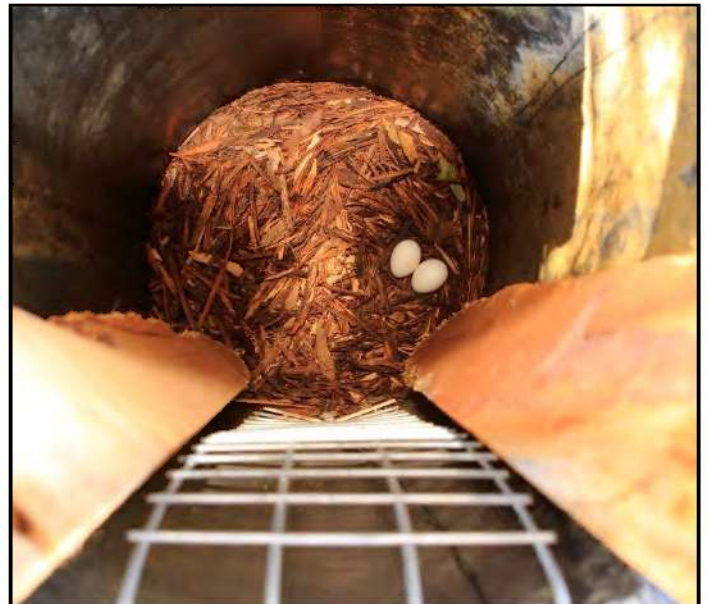
Carnaby's cockatoo eggs in an artificial hollow.
Photo by Rick Dawson

Example materials that could be used for artificial hollow bases include heavy duty stainless steel, galvanised or treated metal (e.g. Zinalume ®), thick hardwood timber slab or marine ply (not chipboard or MDF). The base material must be cut to size to fit internally with sharp or rough edges ground away or curled inwards and fixed securely to the walls.

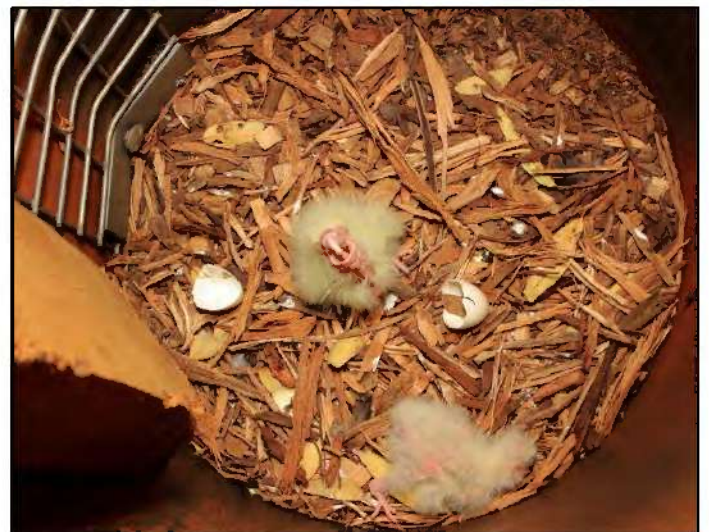
Bottom of an artificial hollow showing ladder that is fixed to the wall and a chewed sacrificial post which is 200 mm from the floor.

It is recommended that at least two posts are provided. Posts 70 x 50 mm have been used, but require replacing at least every second breeding season when the nest is active. Birds do vary in their chewing habits and therefore the frequency at which the chewing posts require replacement will also vary.

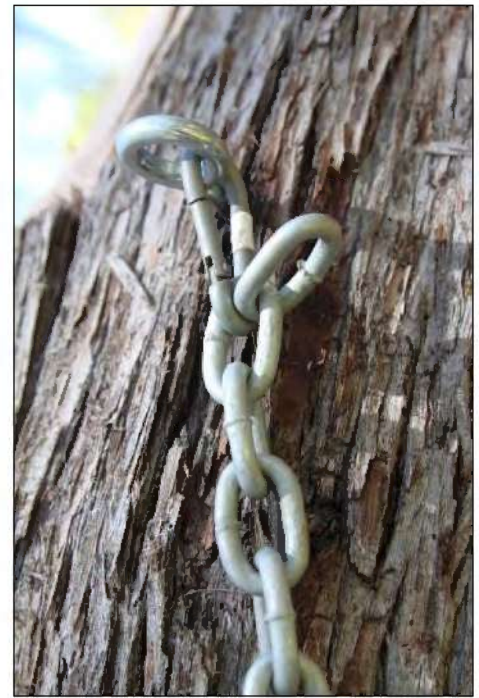
Example fixing for artificial hollow
Photo by Christine Groom

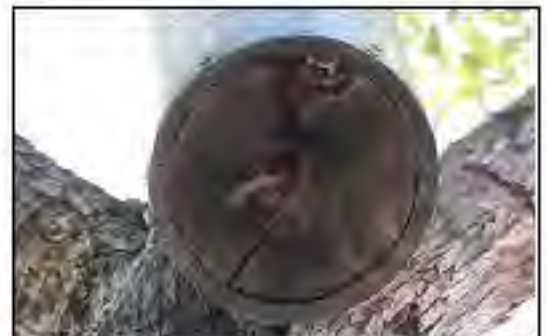
Artificial hollow base needing repair.
Photo by Christine Groom

- Condition of chewing posts (if present)
- Condition of attachment points
- Condition of hollow bases
- Stability of tree or pole used to mount the artificial hollow
