Annual Audit Compliance Report Form

Section A – Licence details			
Licence number:	L5206/1987/10	Licence file number:	2012/006906
Licence holder name:	Wiluna Operations Pty Ltd		
Trading as:	Wiluna Mining Corporation		
ACN:	166 954 525		
Registered business address:	Level 3, 1 Altona Street, Wet Perth WA 6005		
Reporting period:	01/01/2022 to 31/12/2022		
Section B – Statement of compliance with licence conditions			
Did you comply with all licence conditions during the reporting period? (please tick the appropriate box)			
<input type="checkbox"/> Yes – please complete: <ul style="list-style-type: none">• section C;• section D (if required); and• sign the declaration in Section F.			
<input checked="" type="checkbox"/> No – please complete: <ul style="list-style-type: none">• section C;• section D (if required);• section E; and• sign the declaration in Section F.			
Section C – Statement of actual production			
Provide the actual production quantity for this reporting period. Supporting documentation is to be attached.

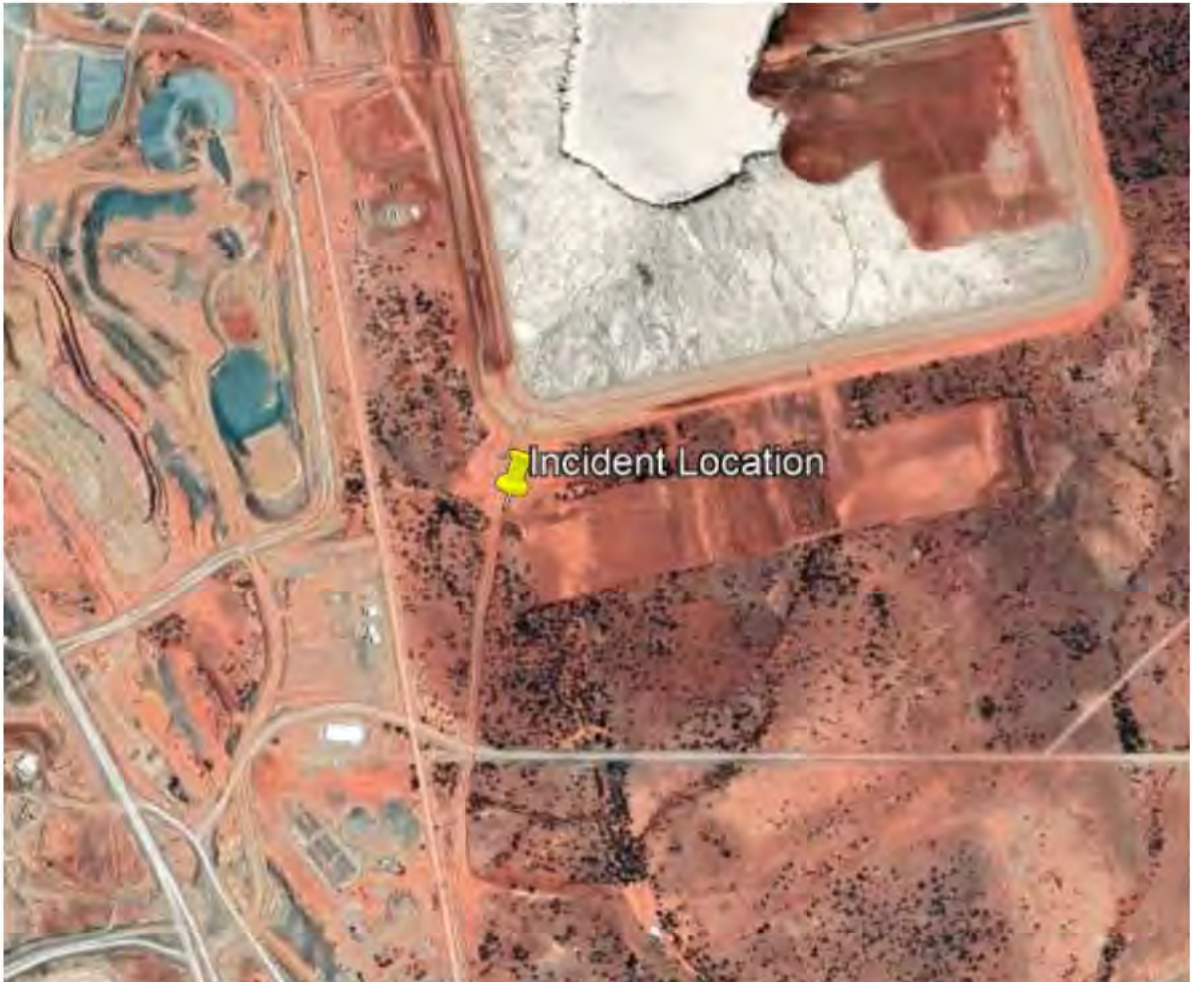
Section E – Details of non-compliance with licence condition			
Please use a separate page for each condition with which the licence holder was non-compliant at a time during the reporting period.			
Condition no:	1.2.2	Date(s) of non-compliance:	20/04/2022
Details of non-compliance:			
Spill - Tailings - Temporary TSFK tailings line spill post flushing.			
What was the actual (or suspected) environmental impact of the non-compliance?			
NOTE – please attach maps or diagrams to provide insight into the precise location of where the non-compliance took place.			
Spill contained to roadway bund, no environmental impact.

Cause (or suspected cause) of non-compliance:			
Following a temporary tailings line flush (southwestern side of TSFK) during stage 2 construction, when disassembling the pipe, residual water and sediment in the pipe spilt onto the ground.			
Action taken to mitigate any adverse effects of non-compliance and prevent recurrence of the non-compliance:

Material cleaned up and disposed of to TSF.

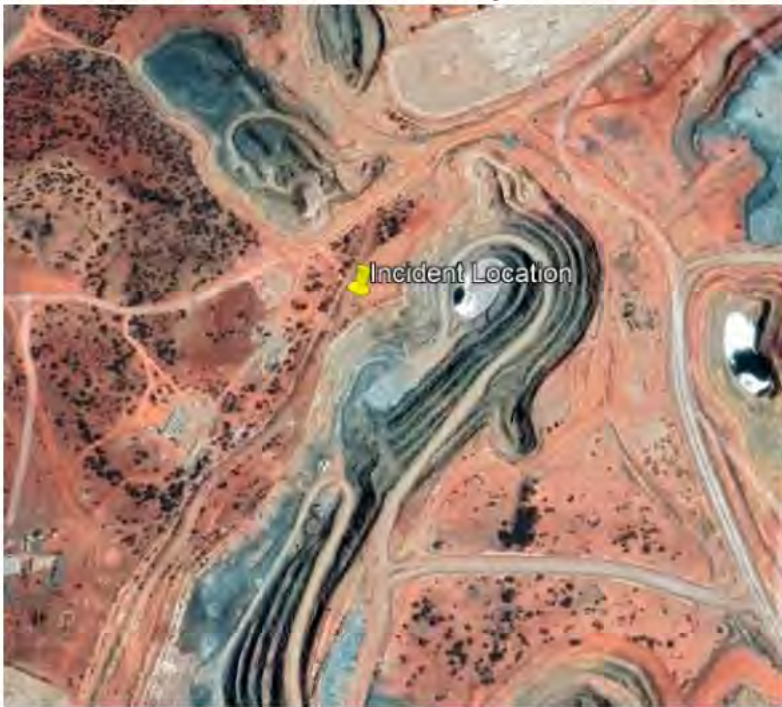
Section E – Details of non-compliance with licence condition			
Please use a separate page for each condition with which the licence holder was non-compliant at a time during the reporting period.			
Condition no:	1.2.2	Date(s) of non-compliance:	19/07/2022
Details of non-compliance:			
Spill - Saline Water - Happy Jack Tank piping split.			
What was the actual (or suspected) environmental impact of the non-compliance?			
NOTE – please attach maps or diagrams to provide insight into the precise location of where the non-compliance took place.			
No environmental impact as contained to bund and roadway.

Cause (or suspected cause) of non-compliance:			
Weld break.			
Action taken to mitigate any adverse effects of non-compliance and prevent recurrence of the non-compliance:			
Pipework repaired and replaced.			
Was this non-compliance previously reported to DWER? No

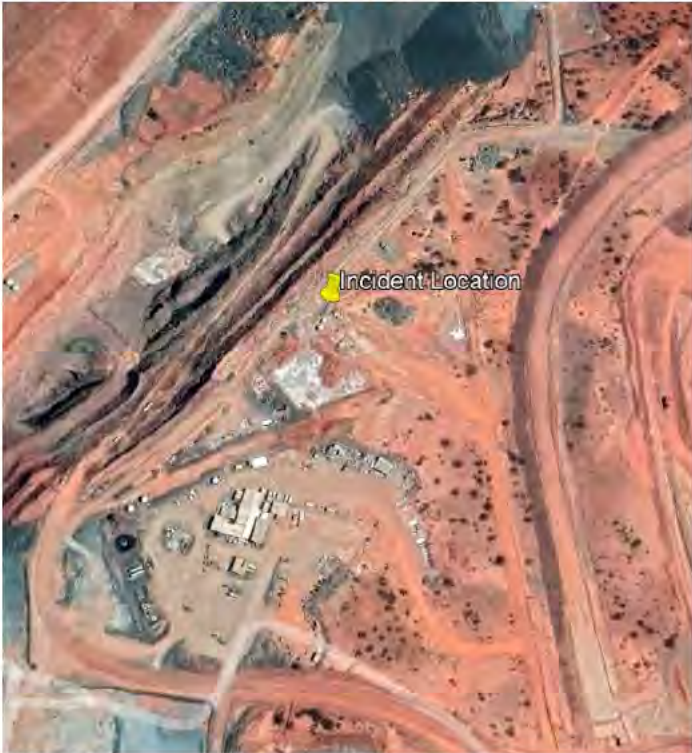
Section E – Details of non-compliance with licence condition			
Please use a separate page for each condition with which the licence holder was non-compliant at a time during the reporting period.			
Condition no:	1.2.2	Date(s) of non-compliance:	4/8/2022
Details of non-compliance:			
Spill - Saline Water - Bulletin Rising Main Tank Overflow.			
What was the actual (or suspected) environmental impact of the non-compliance?			
NOTE – please attach maps or diagrams to provide insight into the precise location of where the non-compliance took place.			
No environmental impact as contained in a historically disturbed operational area.

Cause (or suspected cause) of non-compliance:			
Failure of overflow pump switch board .			
Action taken to mitigate any adverse effects of non-compliance and prevent recurrence of the non-compliance:			
Repaired infrastructure.			
Was this non-compliance previously reported to DWER? No

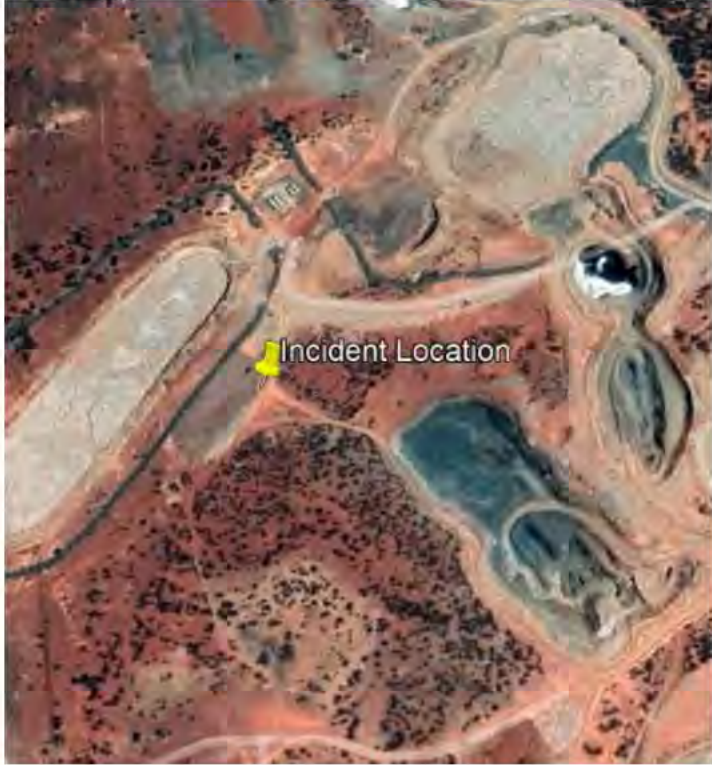
Spill - Saline Water - Happy Jack to Lone Hand Line.

No environmental impact as in operational area and contained.

Old pipework and infrastructure.

Pipework repaired and replaced.
