Annual Audit Compliance Report Form

Environmental Protection Act 1986, Part V

Section A – Licence Details			
Licence number:	L5946/1988/13	Licence file number:	2011/005899; and DER2016/000718
Licence holder:	Kalgoorlie Consolidated Gold Mines Pty Ltd		
Trading as:			
ACN:	97 009 377 619		
Registered address:	Northern Star Resources Ltd Level 4, 500 Hay Street, Subiaco WA 6008		
Reporting period:	1 January 2024 to 31 December 2024

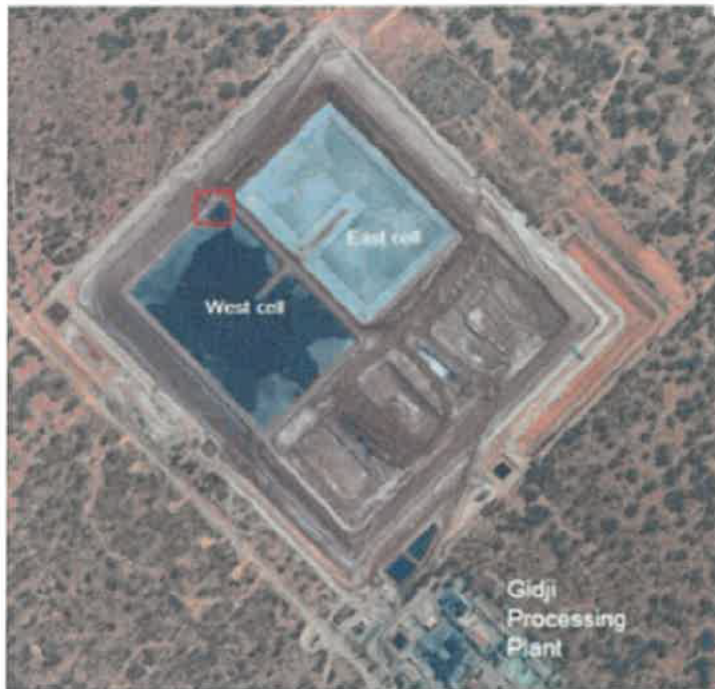
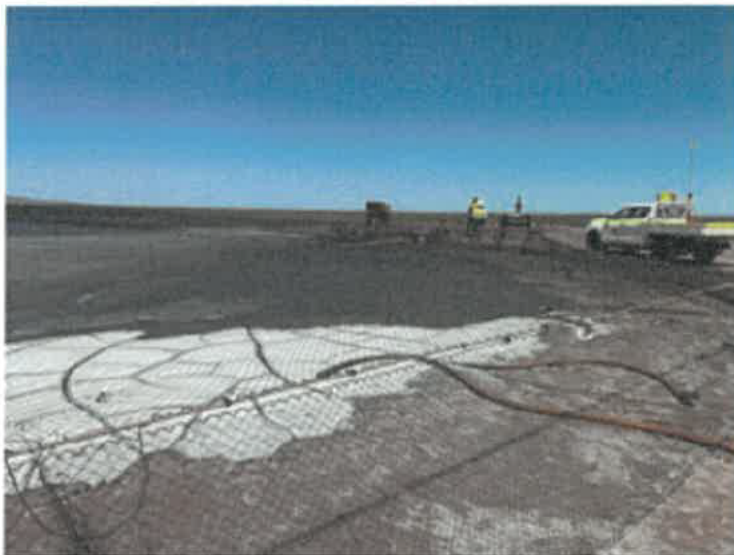
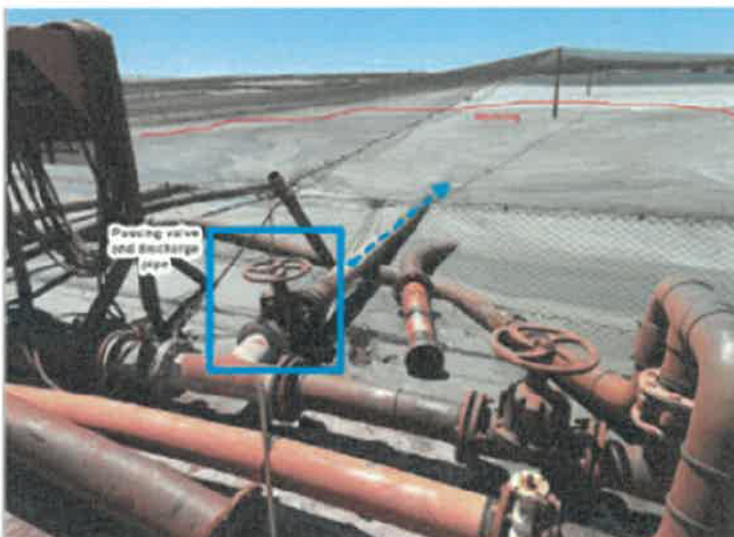
Section E – Details of Non-Compliance with Licence Condition			
Please use a separate page for each condition with which the licence holder was non-compliant at a time during the reporting period.			
Condition no:	1.2.2	Date(s) of non-compliance:	25 December 2024
Details of non-compliance:			
Breach of 300mm freeboard limit in Gidji II TSF West Cell.			
What was the actual (or suspected) environmental impact of the non-compliance?			
NOTE – please attach maps or diagrams to provide insight into the precise location of where the non-compliance took place.			
There are negligible impacts expected on the surrounding environment. Any suspected impacts would be localised within the TSF containment structure. Refer to map and photos attached.			
Cause (or suspected cause) of non-compliance:			
Passing bypass valve on Tails Line #2 to West Cell, resulting in breach of 300mm freeboard limit.			
Action taken to mitigate any adverse effects of non-compliance and prevent recurrence of the non-compliance:

Location and photos of Gidji II TSF West Cell - freeboard breach on north-west wall (outlined in red)

Changed the TSF deposition from West Cell to East Cell. Replaced the bypass feed valve on the North-east corner of the West Cell (Line #2). Restored freeboard on the North-east corner of the West Cell.			
Was this non-compliance previously reported to DWER?			
<input type="checkbox"/> Yes, and			
<input type="checkbox"/> Reported to DWER verbally		Date: / / N/A	
<input checked="" type="checkbox"/> Reported to DWER in writing		Date: 27 December 2024
