Pilbara Manganese Pty Ltd

Woodie Woodie Annual Environmental Report

Annual Period: 1st October 2024 – 30th September 2025

Premises: Woodie Woodie Manganese Project

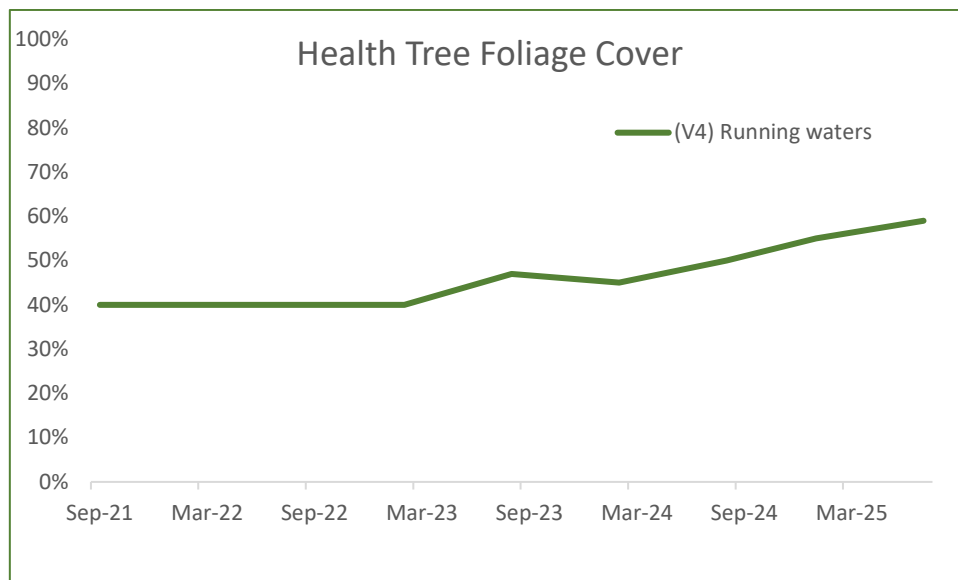
Chart 14. V4 Health and foliage score 2021 to 2025

Foliage coverage has slightly increased (+9%) during the reporting period, whilst tree health may have declined slightly with the previous reporting period. Results for foliage coverage and health condition assessments at the V4 monitoring site are presented below in Chart 14 and above in Table 2.
