Mullewa Waste Management Facility Annual Environmental Report for 2025

Department of Water and Environmental
Regulation: Licence Number
L6913/1997/10

City of Greater Geraldton

Mullewa Waste Transfer Station

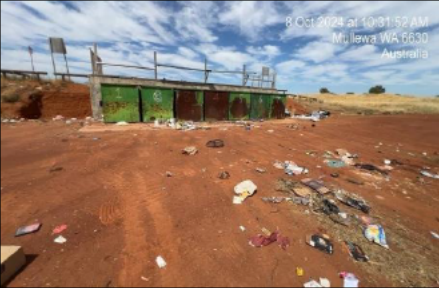
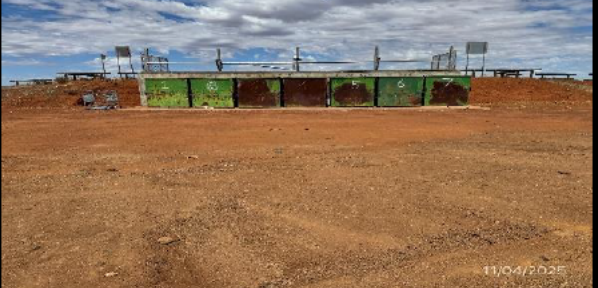
<p>Photograph 2a: Drum muster containers & Hydrocarbon material inside drums</p>	<p>Photograph 2b: Drum Muster Cage</p>

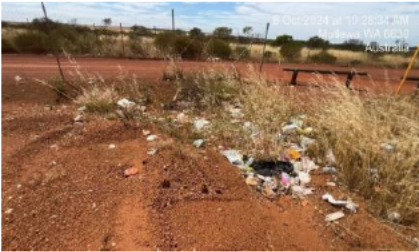
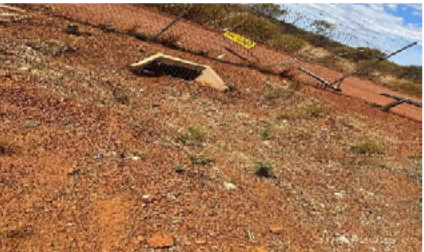
<p>Photograph 3a: Accumulated waste on the stormwater drainage channels</p>	<p>Photograph 3b: Cleared stormwater drainage channels</p>

the Premises and a contact number for alternative disposal options.		
1.2.15	The Licensee shall maintain all access roads and drainage channels at the Premises to ensure that uncontaminated stormwater runoff does not come into contact with wastes.	Officers observed waste within the stormwater drainage channels	<ul style="list-style-type: none"> • All debris has been removed from the stormwater drainage channels (Photographs 3b to 5b). • Inspection schedules have been implemented to ensure the continued functionality and effectiveness of the drainage system.

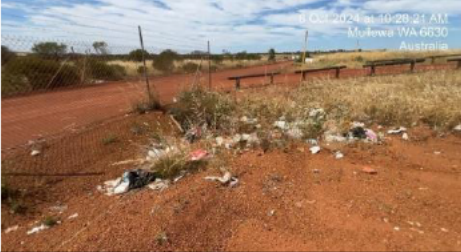
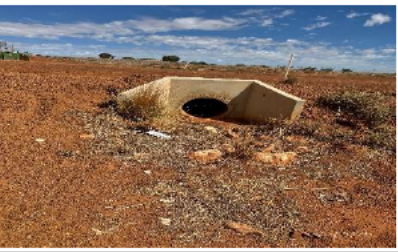
<p>Photograph 4a: Accumulated waste on the stormwater drainage channels</p>	<p>Photograph 4b: Cleared stormwater drainage channels</p>

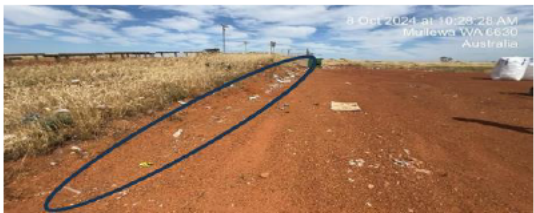
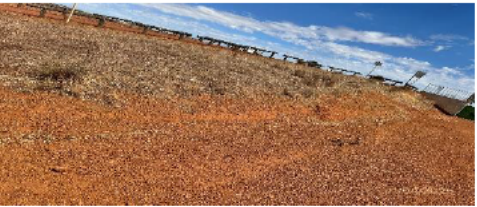
<p>Photograph 5a: Waste observed within the stormwater drainage channels</p>	<p>Photograph 5b: Cleared stormwater drainage channels</p>

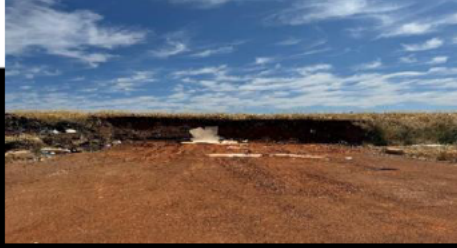
Photograph 7a: Excavated portion of the landfill

It has been noted that works were observed to have been carried out at the landfill site that could potentially lead to the release of asbestos fibres (Photographs 21 to 27, Appendix A).

The DWER has requested that the area be covered within two days. However, since no asbestos was buried at this location, and given that Condition 1.2.5 in Table 2 of the Compliance Inspection Report requires the reinstatement of final soil cover on the landfill cell within 60 days, the City proposes to take the necessary actions in line with this condition.

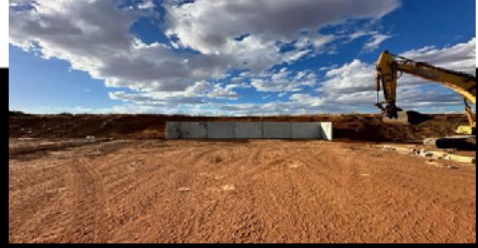
Photograph 7b: Clean fill to cover the excavated portion

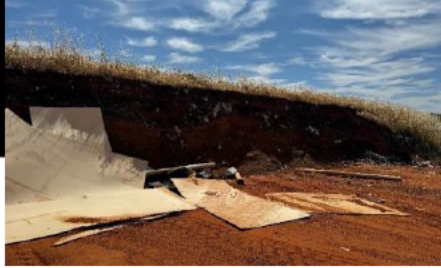
<p>1.2.5 Table 1.2.3</p>	<p>The Licensee shall ensure that cover is applied to waste in accordance with Table 1.2.3 and that sufficient stockpiles of cover are always maintained on site. Refer to Table 1.2.3 in the Licence</p>	<ul style="list-style-type: none"> • Uncovered stockpiles of waste materials in the landfill area such as C & D Waste, tyres. • Recently exposed landfill that appeared to have been excavated. • No final cover on the landfill. 	<ul style="list-style-type: none"> • Exposed areas have been appropriately capped with clean fill and reinforced with L-shape concrete retaining walls to ease operations. • Stockpiles have been reorganised to enhance site presentation and ensure regulatory compliance (Photographs 6b to 9b).
<p>1.2.10</p>	<p>The Licensee shall install and maintain a sign at the</p>	<p>Officers observed a sign located at the entrance to the Premises. The</p>	<ul style="list-style-type: none"> • The new signage has been designed and installed in compliance with all relevant

Photograph 8a: No cover material observed on the active landfill tip face.

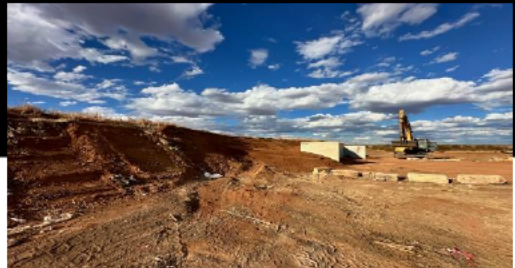
Photograph 8b: Clean fill to cover the excavated portion

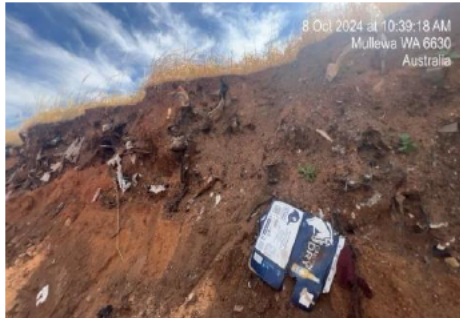
Photograph 9a: Exposed landfill section showing layers of mixed waste materials.

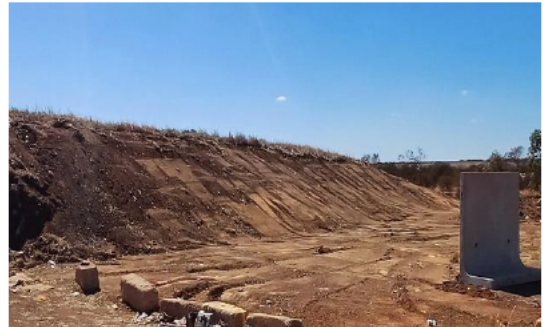
Photograph 9b: Cover material placed
