Annual Audit Compliance Report Form

Section A – Licence details			
Licence number:	L7750/2001/10	Licence file number:	2011/009482-1
Licence holder name:	Evolution Mining (Mungari) Pty Ltd		
Trading as:	Evolution Mining		
ACN:	002 124 745		
Registered business address:	Level 30 175 Liverpool Street SYDNEY NSW 2000		
Reporting period:	01/01/2024 to 3	31/12/2024

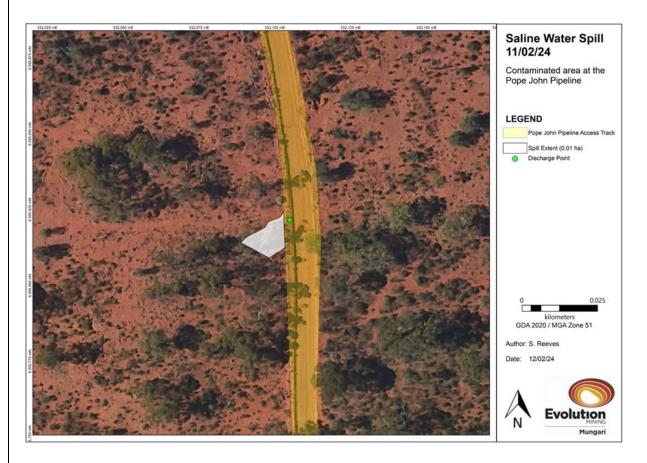
Pope John Pipeline Spill

During track maintenance activities a grader blade accidentally contacted the buried Pope John Pipeline, puncturing it and causing a leak. No water was being pumped through the pipeline at the time of the incident and only the contents of the pipeline above the puncture was discharged. The majority of the water was contained within the access track; however, a small amount was released to the surrounding vegetation, approximately 113m². The total volume of the spill was approximately 200kL.

Minimal environmental impact, small saline spill to vegetation approximately 113m².

Grader contact with buried HDPE dewatering pipeline, known as the Pope John Pipeline.

The spilled material was scraped up and removed. An internal investigation was carried out and the following actions implemented:

- Signs installed showing where the Pope John Pipeline is situated
- Roadside delineators installed
