Annual Audit Compliance Report Form

Licence number:	L7799/2001/8	Licence file number:	DER2015/001639-1
Licence holder name:	Resource Recovery Group		
Trading as:	Resource Recovery Group		
ACN:			
Registered business address:	9 Aldous Place BOORAGOON WA 6154		
Reporting period:	01/07/2024 to 30/06/2025

BIOFILTER ODOUR EMISSIONS COMPLIANCE REPORT

**RESOURCE RECOVERY GROUP:
CANNING VALE CENTRE**

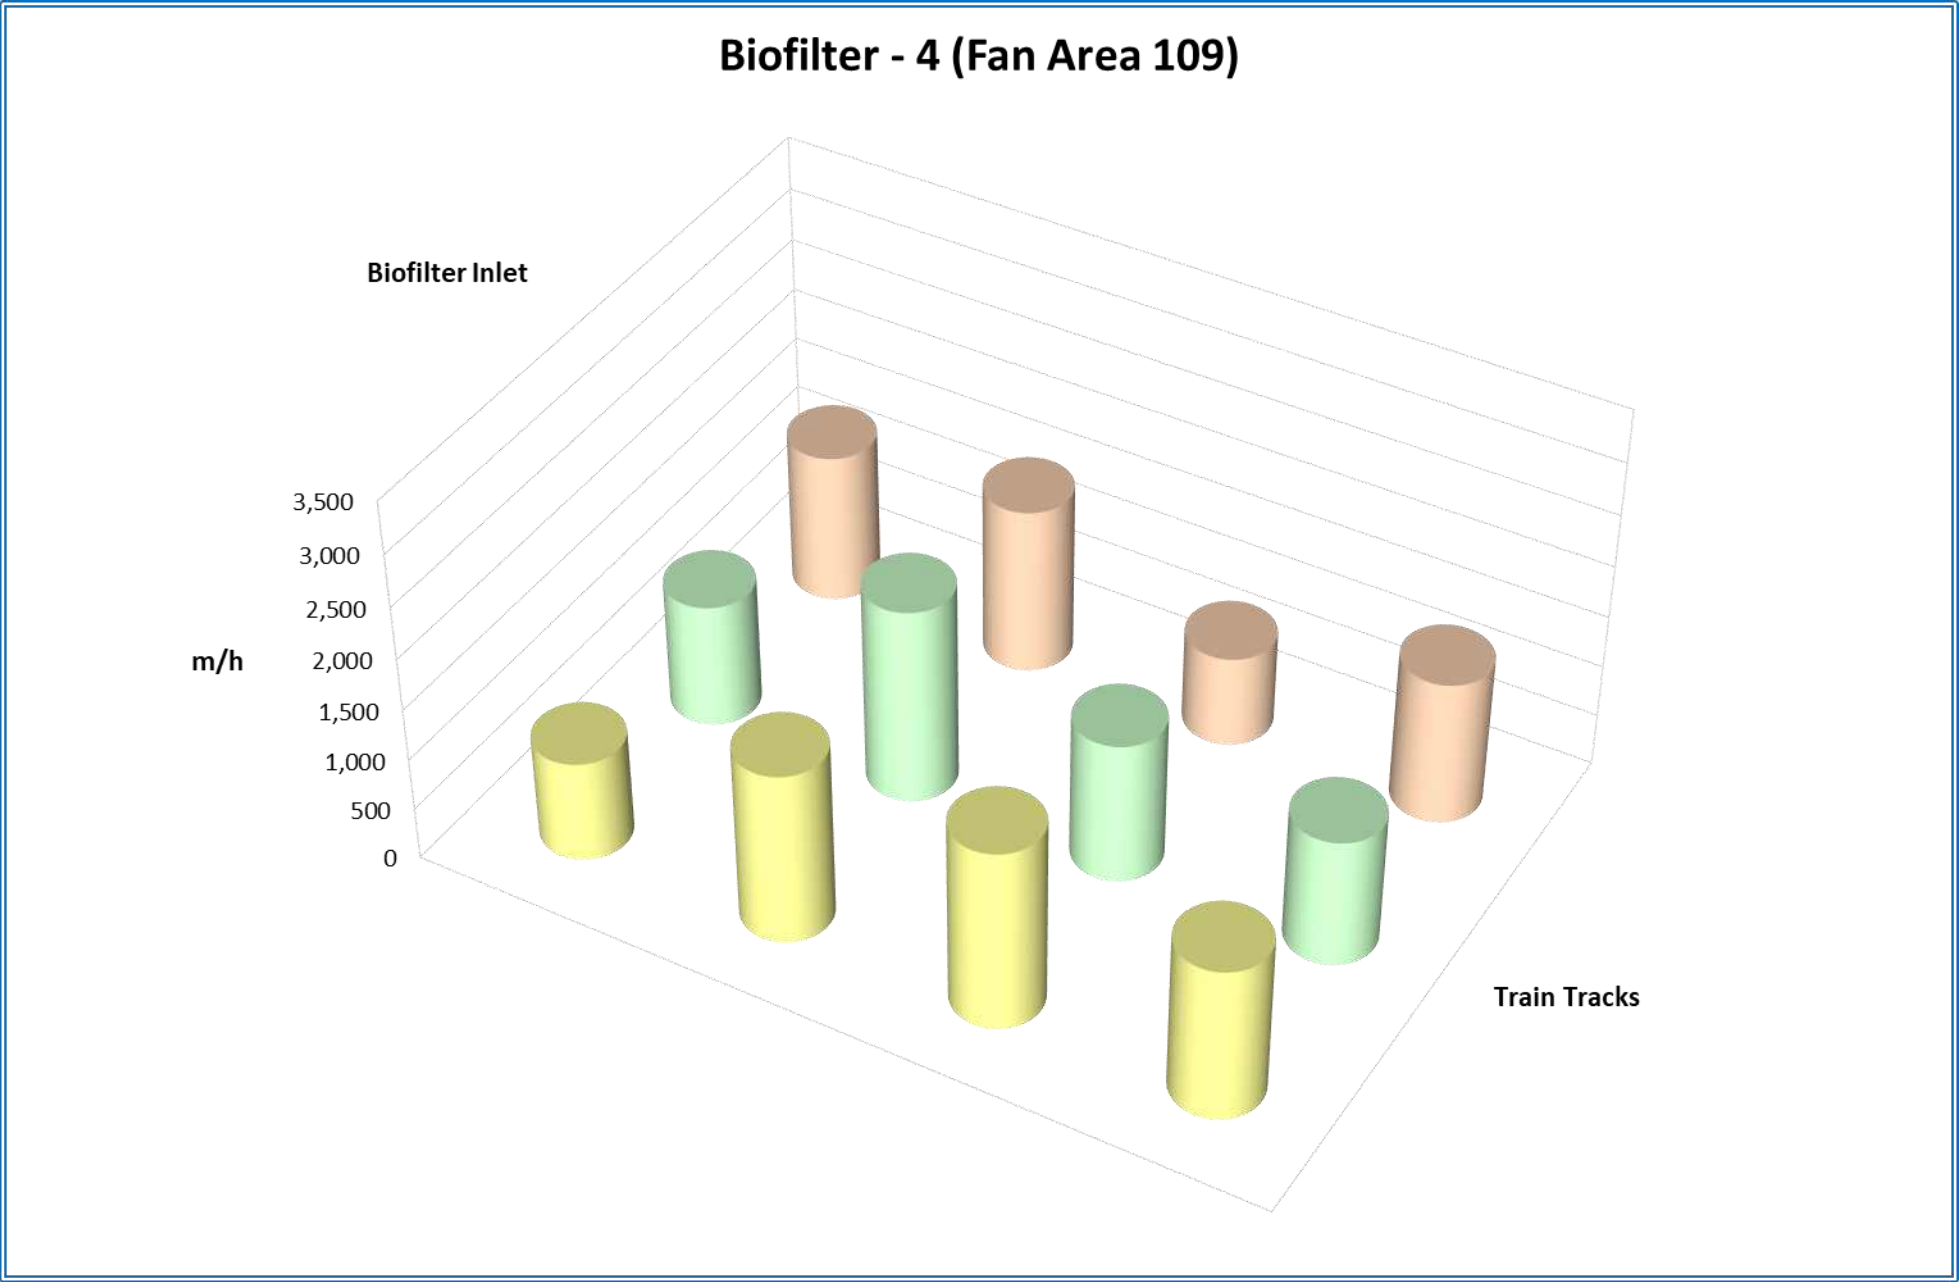
Surface Temperature Profile – Fan Area 109		
Front – adjacent to Aeration Building		
21.6	21.5	21.7
20.5	21.5	19.9
22.0	21.5	21.4
20.7	21.7	21.5
Rear – Train Tracks

Average Surface Velocity (m/h)	Fan Area (m²)	Average Surface Flow (m³/h)	Average Surface Flow (scaled up) (m³/h)
1,420	389	12,850	51,459

Results from the upcoming March sampling period will determine if Fan Area 109 is properly acclimatised to the reintroduction of normal airflows.

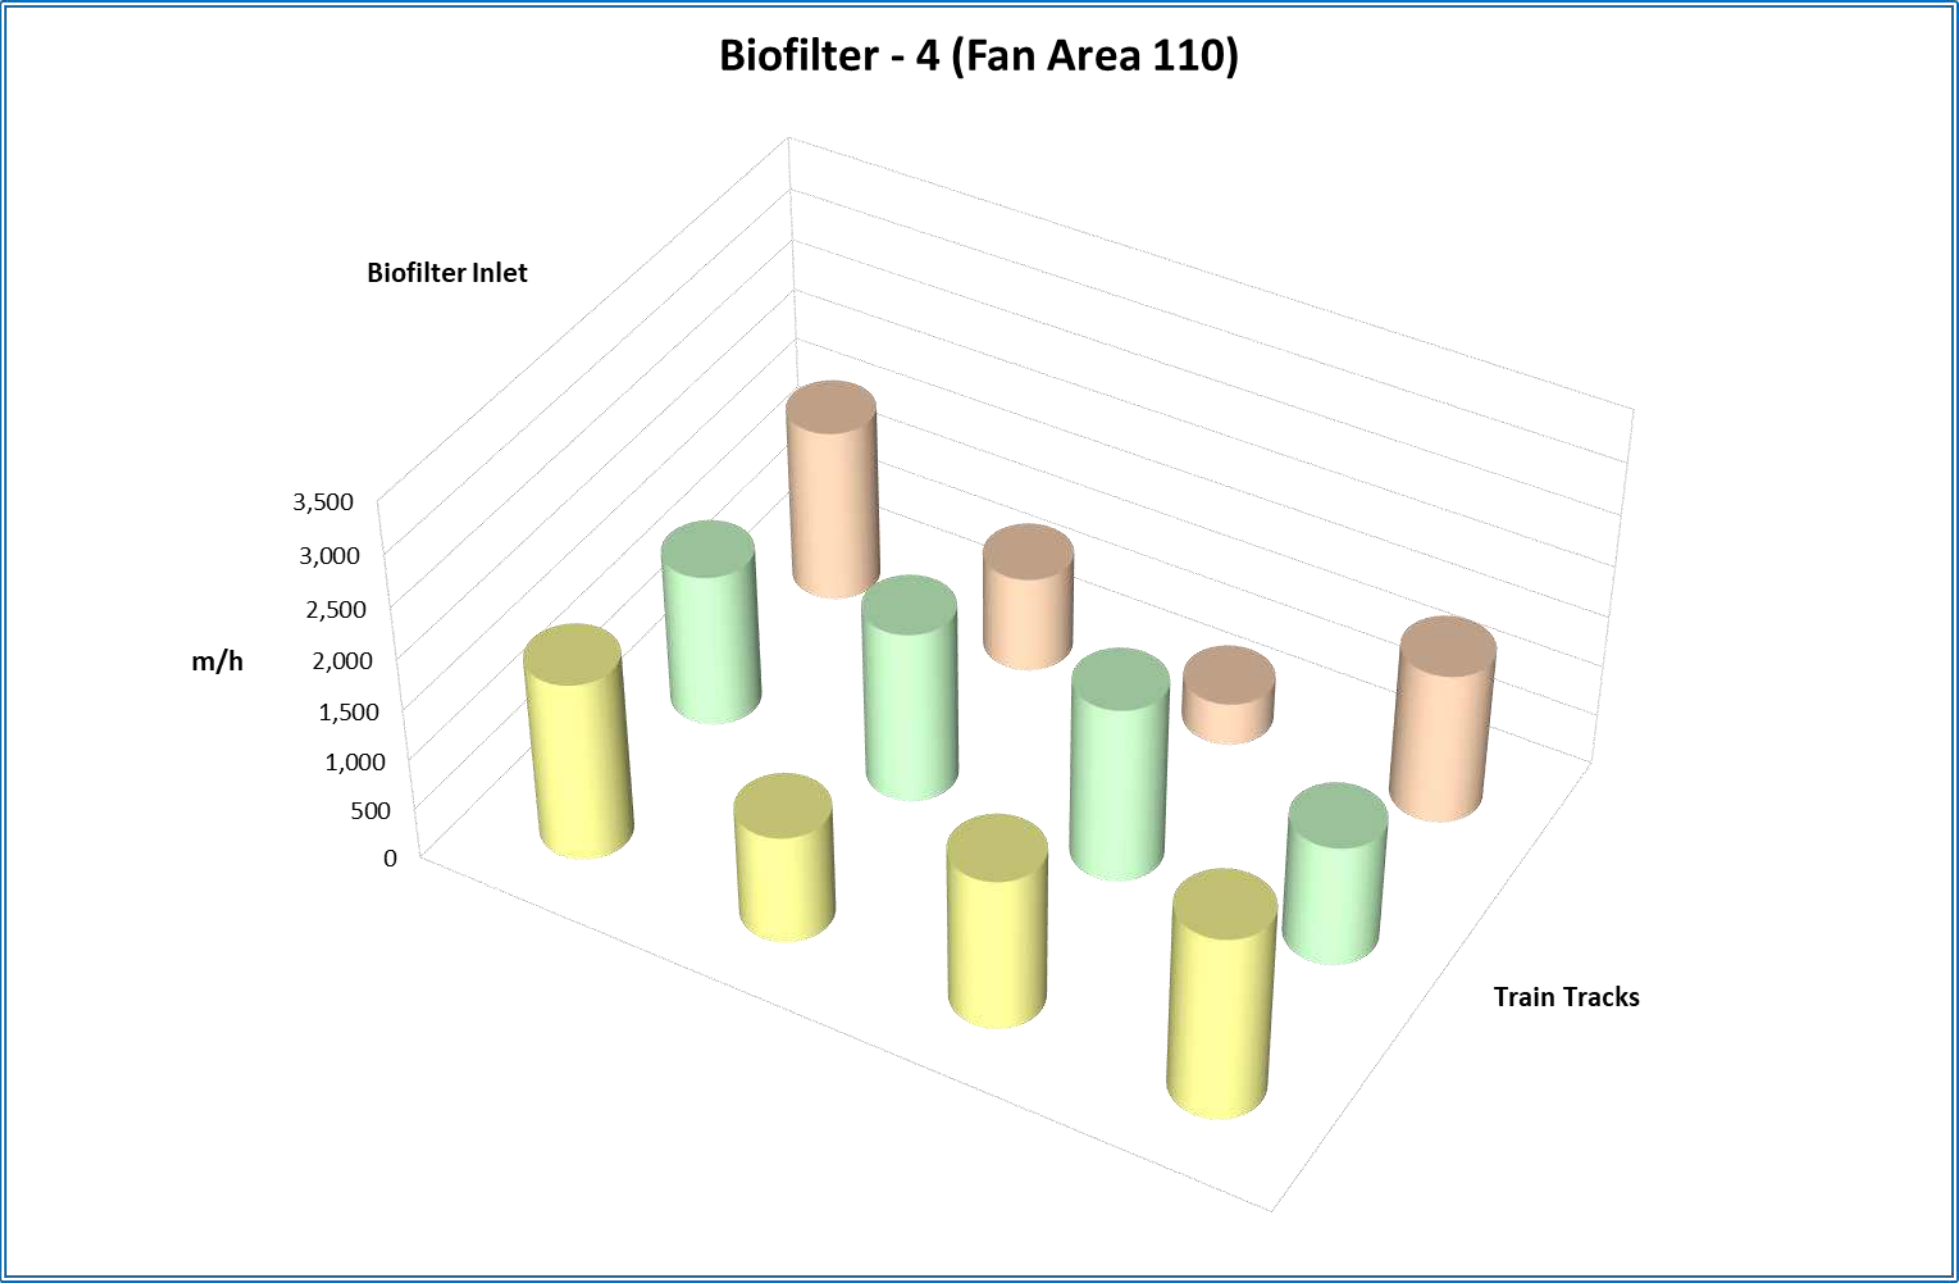
Surface Temperature Profile – Fan Area 110		
Front – adjacent to Aeration Building		
21.4	21.4	22.0
21.6	22.0	22.0
21.8	22.0	21.6
21.8	21.0	20.9
Rear – Train Tracks

Average Surface Velocity (m/h)	Fan Area (m²)	Average Surface Flow (m³/h)	Average Surface Flow (scaled up) (m³/h)
1,404	389	12,713	26,012

The exceedance of odour strength from Fan Area 110 is not readily explained, although there was an exceedance from Fan Area 110 during the December 2024 sampling period suggesting that Fan Area 110 may be due for refurbishment.
