Bibra Lake Resource Recovery Park Annual Environment Report

Jan 2025 - Dec 2025

Odour Management Plan

Licence L8798/2013/1 - Conditions 24 & 25

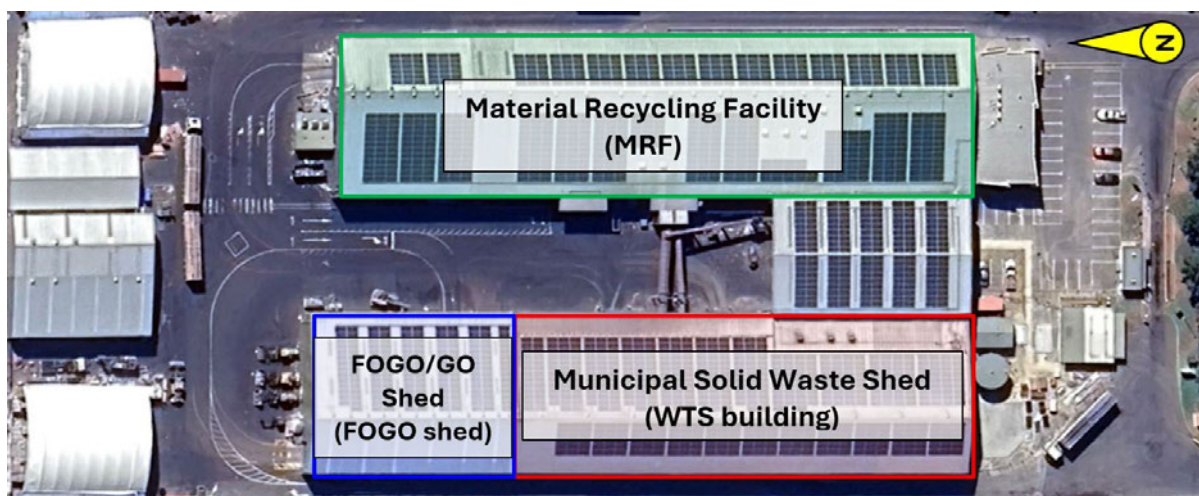
Figure 1: MRF, MSW shed and FOGO shed

As depicted in **Figure 1**, the eastern shed houses the MRF for receipt and processing recyclable wastes. Mixed waste and C&I waste are received into the MSW shed (**WTS building**), and FOGO/GO is received into the purpose built shed extension (**FOGO shed**) that became operational in December 2022.

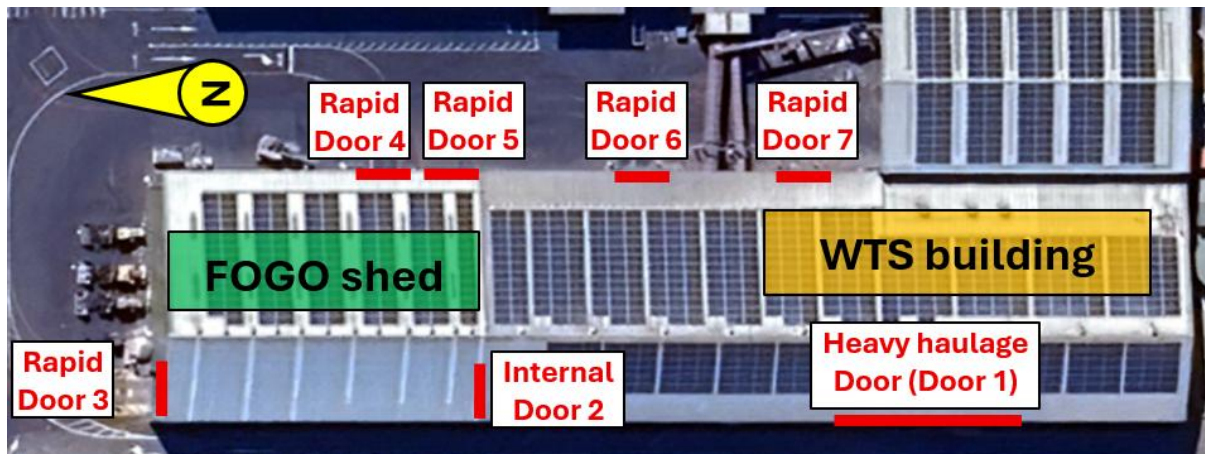
Figure 2: Door numbering for the WTS building and the FOGO shed

The entire building is equipped with automatic access doors, most of which are fast acting, opening and closing within approximately five seconds to allow vehicle movement. Door 1, due to its larger size, is not fast-acting and consists of two panels (north and south).

A detailed layout showing the door numbering and configuration is provided in **Figure 2**.

Door 1, due to its large size and the presence of two heavy sliding panels, operates more slowly. For safety reasons, this door remains open for approximately 2.5 minutes after no vehicle movement is detected. This extended open period represents a key pathway for fugitive odour emissions. Veolia investigates solutions to reduce the opening time of Door 1. Veolia can commit to reviewing this time to shorten where possible, however, the risk of damage or impact to Door 1 must be managed as a priority to ensure that Door 1 remains operational.
