**PRELIMINARY ENVIRONMENTAL IMPACT ASSESSMENT AND
ENVIRONMENTAL MANAGEMENT PLAN (MINOR PROJECTS)**

**MATERIAL PIT EXTENSIONS
NORTH WEST COASTAL HIGHWAY
397.4 & 416.9 SLK**

Prepared by Crystelle Evangelista (Environment Officer)
Gascoyne Region
March 2008

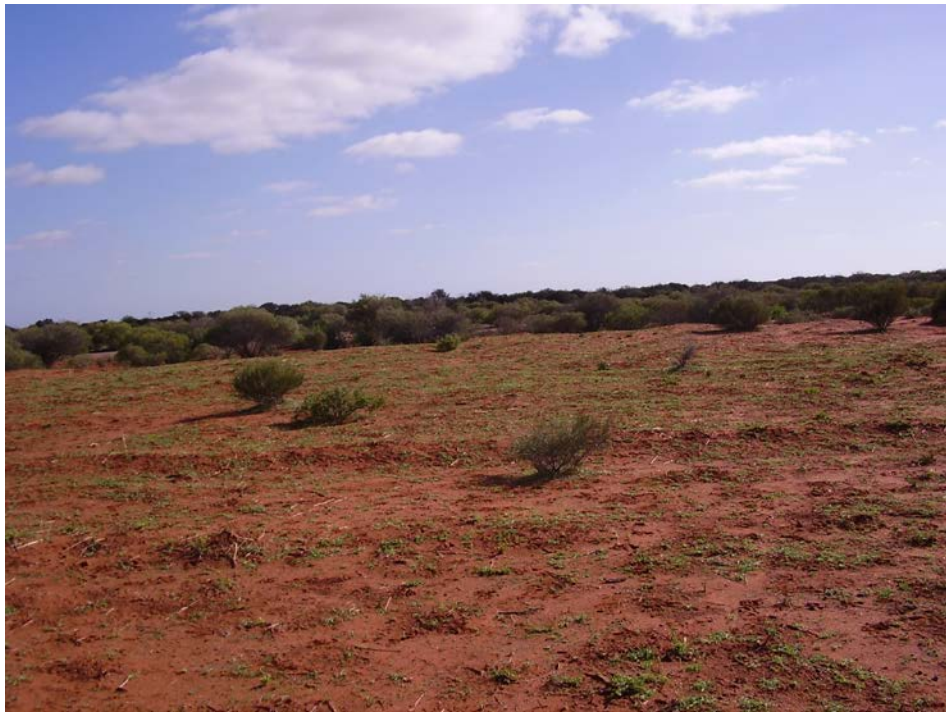
Photograph 1: Pit Extension 397.4 SLK – North West Coastal Highway – North View

This material pit occurs within vegetation association No. 346 which is described as Mosaic: "Shrublands; *Acacia sclerosperma*, *A. victoriae* & snakewood scrub / Shrublands; patches of low mixed scrub". According to Native Vegetation Association Data (DEC & DAF) this vegetation association is well represented in the region with 100% remaining. The condition of the vegetation is best described as degraded due to the grazing of cattle and previous material extraction.

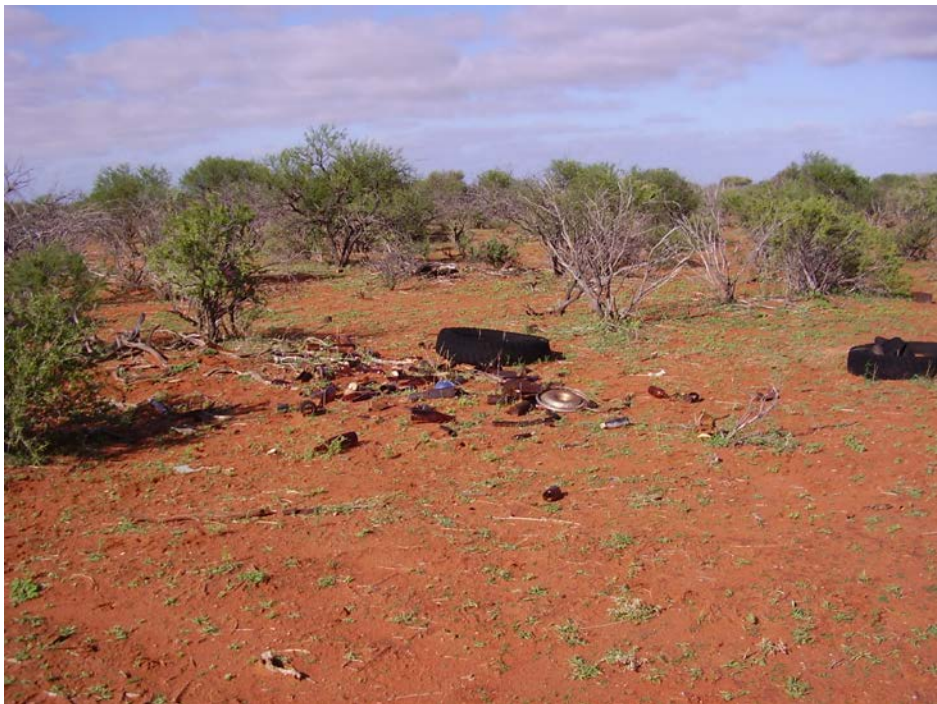
Photograph 4: Pit Extension 397.4 SLK – North West Coastal Highway – Dumped Rubbish

All waste materials from the development are to be completely removed from the site upon completion of the development. Final clean-up shall be to the satisfaction of the Project Manager and the Site Superintendent.	Contractor	Main Roads

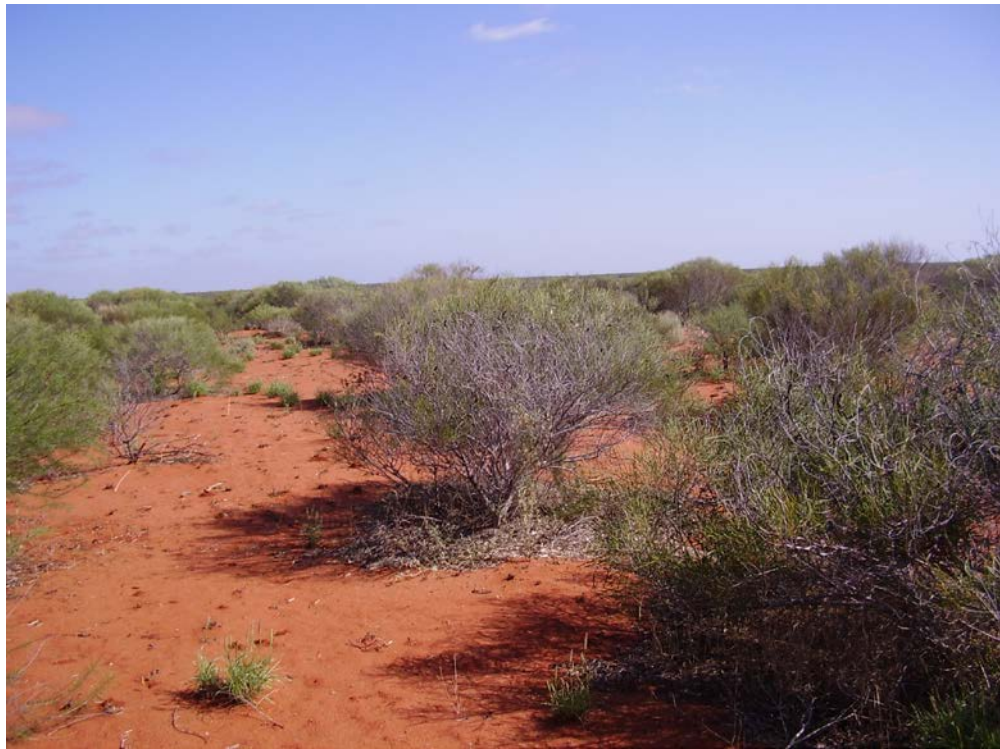
Photograph 5: Pit Extension 416.9 SLK – North West Coastal Highway – North View

This material pit occurs within vegetation association No. 346 which is described as Mosaic: "Shrublands; *Acacia sclerosperma*, *A. victoriae* & snakewood scrub / Shrublands; patches of low mixed scrub". According to Native Vegetation Association Data (DEC & DAF) this vegetation association is well represented in the region with 100% remaining. The condition of the vegetation is best described as degraded due to the grazing of cattle and previous material extraction.
