## Annual Audit Compliance Report Form

Section A – Licence details			
Licence number:	L7465/1999/9	Licence file number:	2011/011727-1
Licence holder name:	Northern Star Resources Limited		
Trading as:	Northern Star Resources Limited		
ACN:	116649122		
Registered business address:	Level 4, 500 Hay Street, Subiaco WA 6008		
Reporting period:	01 / 01 / 2022 to 31 / 12 / 2022

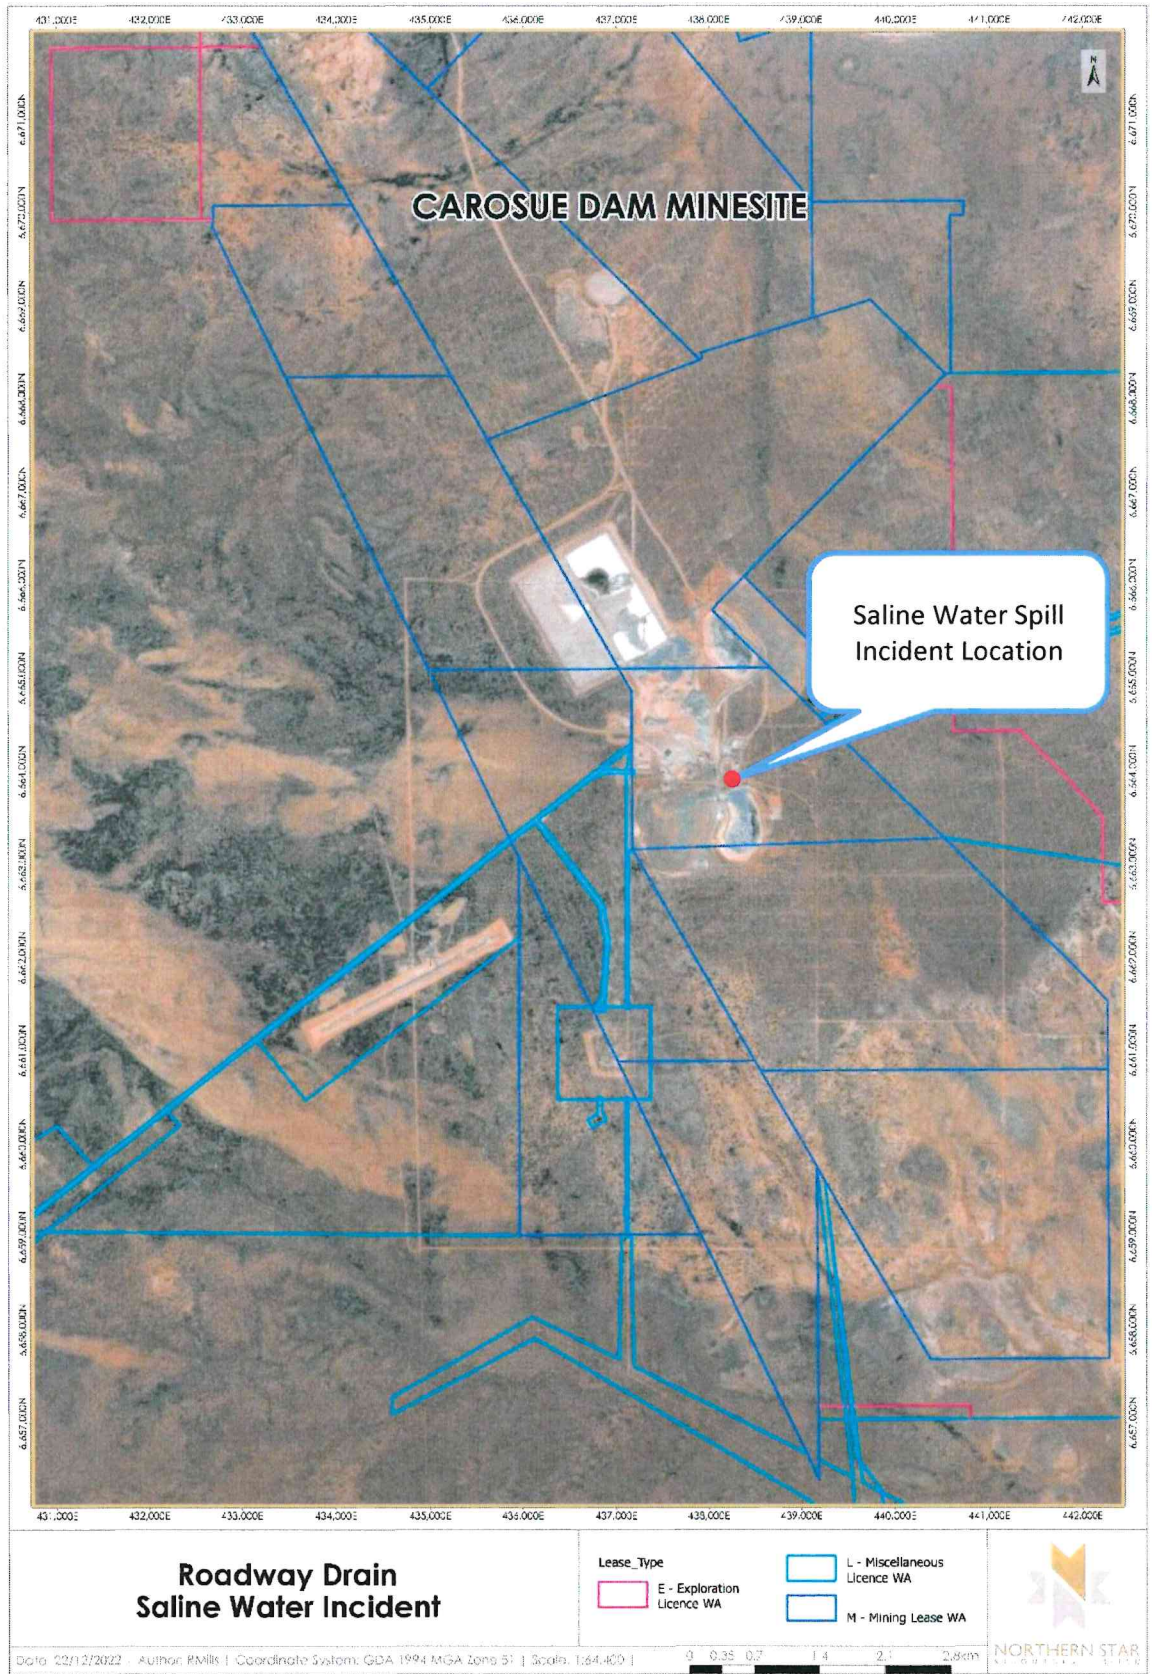
Image on next page shows the location of the spill at the Carosue Dam Operation.

Section E – Details of non-compliance with licence condition	
<b>Cause (or suspected cause) of non-compliance:</b>	
Due to roadway maintenance following a 10mm rain event, new drainage slots were cut into the roadside bunding allowing discharge of hypersaline dust suppression water when mobilised by rainfall events.	
<b>Action taken to mitigate any adverse effects of non-compliance and prevent recurrence of the non-compliance:</b>	
Entire spill was recovered. A bobcat was used to recover the salt effected areas and trees not affected by the salt will be left in-situ. Sumps were dug to capture any potential future water drainage from the roadway.	
<b>Was this non-compliance previously reported to DWER?</b>	
<input checked="" type="checkbox"/> Yes, and	
<input type="checkbox"/> Reported to DWER verbally	Date: / /
<input checked="" type="checkbox"/> Reported to DWER in writing	Date: 22 / 12 / 2022

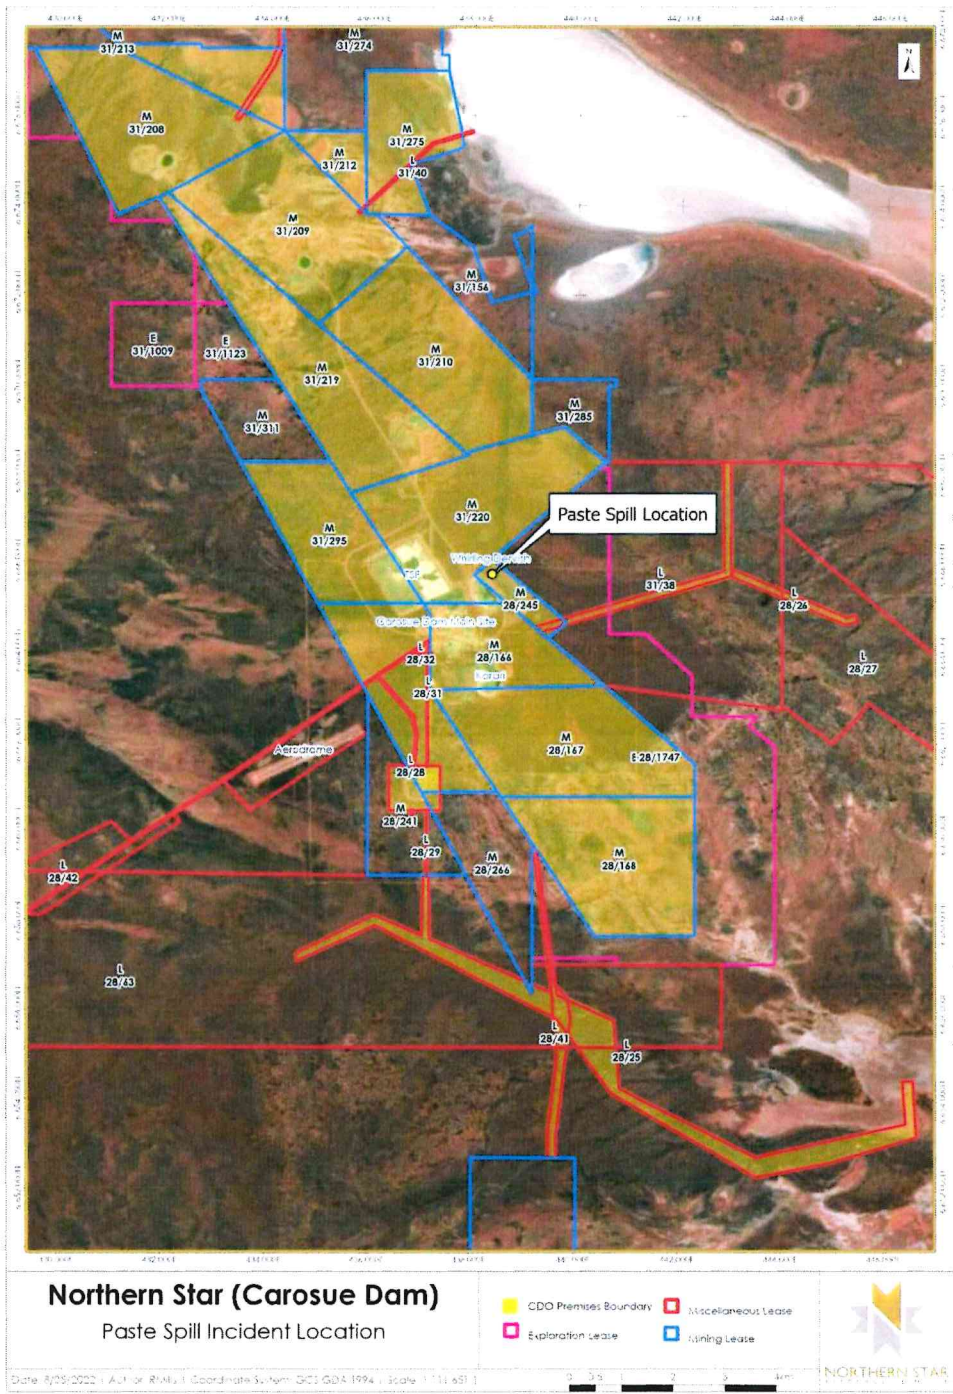
Figure 1- Paste Spill Incident Location in Relation to CDO Premises Boundary

Section E – Details of non-compliance with licence condition			
<b>Please use a separate page for each condition with which the licence holder was non-compliant at a time during the reporting period.</b>			
<b>Condition no:</b>	Condition 3	<b>Date(s) of non-compliance:</b>	20/05/2022
<b>Details of non-compliance:</b>			
Approximately 70m3 of Paste fill material (consisting of 5% cement binder and 95% dried tailings material) was discharged to a disturbed area immediately surrounding the Whirling Dervish Paste Injection infrastructure.			
<b>What was the actual (or suspected) environmental impact of the non-compliance?</b>			
<b>NOTE – please attach maps or diagrams to provide insight into the precise location of where the non-compliance took place.</b>			
Paste left to dry, then cleaned up with bobcat. Spill occurred to disturbed area only, no material impact to the Environment. Images of incident area and map location included below.

Map of spill location included below and images displaying the extent of the spill.

The spill occurred after the paste pipeline became blocked by scale build up which dislodged within the pipeline and blocked the line at the injection site. A dump valve was opened into the purpose-built catch sump to relieve pressure build up. Due to the volume of material discharged, the sump was overwhelmed, resulting in the sump overflowing to the immediate adjacent area.

Paste left to dry, then cleaned up with bobcat. Waste material disposed of within the Whirling Dervish central landform licenced paste waste location. Spill occurred to disturbed area only, no material impact to the Environment. Incident reported to DWER under Section 72.

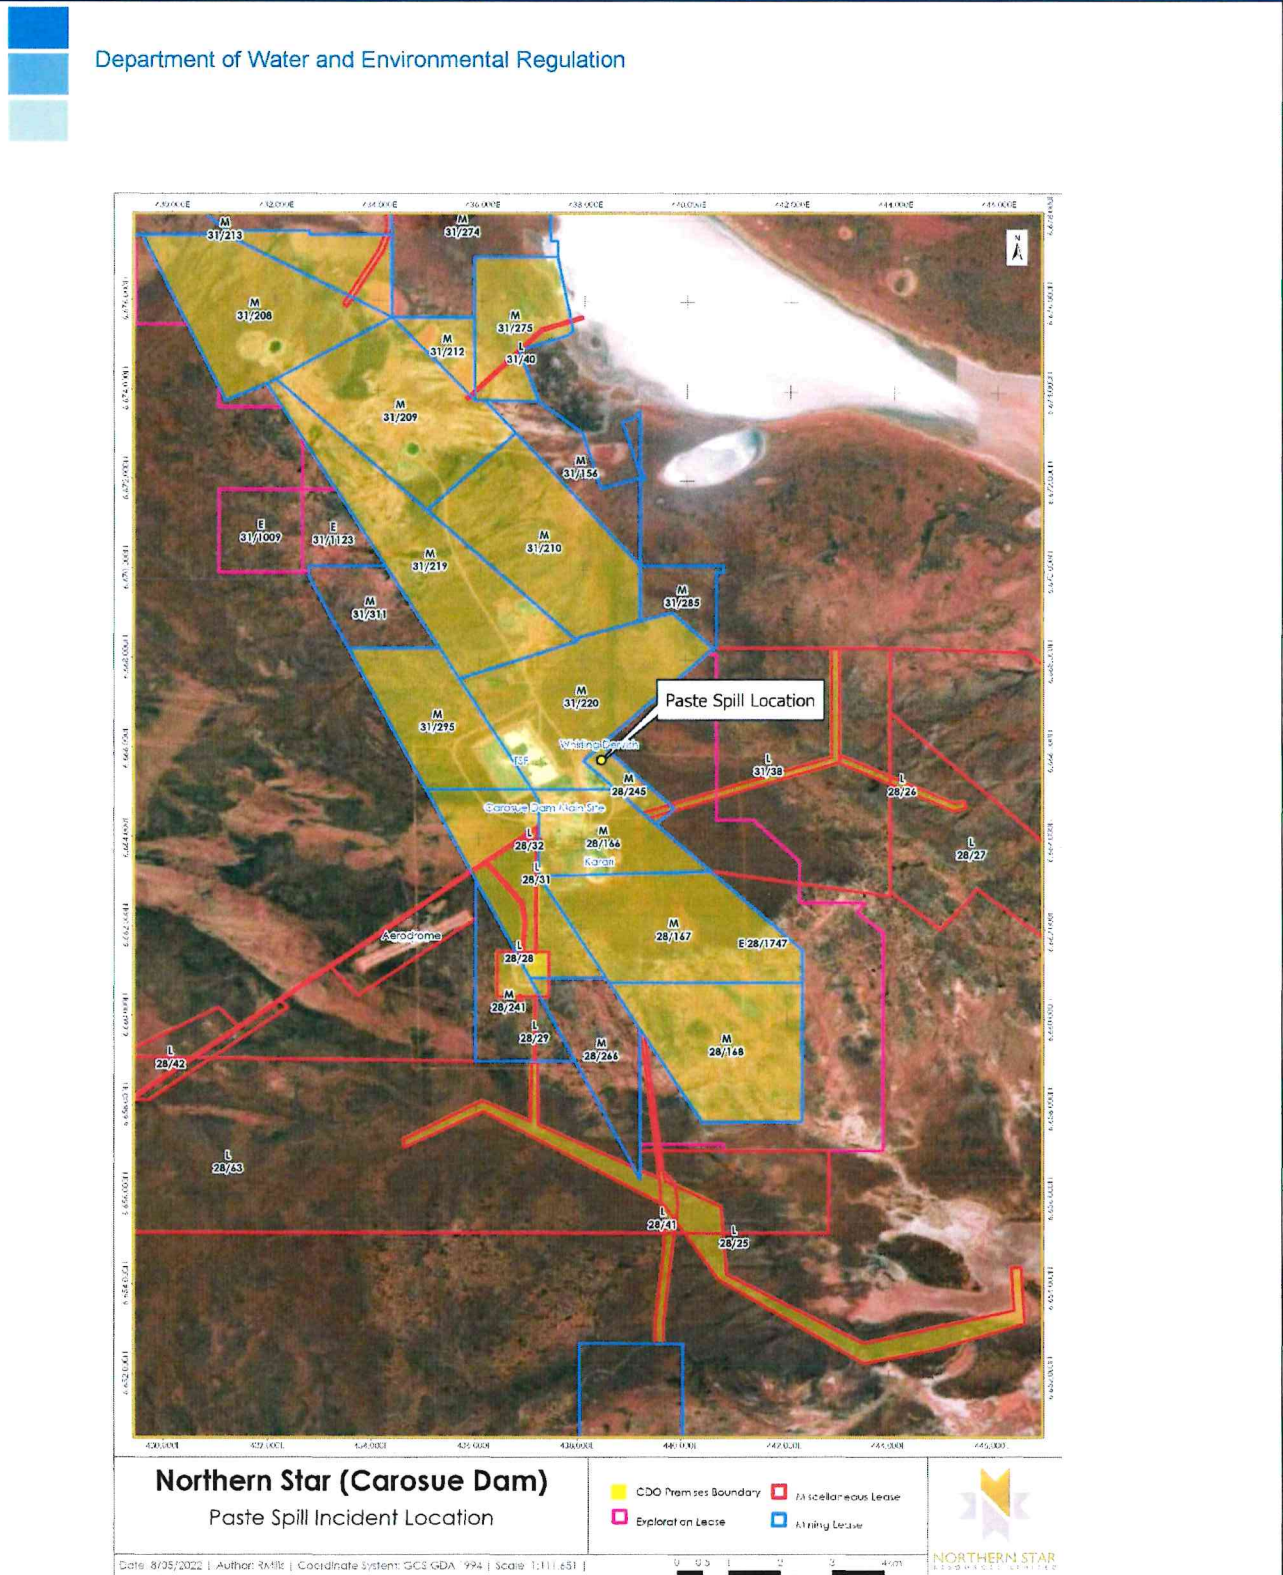
Figure 1- Paste Spill Incident Location in Relation to CDO Premises Boundary

Section E – Details of non-compliance with licence condition			
Please use a separate page for each condition with which the licence holder was non-compliant at a time during the reporting period.			
Condition no:	Condition 3	Date(s) of non-compliance:	07/05/2022
<b>Details of non-compliance:</b>			
Approximately 50m <sup>3</sup> of Paste fill material (consisting of 5% cement binder and 95% dried tailings material) was discharged to a disturbed area immediately surrounding the Whirling Dervish Paste Injection infrastructure.			
<b>What was the actual (or suspected) environmental impact of the non-compliance?</b>			
<b>NOTE – please attach maps or diagrams to provide insight into the precise location of where the non-compliance took place.</b>			
Paste left to dry, then cleaned up with bobcat. Spill occurred to disturbed area only, no material impact to the Environment. Images of incident area and map location included below.

Map of spill location included below and images displaying the extent of the spill.
