Annual Audit Compliance Report Form

Environmental Protection Act 1986, Part V

Licence number:	L8008/2004/3	Licence file number:	DER2014/000631
Licence holder:	FQM Australia Nickel Pty Ltd		
Trading as:			
ACN:	135 761 465		
Registered address:	Level 2, 18-32 Parliament Place, West Perth, WA 6000		
Reporting period:	01 / 05 / 2024 to 30 / 04 / 2025

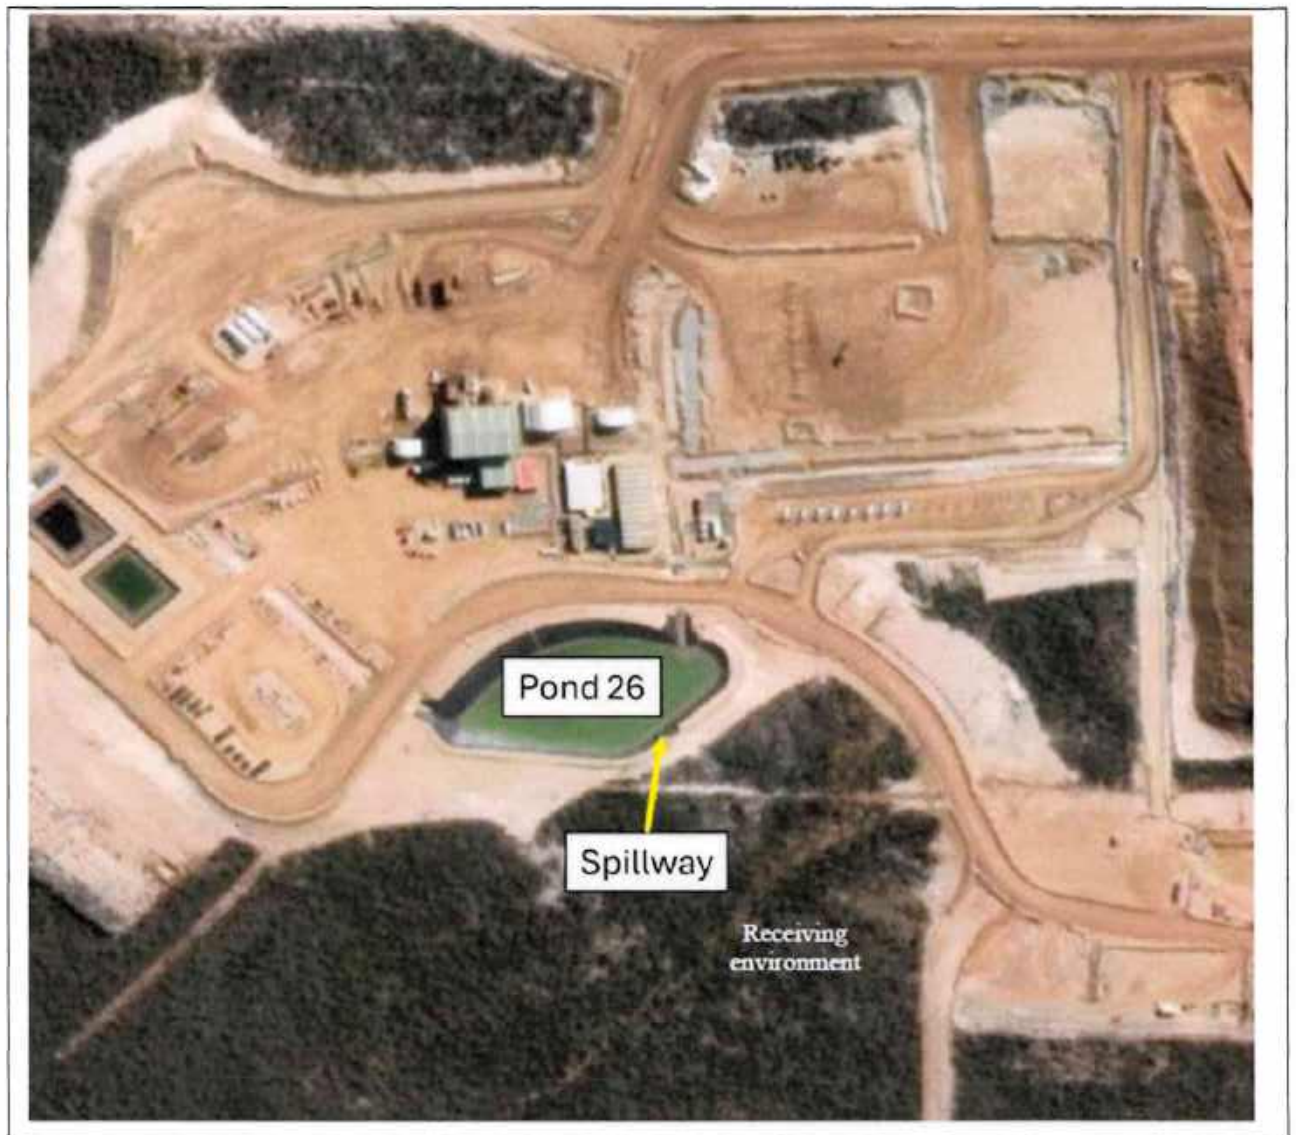
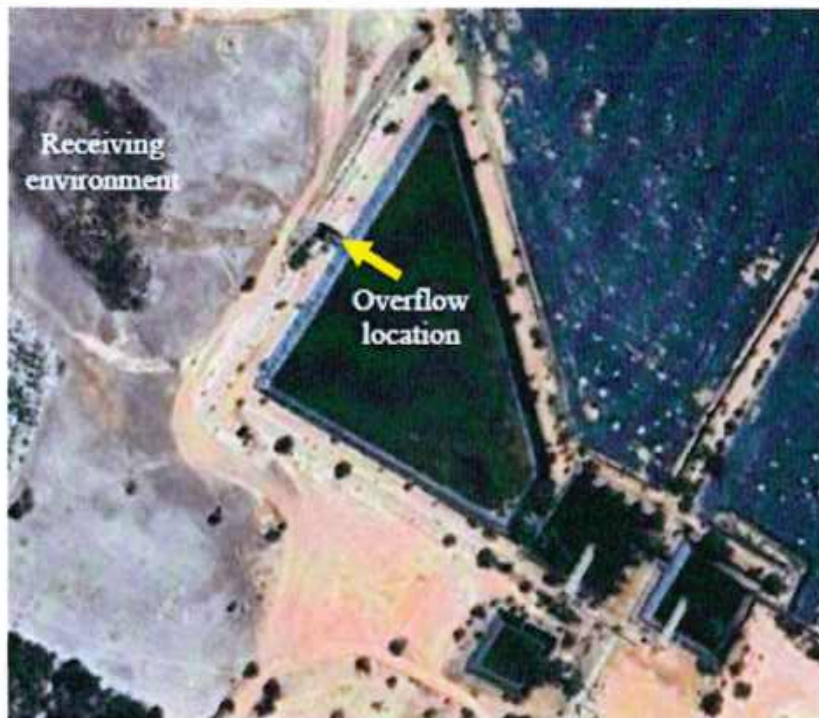
Figure 1: Overflow location and receiving environment

Condition no:	7 & 8	Date(s) of non-compliance:	14/04/2025
Details of non-compliance:			
<p>HV workshop, SML Stormwater and SRSF Ponds overtopping. The incident relates to Conditions 7 & 8, Table 3, Map reference of three ponds - Pond 12, 26 and 32. It was notifiable under Condition 8 of the extant L8008/2004/3 version as at time of the incident (since superseded)</p>			
What was the actual (or suspected) environmental impact of the non-compliance?			
<p>NOTE – please attach maps or diagrams to provide insight into the precise location of where the non-compliance took place.</p>

Nil to negligible actual impact due to the water which was inadvertently discharged to land being fresh and clean in nature. Some minor water logging consistent with broader environmental condition after a considerable rain event.

All three bodies of water catch significant quickflow in the event of a high rainfall event, such as the 70mm in 24 hours which preceded this incident. During care and maintenance, there is little demand for fresh water in the process system whereas in the past, considerable water could be consumed within the plant. This has resulted in capacity of these ponds being rapidly and unforeseeably overwhelmed, as the actual rain received was well in excess of the forecast at the time, which predicted sub 20mm for that period.
