Appendix C

Dam Safety Emergency Plan (DSEP)

This Dam Safety Emergency Plan (DSEP) applies to Tailings Storage Facility 3 (TSF3) at the Moolart Well Gold Project (MWGP), a gold mine located approximately 130 km north of Laverton and 790 km northeast of Perth, Western Australia. MWGP is owned by Regis Resources Limited (RRL).

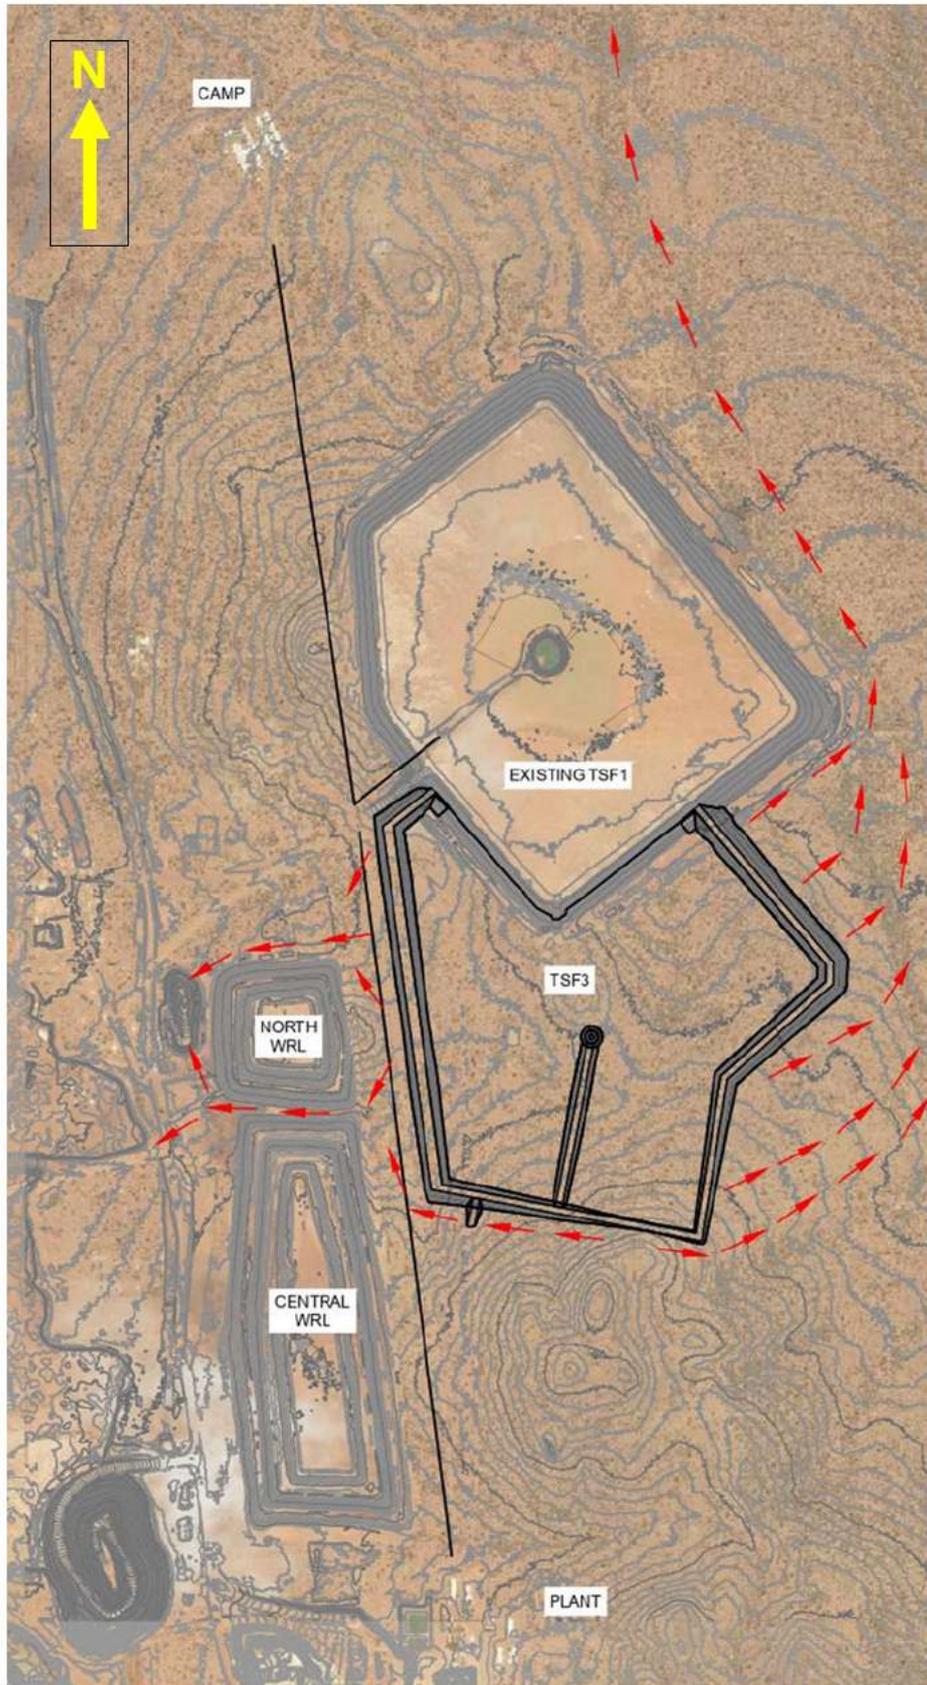
An Inundation Map is shown below.

Figure: Inundation Plan (ref: CMW (2021) Design Report)

The result from breach modelling indicates that the maximum (peak) run-out flow from a 'dam break' under 'worst-case' (Probable Maximum Precipitation, PMP) rainy day conditions will be approximately 751 to 1,539 m³/s over 2 hours.

- A dam break is unlikely to inundate the plant or the camp, however, there is potential for loss of life due to the presence of infrastructure along the western corridor of TSF3.
- No public infrastructure is likely to be affected.
- Economic loss from permanent loss of assets including infrastructure, repairs of damaged sections of TSF, damage to plant and local mine site roads.
- Limited impact on heritage value areas and on the natural environment, and effects on native flora and fauna downstream of TSF3. Damage would reasonably be expected to be concentrated in the ephemeral streams.
- Prolonged damage to the natural environment with potential for contamination of soils and vegetation distress requiring environmental 'clean-up', and permanent damage to heritage areas with remediation possible but difficult.
