<b>Licence Number</b>	L8008/2004/3
<b>Licence Holder</b>	Ravensthorpe Nickel Operations Pty Ltd
<b>ACN</b>	092 506 584
<b>File Number:</b>	DER2014/000631
<b>Premises</b>	Ravensthorpe Nickel Operations Mining tenements M74/114, M74/115, M74/116, M74/123, M74/144, M74/145, M74/173, M74/174, M74/175. RAVENSTHORPE WA 6346
<b>Date of Amendment</b>	27 September 2019

## 1. Amendment notice

This notice is limited only to an amendment of conditions to reflect monitoring and reporting requirements during operational and non-operational periods, inclusion of definitions, and the addition of an improvement condition.

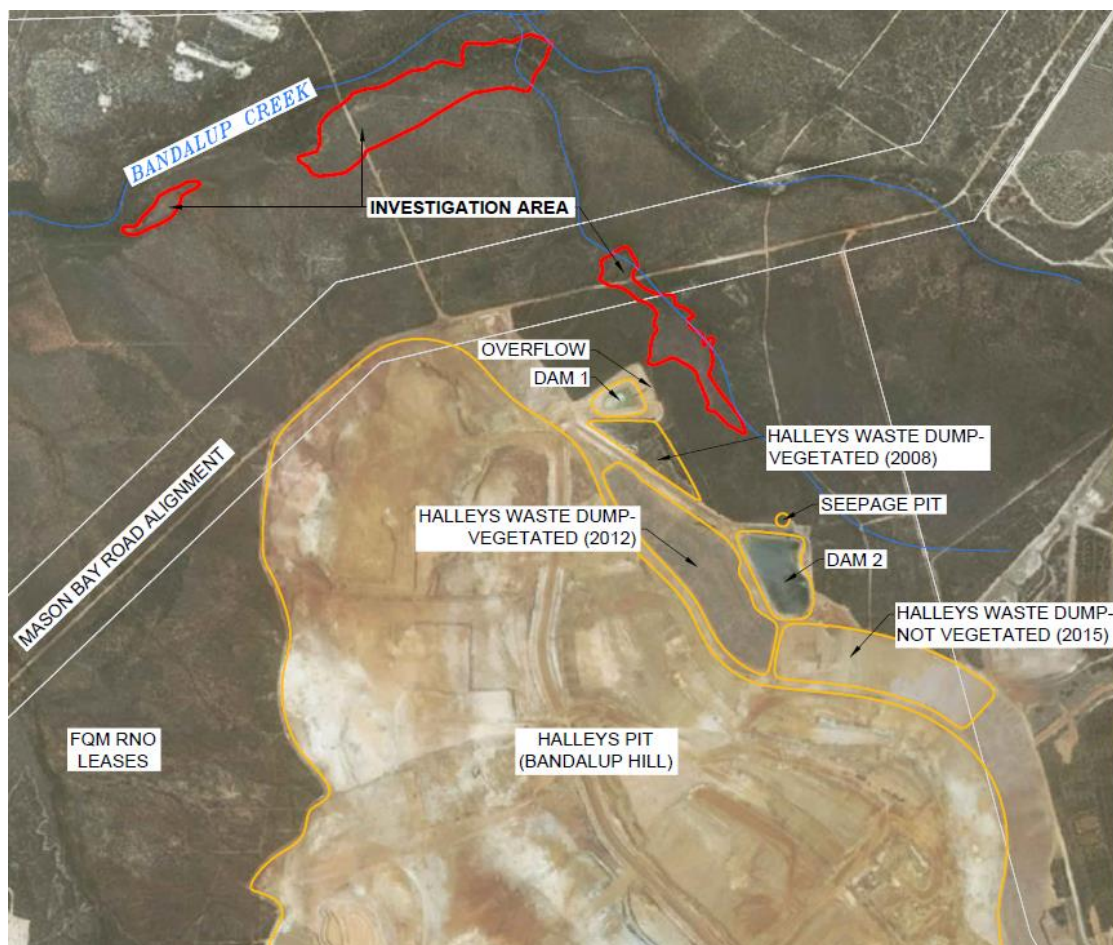
**Figure 1: Dam 2 location in relation to Halleys waste dump, tributaries, Bandalup Creek and areas of vegetation death and decline**

The PDSI concluded that the likely cause of the vegetation decline and deaths was the seepage of and/or overflow of saline water from Dam 2. The impacted areas are located adjacent to several tributaries which feed into Bandalup Creek, one of which originates near the base of Halleys waste dump. The extent of the areas of vegetation death and decline have not been fully delineated to date. Figure 1 below shows Dam 2 in relation to Halleys Pit, Halleys waste dump, tributaries, Bandalup Creek and the investigation areas considered in the PDSI.
