# **Validation Report: Lots 8-9-10 Preliminary Earthworks**

Red Hill Waste Management Facility

Prepared for Eastern Metropolitan Regional Council

Project Number: TW19110

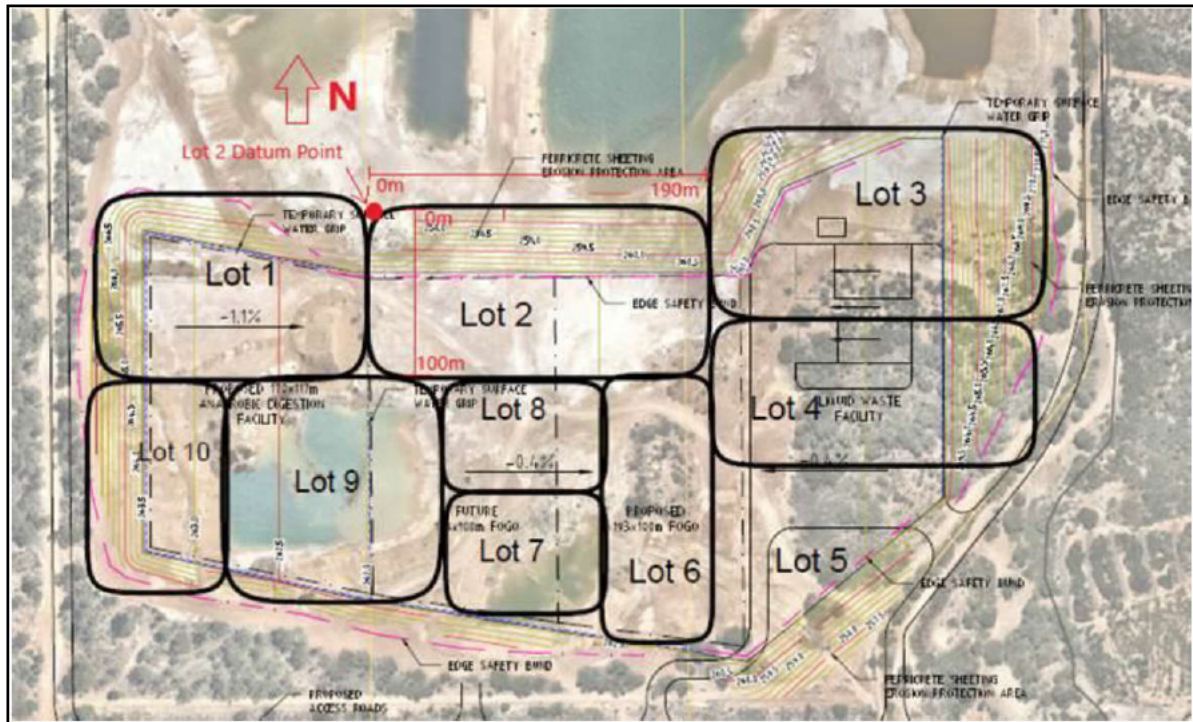
For quality control purposes, the Works were divided into 10 Lots for the construction of the hardstand as per Diagram 2-1.

Diagram 2-1: Lot Map for Structural Fill Hardstand

Approximately 221,217m<sup>3</sup> of General and Structural Fill was ultimately placed during the Works.

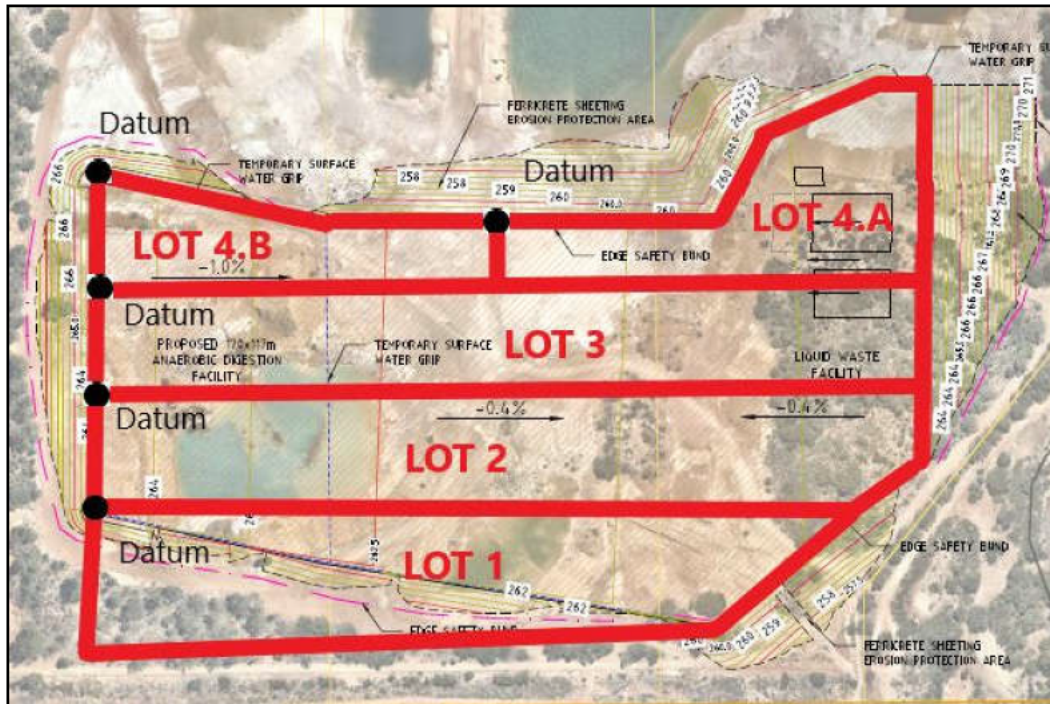
Approximately 45,110m<sup>3</sup> of ferricrete sub-base was ultimately placed during the Works. For quality control purposes, the Works were divided into 4 Lots for the placement of the ferricrete as per Diagram 2-2.

Diagram 2-2: Lot Map for Ferricrete Placement
