SUPPORTING DOCUMENT

Proposed works include construction and time limited operations of a new Inpit tailings storage facility (TSF) known as the 8 Series Inpit TSF with a design capacity of 4,620,000 tonnes per year.

Design Report (Geotechnical Assessment)

Reference: 754-PERGE318544_MMO IPTSFs 815_7_8 Series DR_Rev0

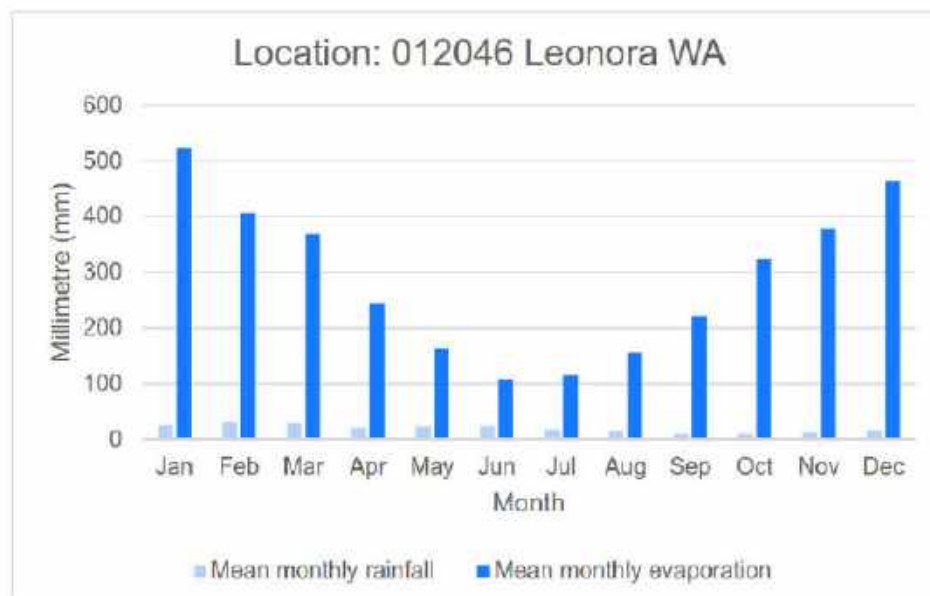
FIGURE 1: MEAN MONTHLY RAINFALL (1898-2013)

The area experiences average maximum temperature of 37°C, and average minimum temperature of 6.1°C. Annual average rainfall is 236.7 mm, with a mean of 28.9 days of rain per year (≥ 1 mm). Rainfall is highest in February at 30.9 mm and lowest in September at 8.9 mm (BOM, 2024). Mean monthly rainfall values and evaporation values are shown in Figure 1. Average annual rainfall of 236 mm and annual evaporation of 3473 mm were adopted for design purposes.

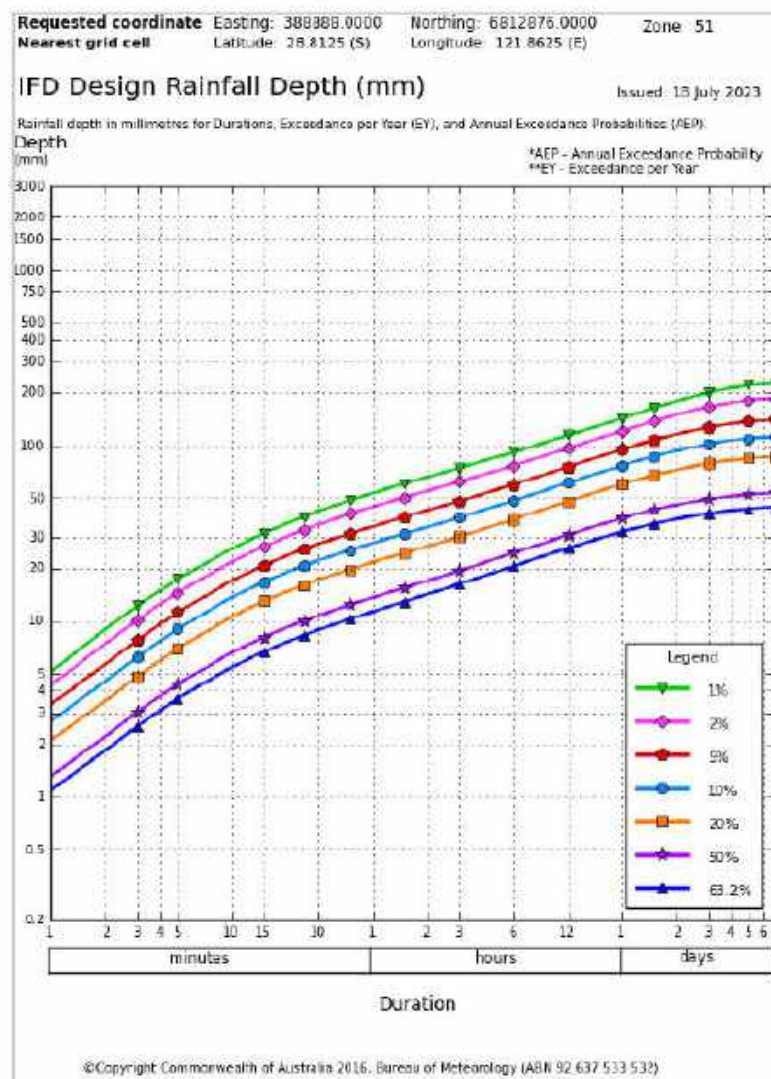
FIGURE 2: RAINFALL IFD CHART

The rainfall intensity-frequency-duration (IFD) chart pertaining to MMO is presented in Figure 2. Based on the IFD chart, a 1:100-year annual exceedance probability, 72-hour storm event can be expected to generate approximately 200 mm of rainfall (BOM, 2024).

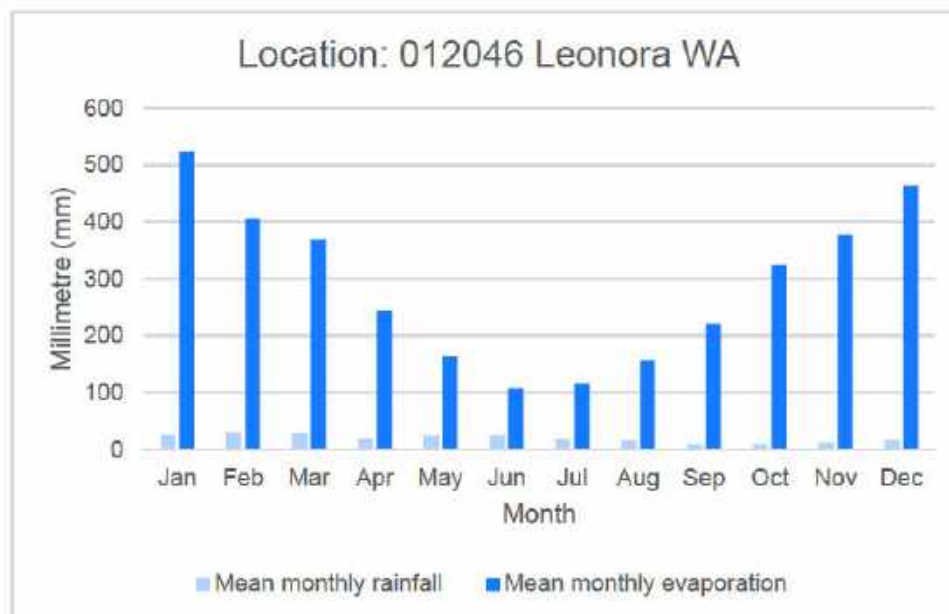
Figure 2. Mean Monthly Rainfall Chart (1898 - 2013) (BoM, 2023)

- The nearest BoM weather station to the MMO site is Leonora WA (Station Number 012046), which has collected rainfall data since 1898 to 2013, and the evaporation data was extracted from Department of Primary Industries and Regional Development – *Evaporation data for Western Australia* with the selection of Leonora station (GJ Luke, KL Burke and TM O'Brien, 2003). The mean monthly rainfall values and evaporation values are shown on Figure 2. Average annual rainfall of 236 mm and annual evaporation of 3473 mm were adopted for design purposes;
- The rainfall intensity intensity-frequency-duration (IFD) chart pertaining to the MMO site is presented on Figure 3. Based on the IFD chart, a 1:100-year AEP, 72-hour storm event can be expected to generate approximately 200 mm of rainfall.

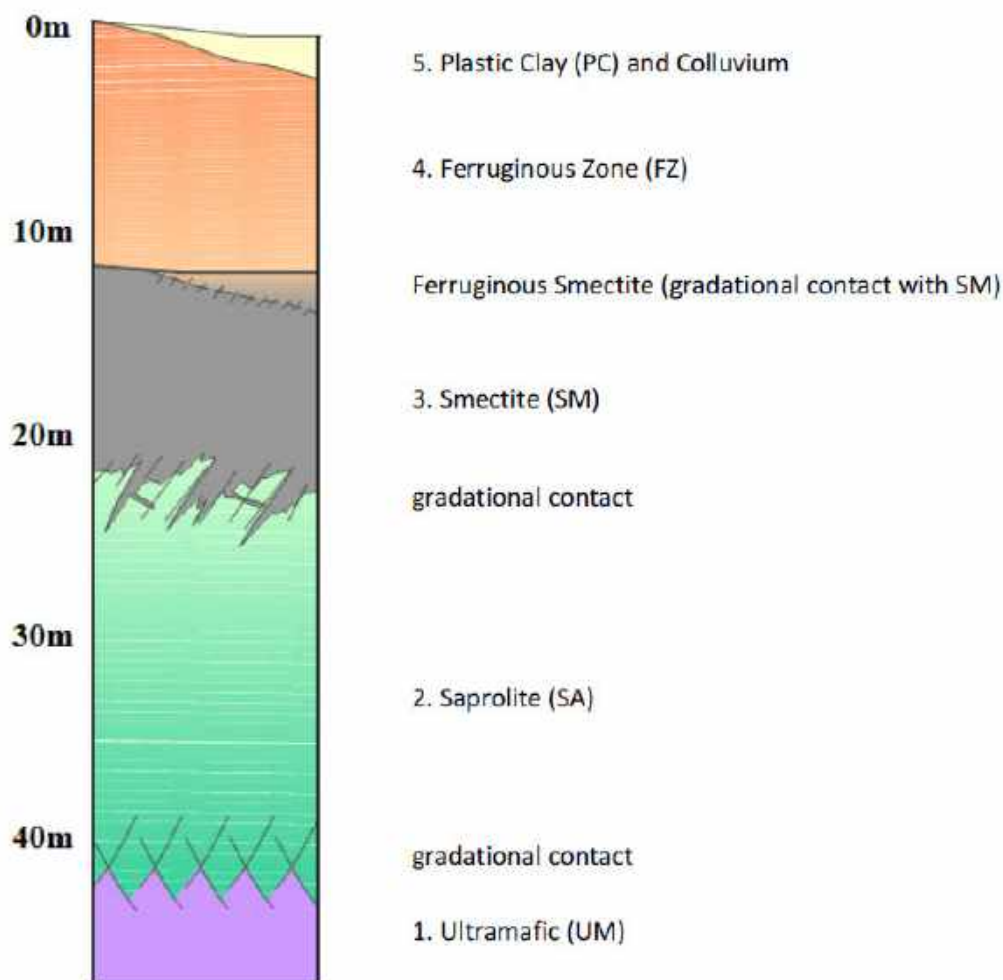
Figure 6. Generic Weathering Profile of the Murrin Murrin Nickel Laterite Deposits (MR, 2023)

The regolith profile at Murrin Murrin North project area can be broadly divided into 5 main geological units produced through lateritic weathering (Figure 6):

1. *The basal unit is slightly weathered locally silicified ultramafic (UM) (Elias M., 2006), that grades upward into,*
2. *Saprolite (SA) zone which is commonly magnesium and silica rich,*
3. *Smectite (SM) is the main nickel bearing unit of the profile (Elias M., 2006). This is overlain by,*
4. *Ferruginous zone (FZ) which is dominantly comprised of kaolinite Fe oxides (typically goethite and hematite) (Wells M., 2003) and is commonly silica rich which is in turn capped with,*
5. *Colluviums and mixed chlorite-kaolinite plastic clays (PC) (Elias M., 2006), also referred to as the mottled zone. The ultramafic regolith profiles are commonly bound by weathered felsic and/or mafic volcanic and intrusive rock.*

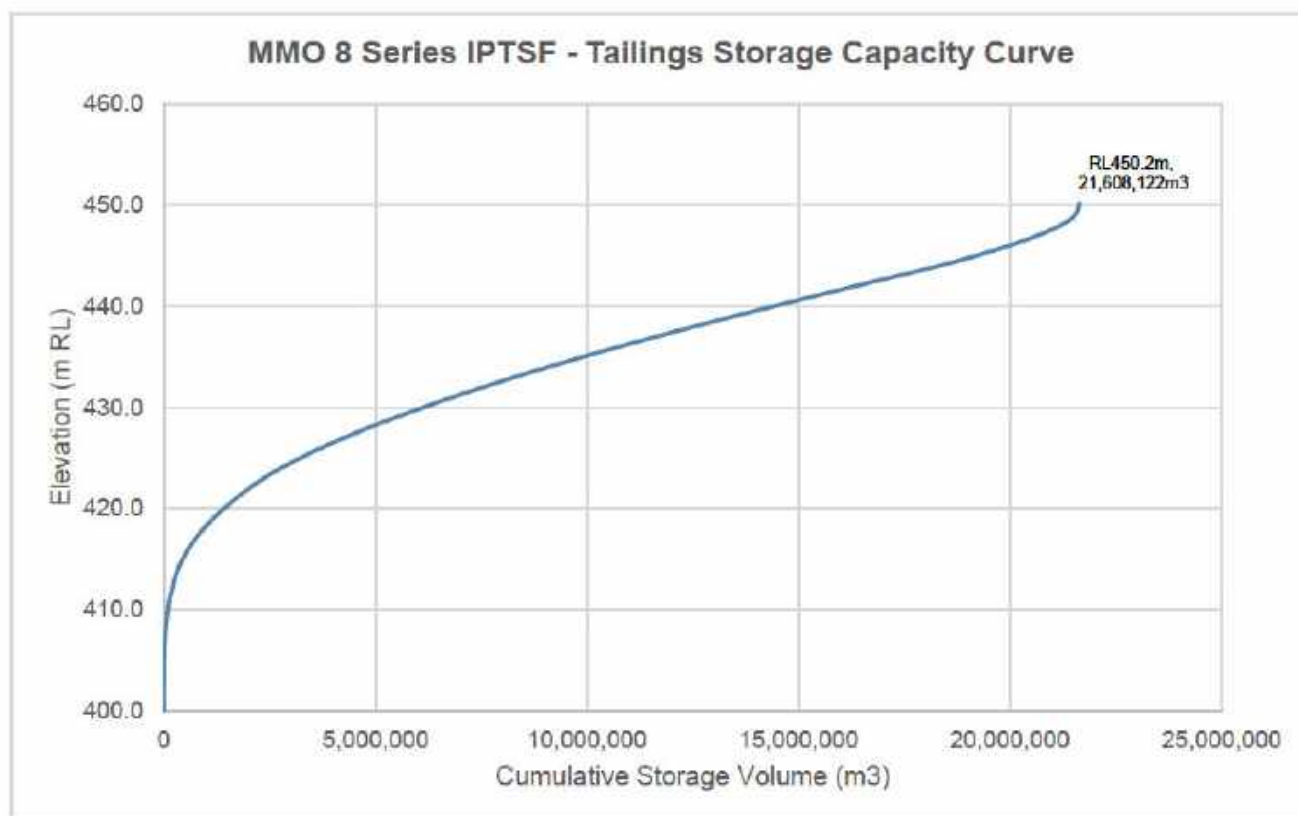
Figure 9. IPTSF 8 Series - Tailings Storage Capacity Curve

*Note: Storage volume was based on the tailings deposition modelling with an assumed tailings beach slope of 1:300 (V:H). Storage capacity and life were conservatively calculated based on the adopted tailings (dry) density of 0.8 t/m³ and tailings production of 4.62 Mtpa.

It is noted that the storage capacity and life are calculated based on the conservatively adopted tailings (dry) density of 0.8 t/m³ and a tailings production of 4.62 Mtpa. The topping-up process is not likely to significantly increase the IPTSF storage life. An assumed tailings beach slope of 1:300 (V:H) and the stormwater volume (from a 1:100-year AEP, 72-hour storm event) temporally stored on top of the IPTSFs and above the normal operating pond level were considered in the calculations. For further clarification, tailings storage capacity curves for the IPTSFs 815, 7 Series and 8 Series are presented in Figures 7, 8 and 9 respectively.

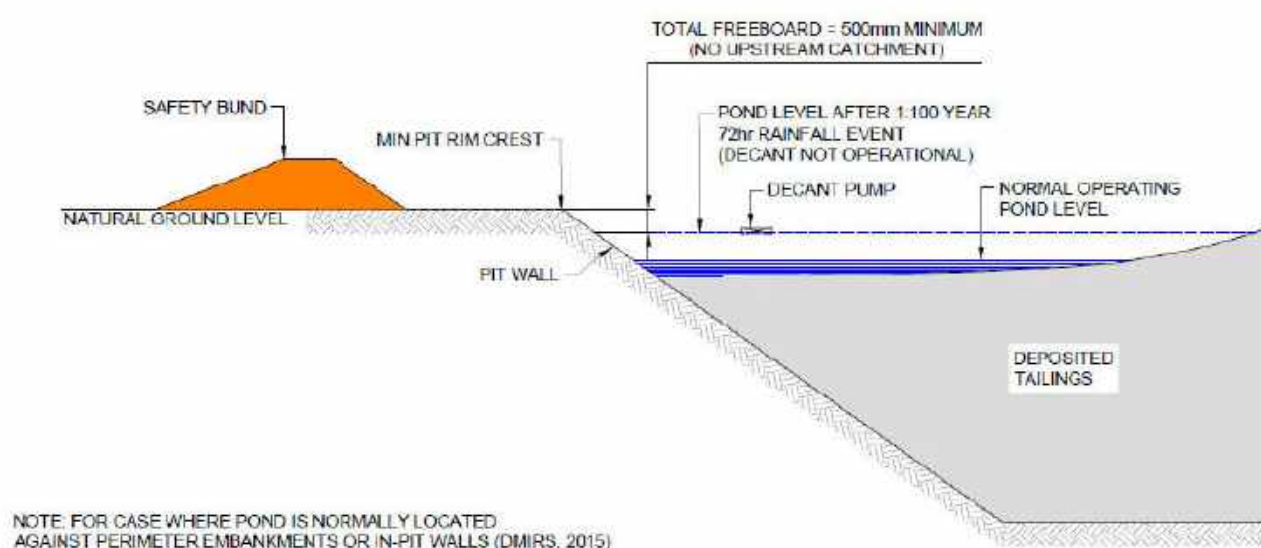
**Figure 10. Freeboard Nomenclature (DMIRS, 2015)**

Flood and freeboard requirements for each IPTSF have been designed in accordance with DMIRS (2015) guidelines as follows. DMIRS freeboard criteria are summarised in Table 8, with freeboard requirements illustrated in Figure 10.

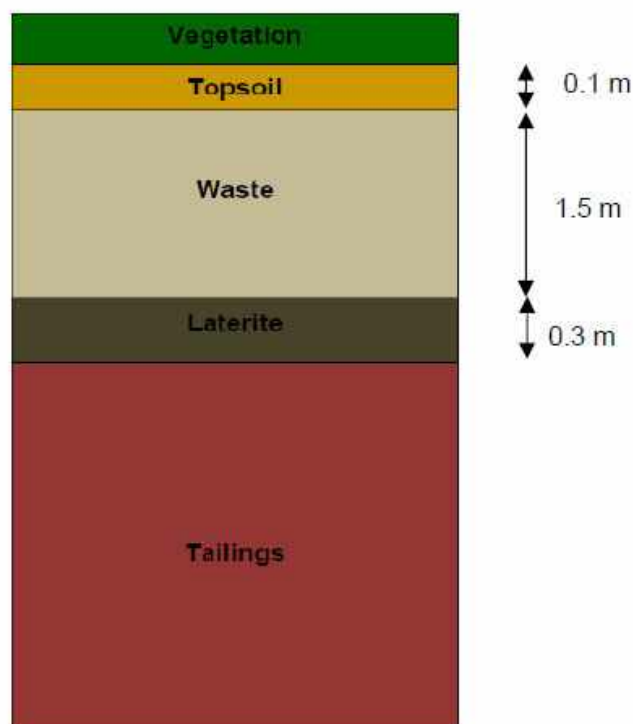
Sketch 1: Preliminary capping layer needed to prevent capillary action into the root zone.

Figure 14. Conceptual Capping Profile at Closure

Geochemical testing assessment (Section 5.1) indicates the tailings samples are not extreme acidity and hypersaline, that would not support vegetation growth. As a result of capillary action in the soil, soil salinisation in the vegetation root zone may occur. Figure 14 illustrates a conceptual capping profile for the proposed IPTSFs which comprises:

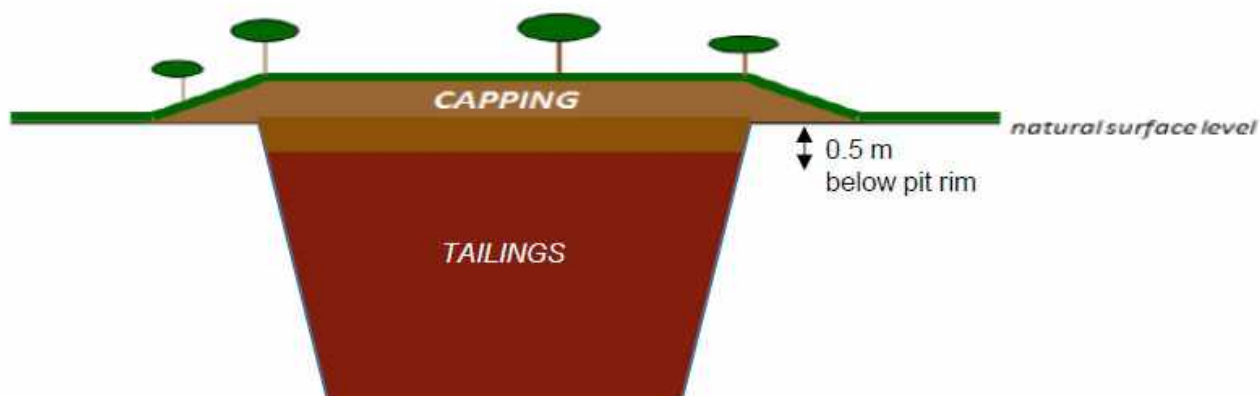
Sketch 2: Cross-section of the MMO IPTSFs indicating rehabilitation of the capping landform.

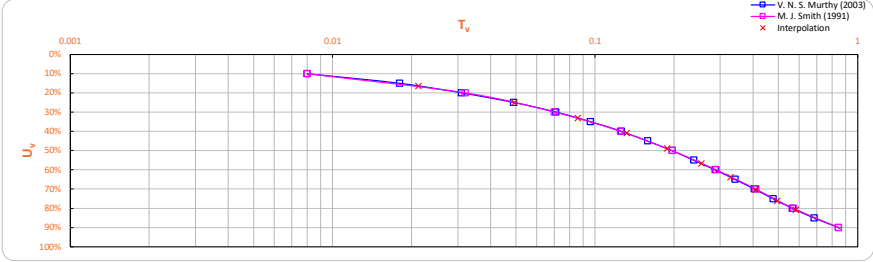
SINGLE DRAINAGE CONSOLIDATION

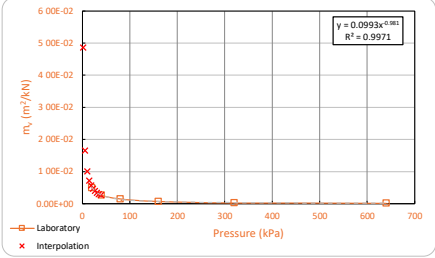
Pressure	[kPa]	20	40	80	160	320	640
m _v	[m²/kN]	5.00E-03	2.70E-03	1.50E-03	7.10E-04	2.90E-04	1.90E-04

PRESSURE vs COEFFICIENT OF COMPRESSIBILITY

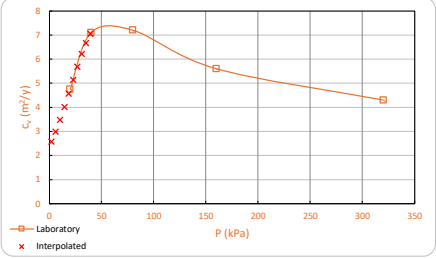
PRESSURE vs COEFFICIENT OF CONSOLIDATION

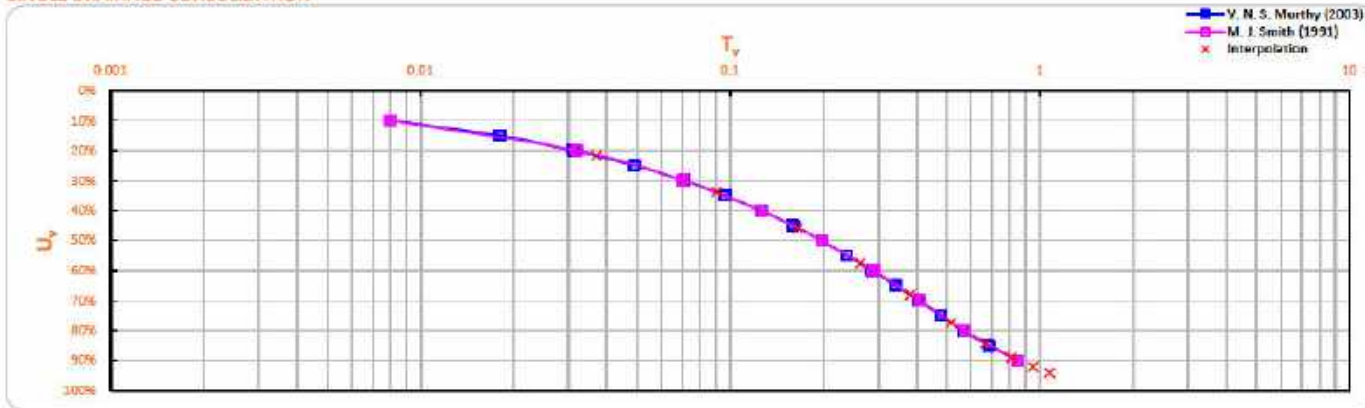
SINGLE DRAINAGE CONSOLIDATION

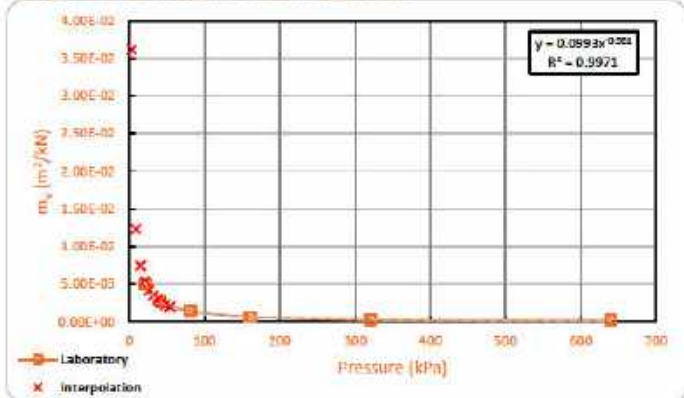
Pressure	[kPa]	20	40	80	160	320	640
m _v	[m ² /kN]	5.00E-03	2.70E-03	1.50E-03	7.10E-04	2.90E-04	1.90E-04

PRESSURE vs COEFFICIENT OF COMPRESSIBILITY

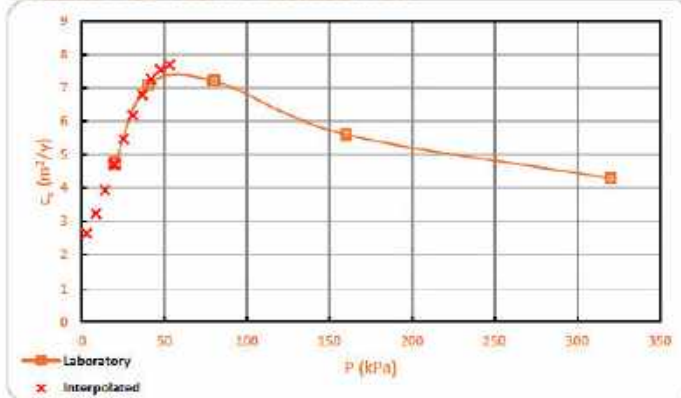
PRESSURE vs COEFFICIENT OF CONSOLIDATION

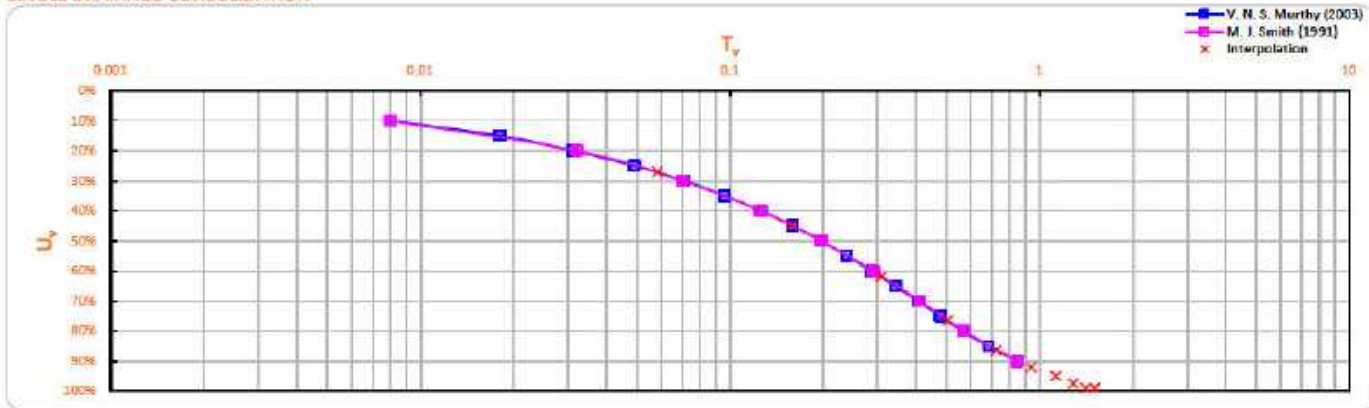
SINGLE DRAINAGE CONSOLIDATION

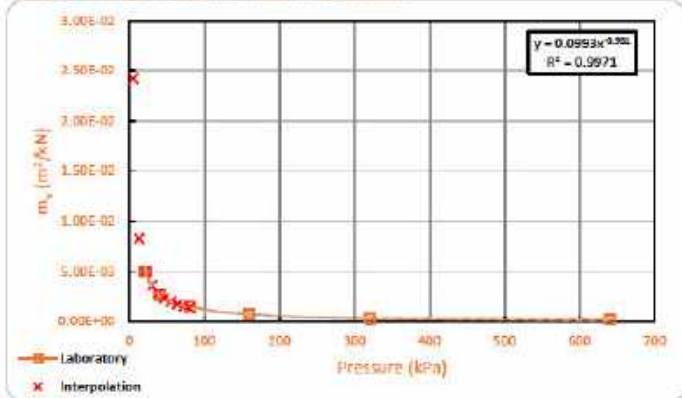
Pressure	[kPa]	20	40	80	160	320	640
m _v	[m ² /kN]	5.00E-03	2.70E-03	1.50E-03	7.10E-04	2.90E-04	1.90E-04

PRESSURE vs COEFFICIENT OF COMPRESSIBILITY

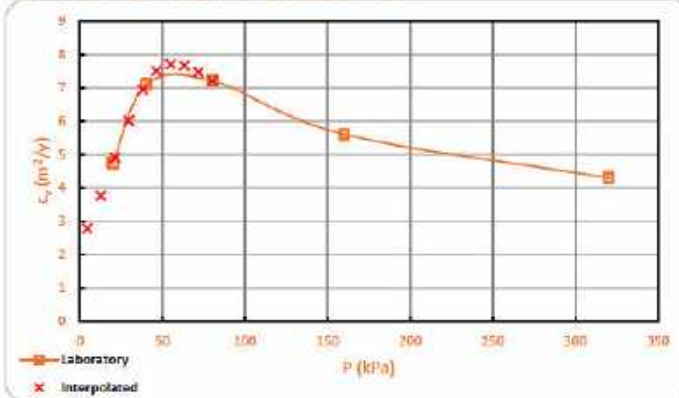
PRESSURE vs COEFFICIENT OF CONSOLIDATION

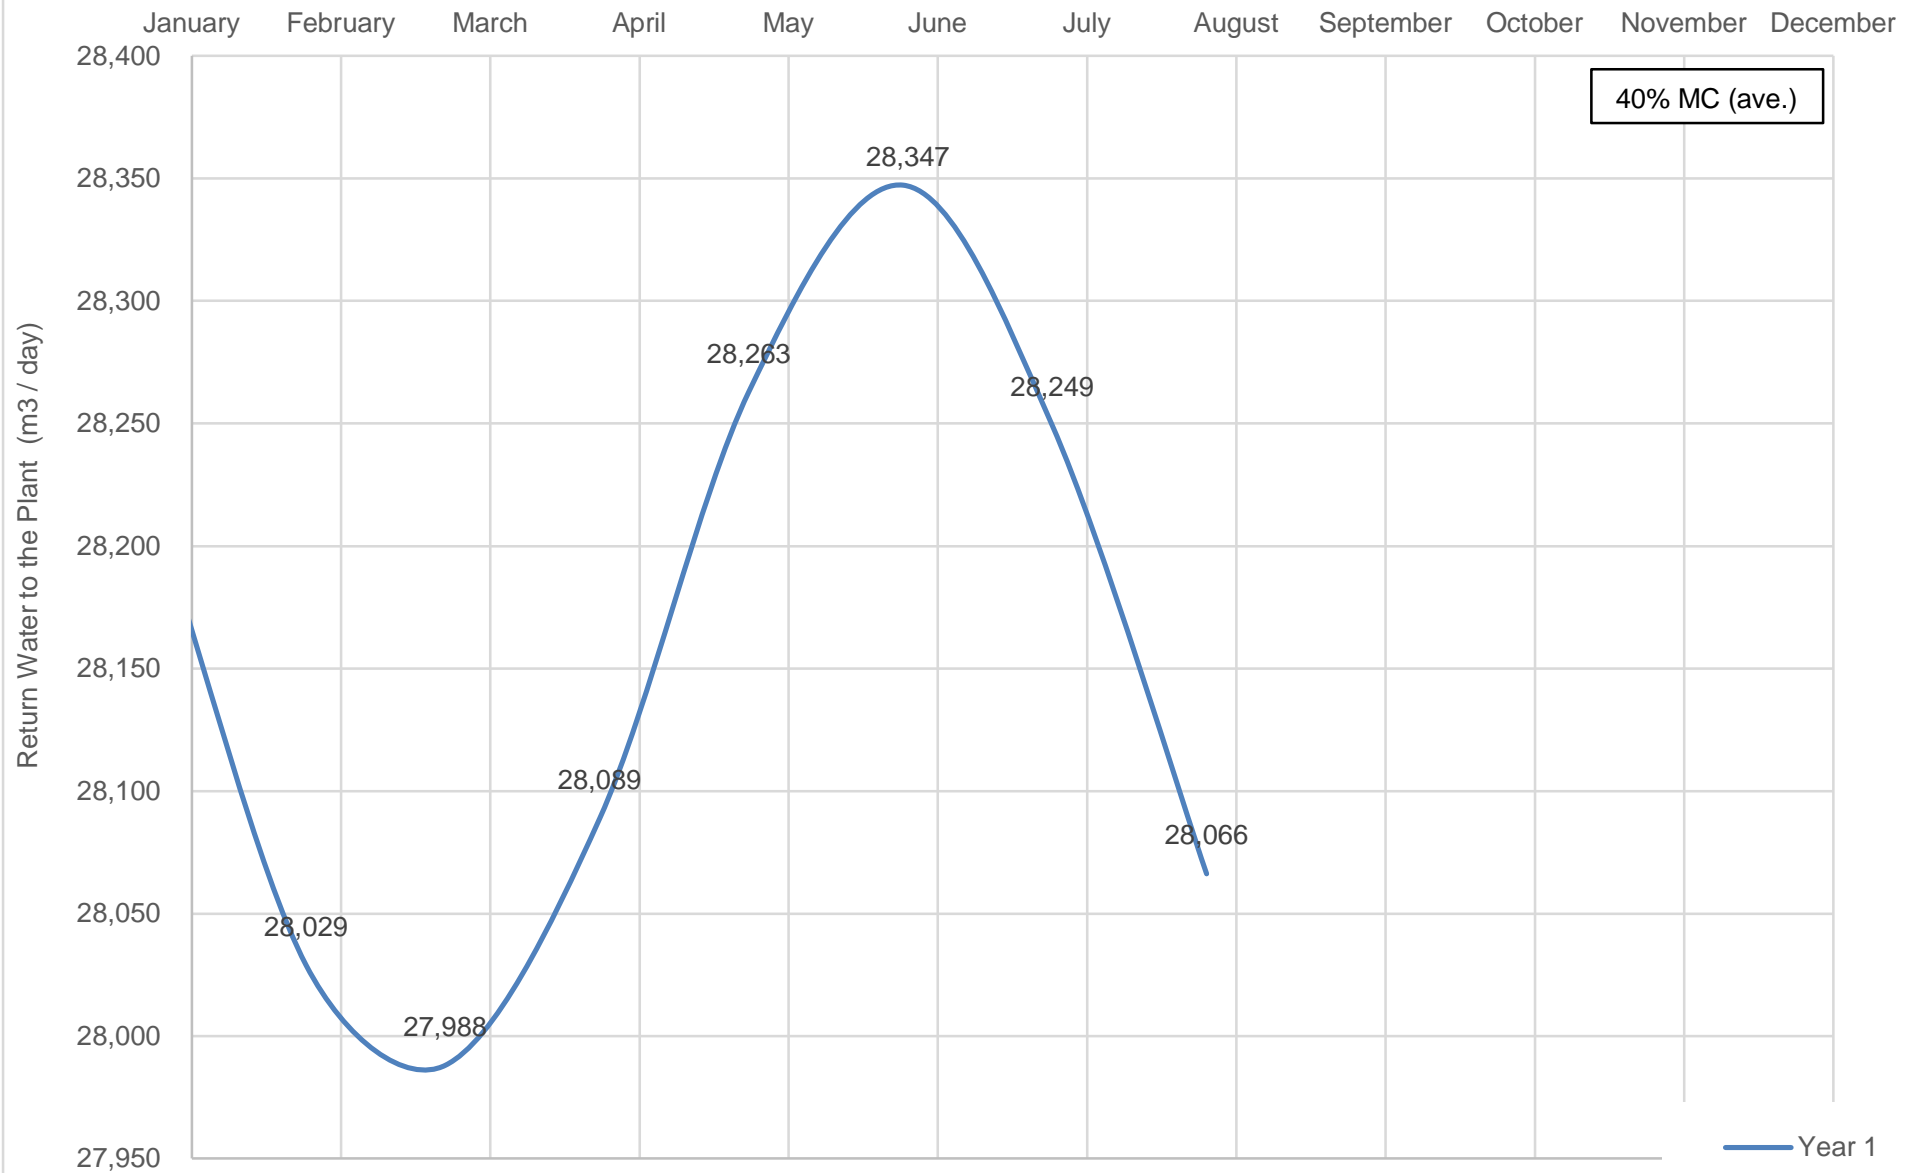
MMO - 815 IPTSF Water Balance - Return Water to Plant

PROJECT	: MURRIN MURRIN OPERATIONS IN-PIT TAILINGS STUDY												
CLIENT	: MURRIN MURRIN OPERATIONS PTY LTD												
LOCATION	: LEONORA, WA												
SUBJECT	: WATER BALANCE - MMO 815 IN-PIT TSF - YEAR 1

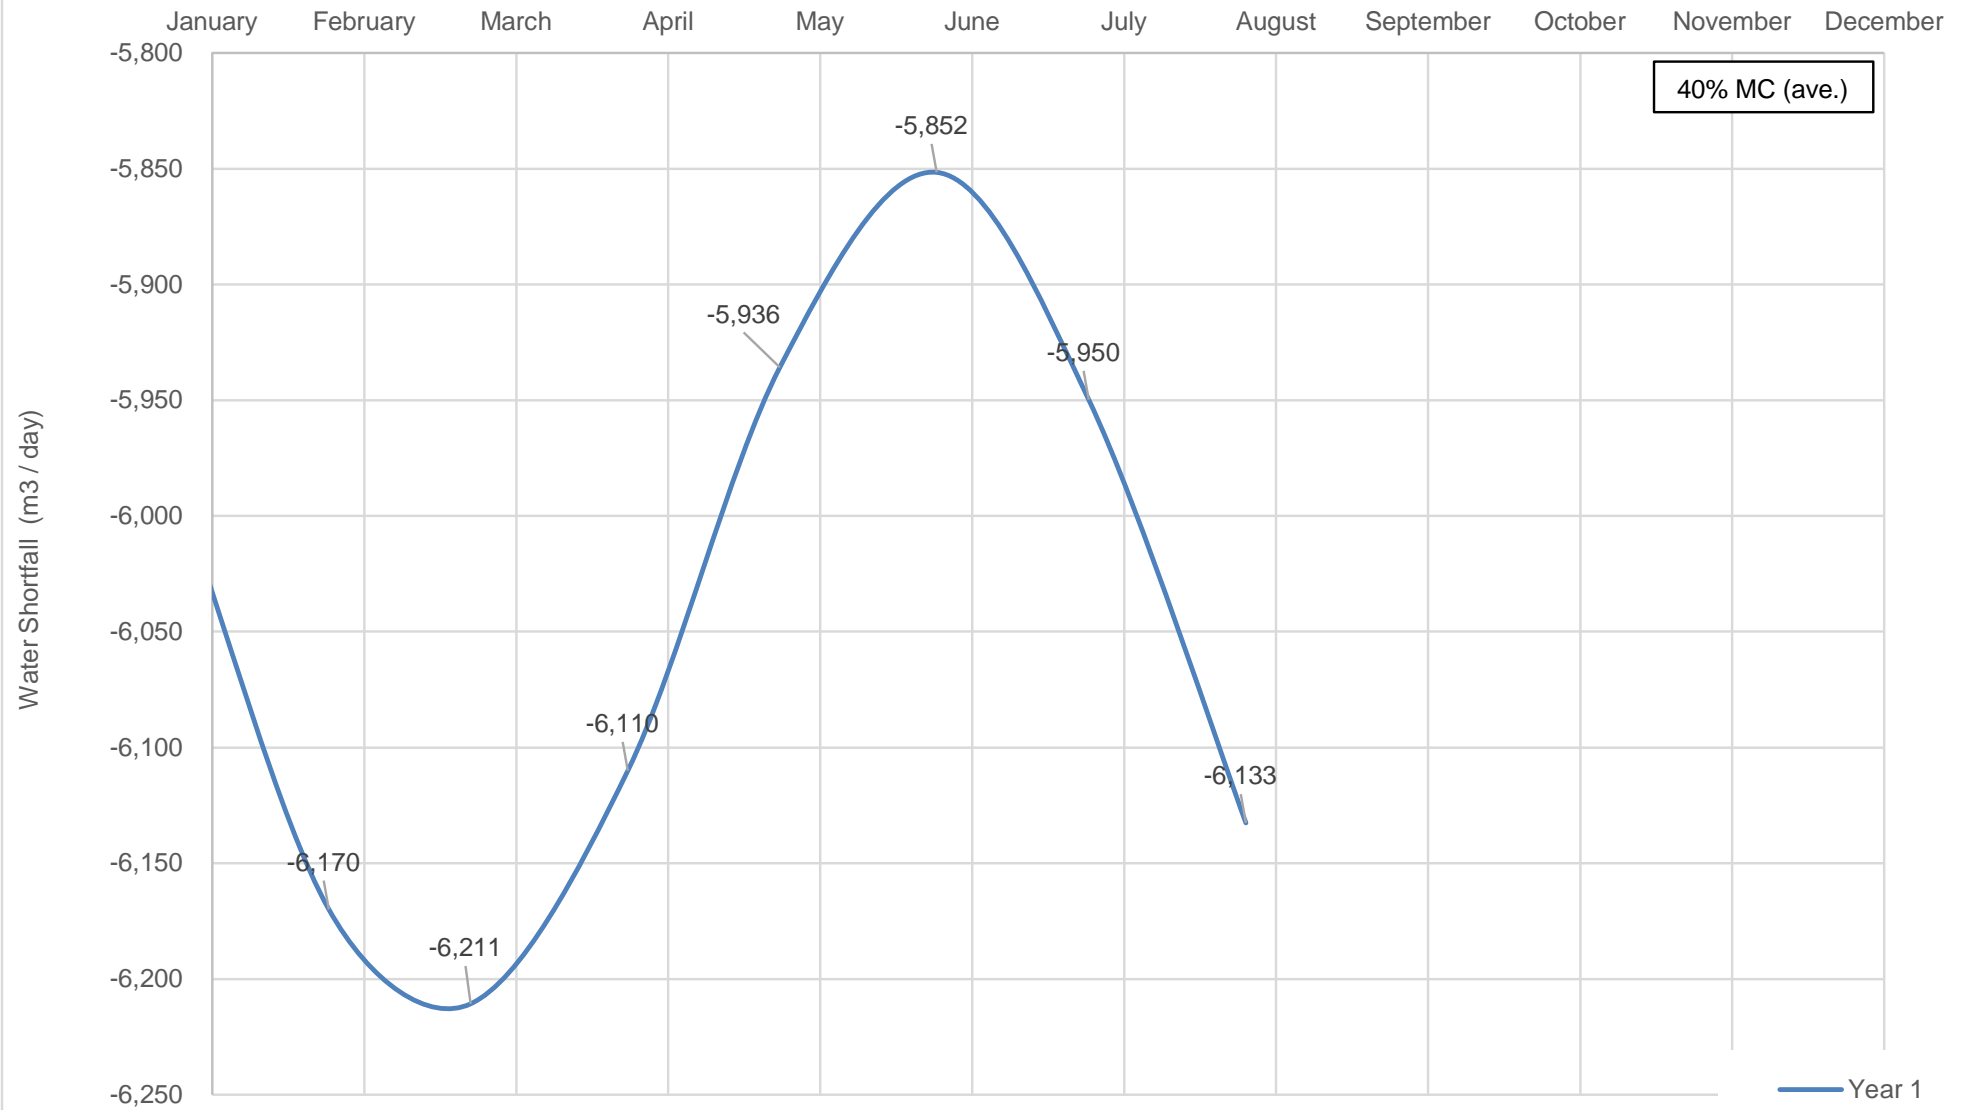
MMO - 815 IPTSF Water Balance - Water Shortfall

Annual Average Water Return (as % of tailings slurry water)	82%												
Summary of Water Balance	JAN	FEB	MAR	APR	MAY	JUN	JUL	AUG					
Water shortfall or excess of requirements (m3/day)	-5,981	-6,170	-6,211	-6,110	-5,936	-5,852	-5,950	-6,133					
Water shortfall or excess of requirements (m3/hr)	-249	-257	-259	-255	-247	-244	-248	-256					
Total water in excess of requirements (m3/month)	-185,411	-174,300	-192,534	-183,301	-184,011	-175,547	-184,441	-190,109					-1,469,653
Total water in excess of requirements (m3/year) =	-1,469,653

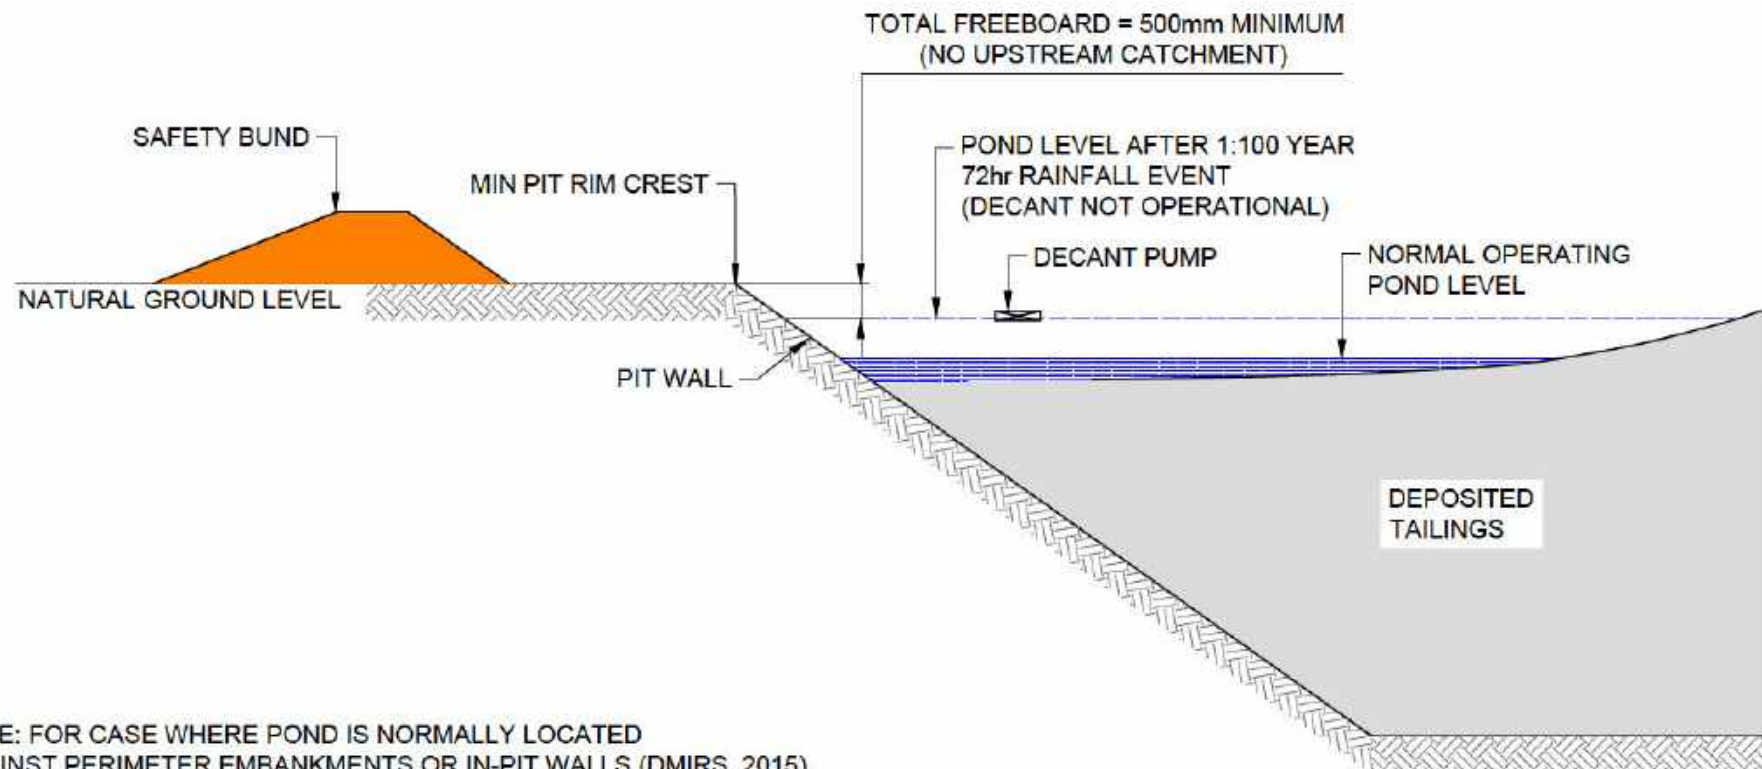
Project: OPERATIONS MANUAL TAILINGS STORAGE FACILITY		
Date:	16-02-2024		Title: FREEBOARD NOMENCLATURE (DMP / DMIRS) (FOR IPTSF)		
Scale:	AS SHOWN		Project no: 754-PERGE312759	Dwg no: FIGURE 3B	Rev:
Original size:	A4

NOTE: FOR CASE WHERE POND IS NORMALLY LOCATED AGAINST PERIMETER EMBANKMENTS OR IN-PIT WALLS (DMIRS, 2015)

For the purposes of TSFs and IPTSFs operations, the following is emphasised in respect to freeboard. Freeboard comprises three distinct elements: operational freeboard, beach freeboard and total freeboard. These elements are graphically illustrated on **Figure 3A** (for TSFs) and **Figure 3B** (for IPTSFs). Each element is defined as follows:

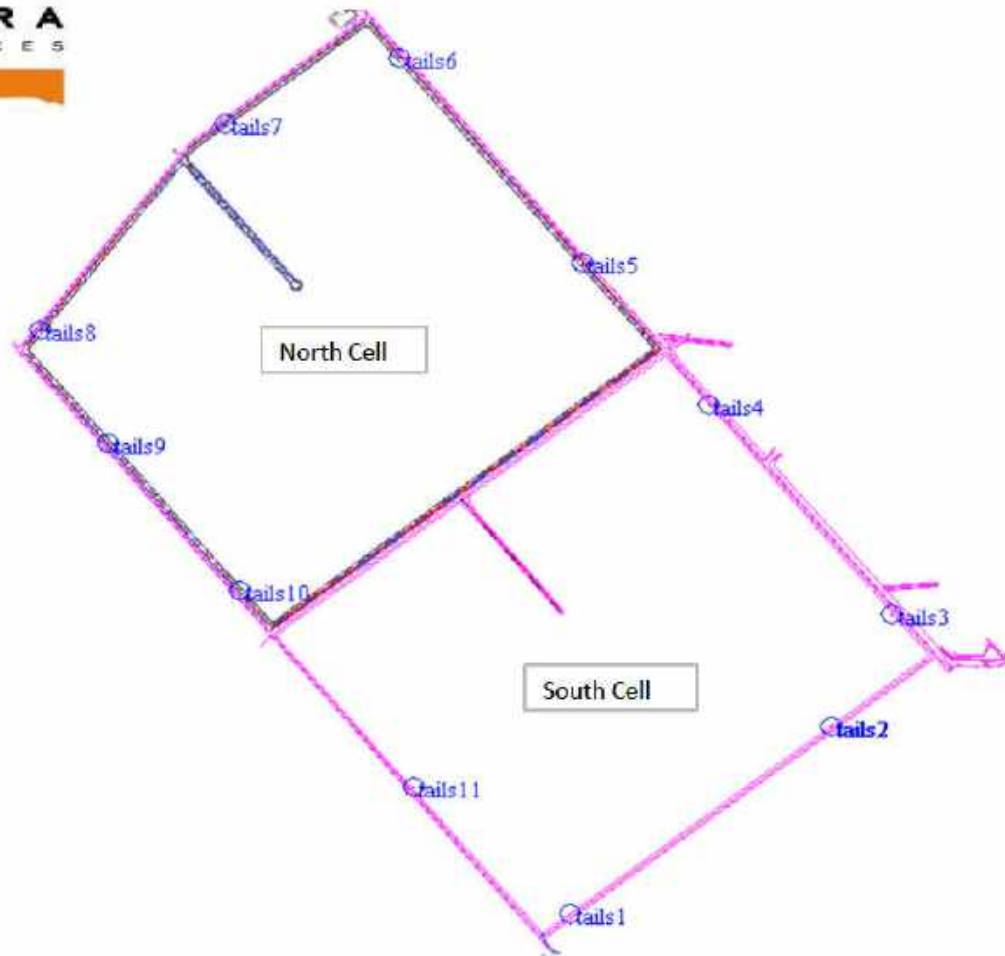
TAILS DAM WALL MONITORING PROGRAM

All stations were established using high accuracy GPS static survey measurements. This involved logging satellite data at each control location, building the data into a geodetic network and performing an adjustment analysis using least squares techniques. All control stations are subsequently surveyed each month to monitor movement on the tailsdam walls.

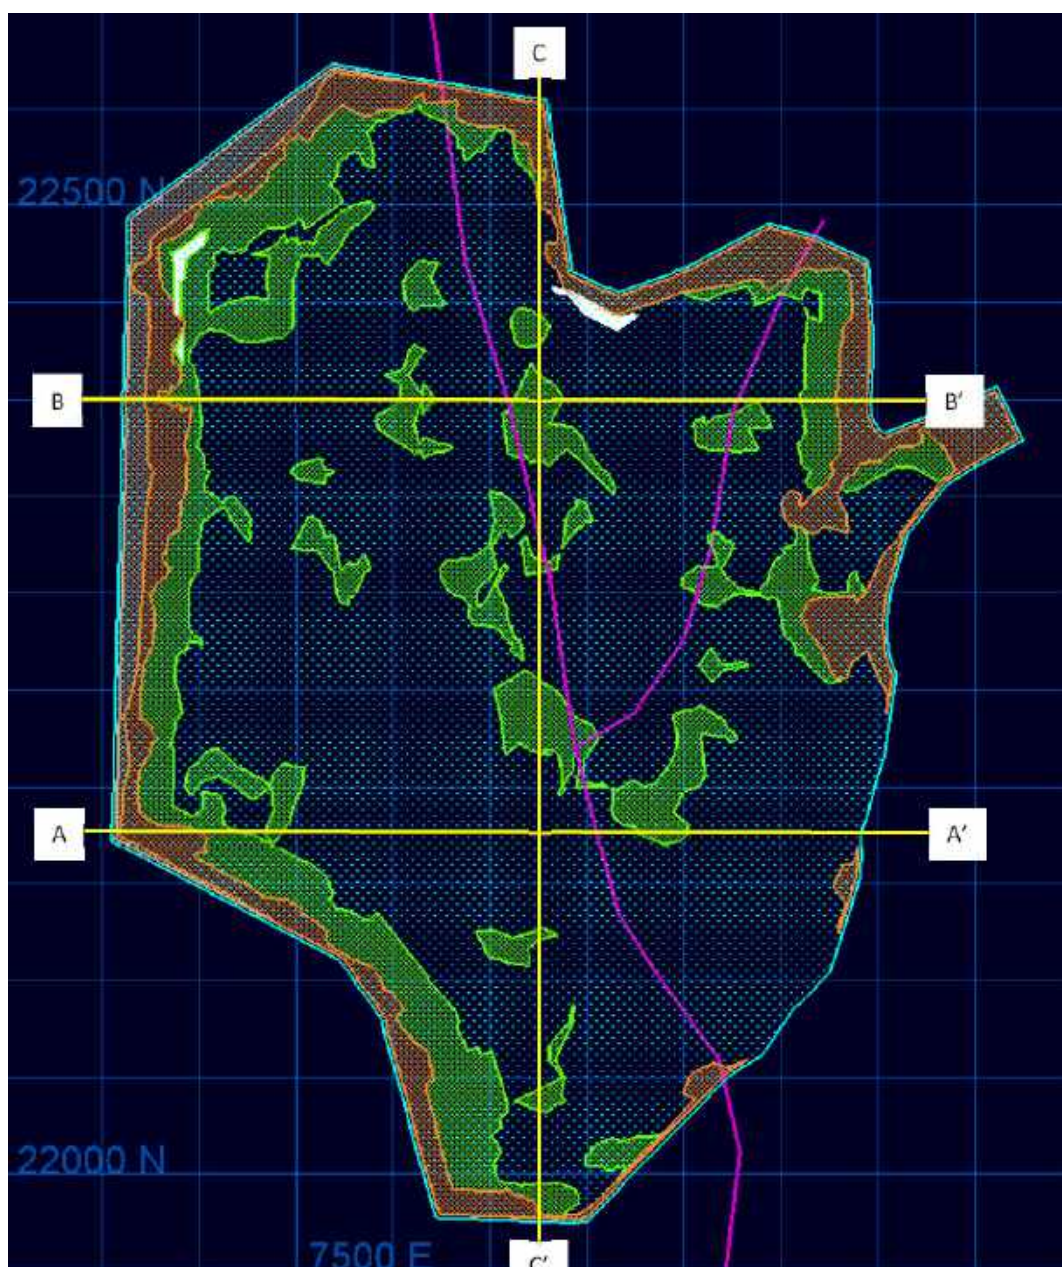
Plate 3 Distribution of Regolith Rock Types – Pit 8/15

The distribution of regolith types in the designed pit wall and floor is illustrated in Plate 3 below; reproduced from the Geological Architecture Report for pit 8/15 (King, 2023b).

Pale Blue (dots) = Saprolite (SA)/ High Silica Saprolite (SSA), Green = Smectite (SM), Orange = Ferruginous Zone (FZ), Pale Brown = Plastic Clays (PC), White = Magnesite (MAG), Pink = Foliated Ultramafic (FUM) (Structure).

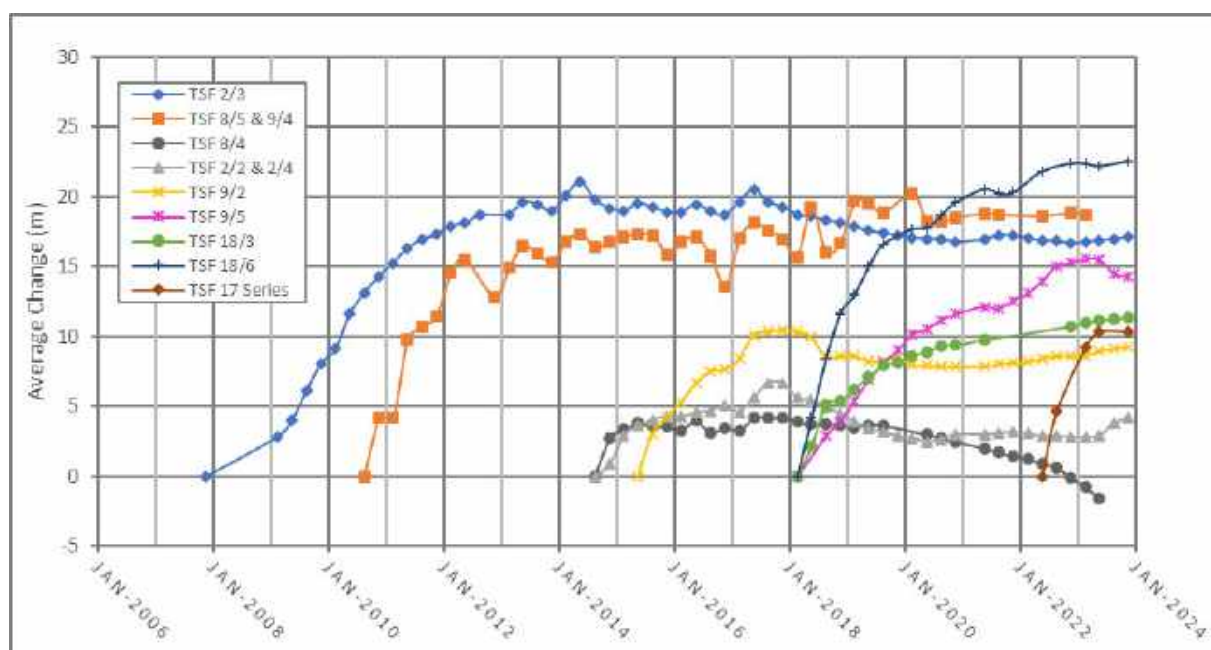
Chart 1 Seepage Indication Bores – Average Water Level Change

Chart 1 displays relative changes in groundwater levels at each in-pit TSF since its commissioning. The chart consists of multiple series, with each series representing the average water level change for all seepage indication bores within a specific in-pit TSF area. To ensure comparability of the presented averages in each series, any data points where one or more water level measurement was not recorded that quarter have been excluded.

The chart shows relatively rapid water level rises during the early stages of tailings deposition at most in-pit TSFs. However, the magnitude of water level rise recorded at seepage indication bores adjacent to each facility differs widely; from less than 5m for in-pit TSF 8/4, to well in excess of 20m for in-pit TSF 18/6.

The overall extent of water level rise at each facility is governed largely by the local hydrogeological conditions and site-specific operational factors. Sites with less mounding and where mounding dissipates quickly (for instance TSF 8/4 compared to TSF 18/6) might indicate higher bulk hydraulic conductivity, with seepage flowing more readily through the subsurface. The wide variation in groundwater mounding supports previous interpretations that the weathering profile is highly heterogeneous and anisotropic.

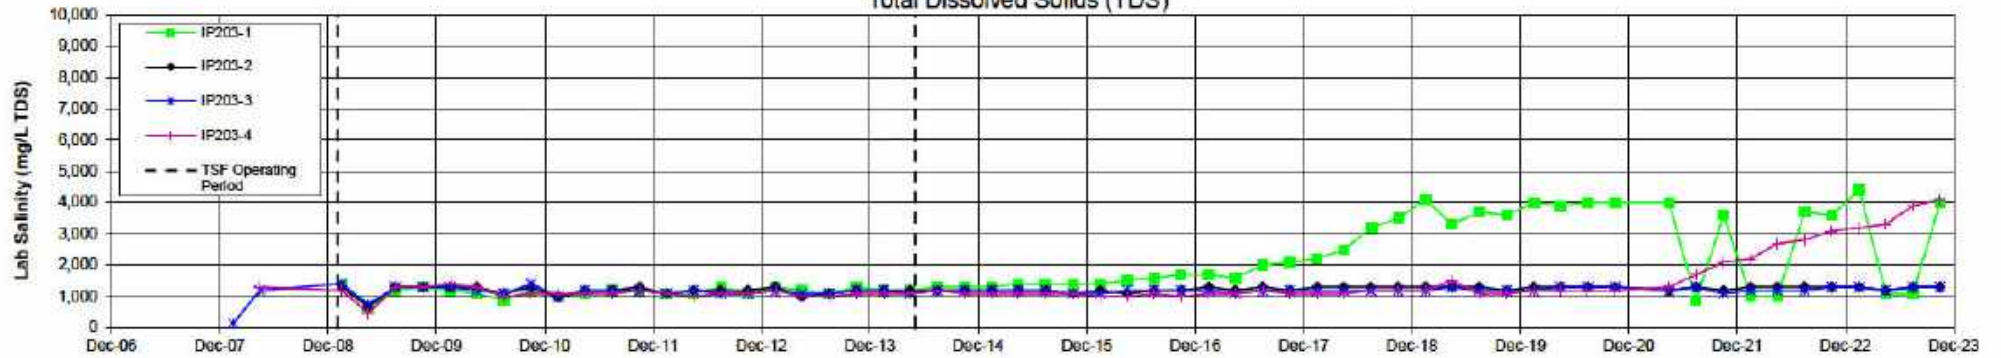
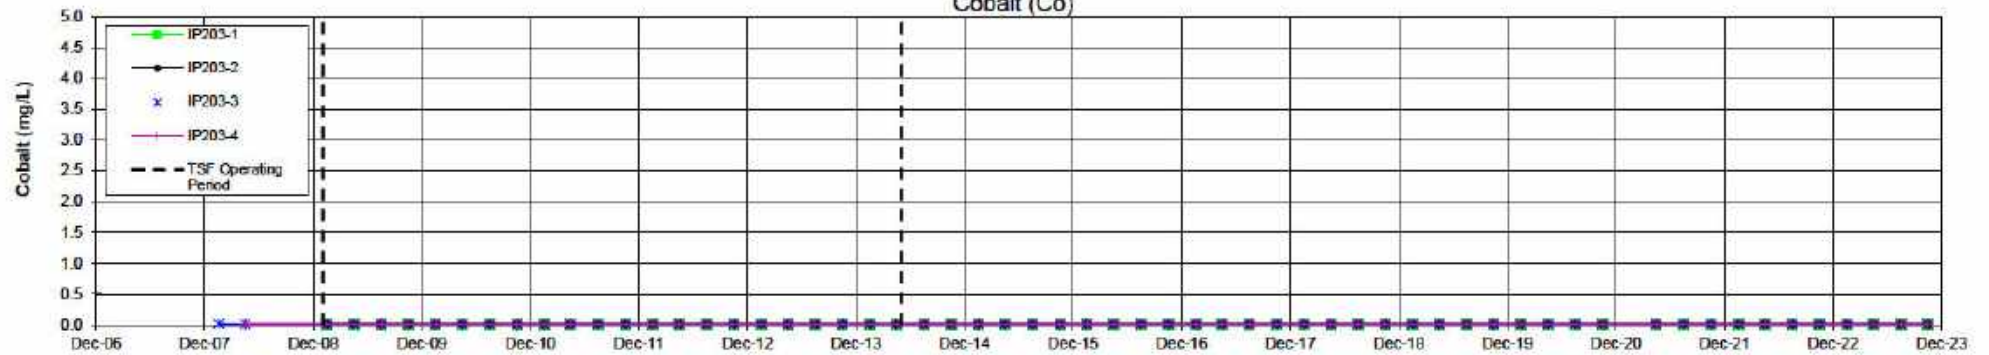
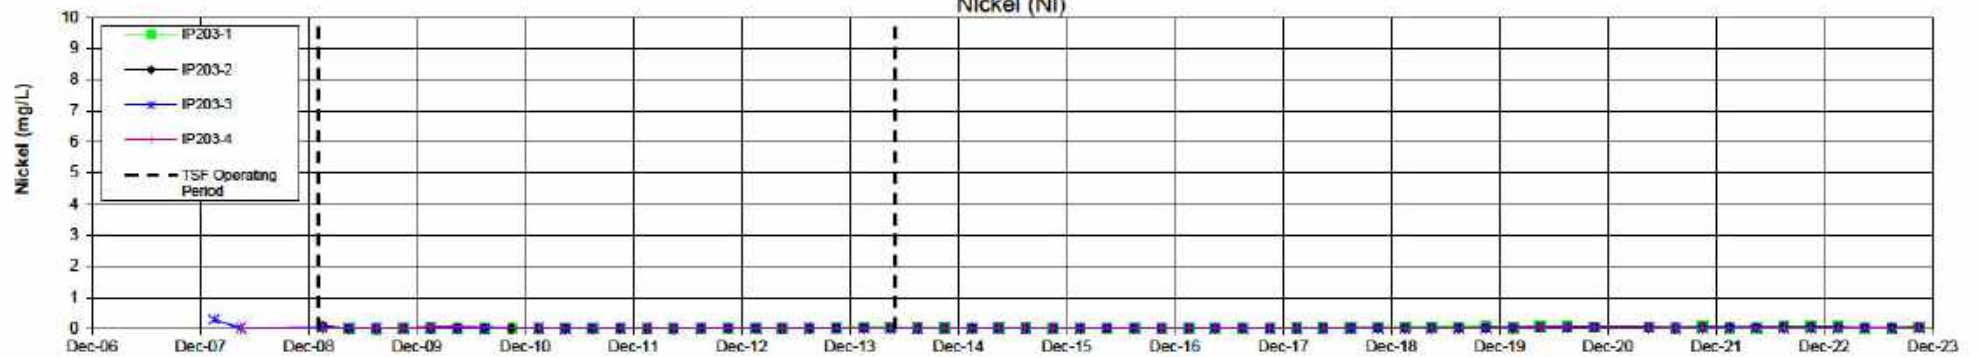
FIGURE: B1

SEEPAGE INDICATION BORE HYDROGRAPHS

Total Dissolved Solids (TDS)

Cobalt (Co)

Nickel (Ni)

The charts show notable increases in concentrations at certain locations, while others show minimal or no changes. These variations are, in part, attributable to the heterogenous nature of the fractured and weathered aquifers in the MMN area. Understanding these aquifer complexities is essential for accurate assessment and effective management of groundwater quality in the inpit TSF areas.
