SUPPORTING DOCUMENT

Proposed works include construction and time limited operations of a new Inpit tailings storage facility (TSF) known as the 8 Series Inpit TSF with a design capacity of 4,620,000 tonnes per year.

Design Report (Geotechnical Assessment)

Reference: 754-PERGE318544_MMO IPTSFs 815_7_8 Series DR_Rev0

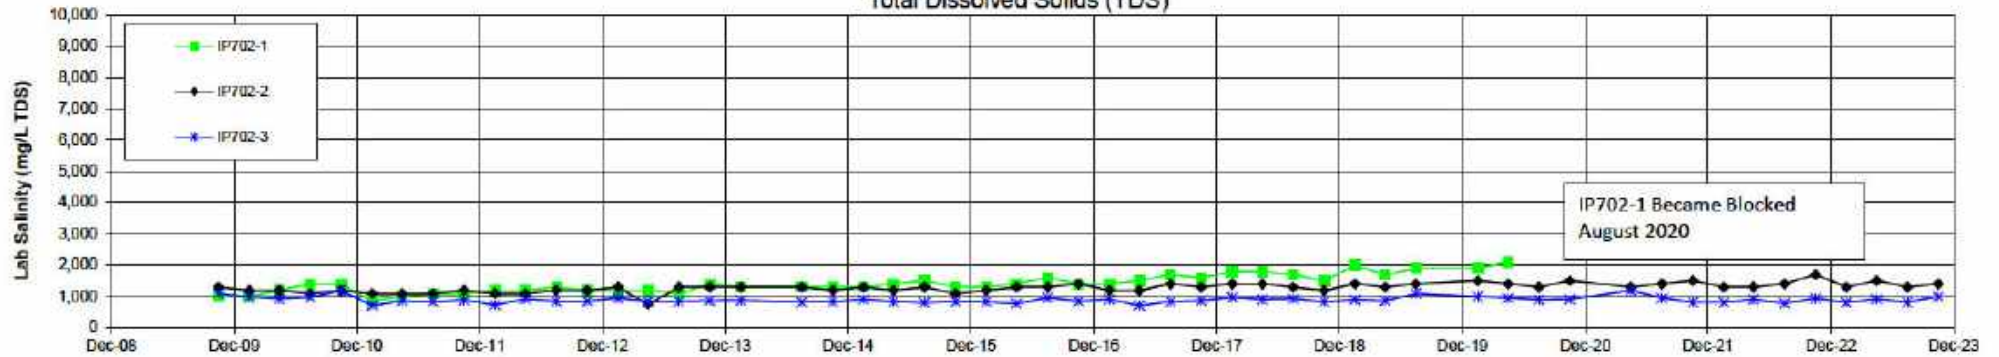
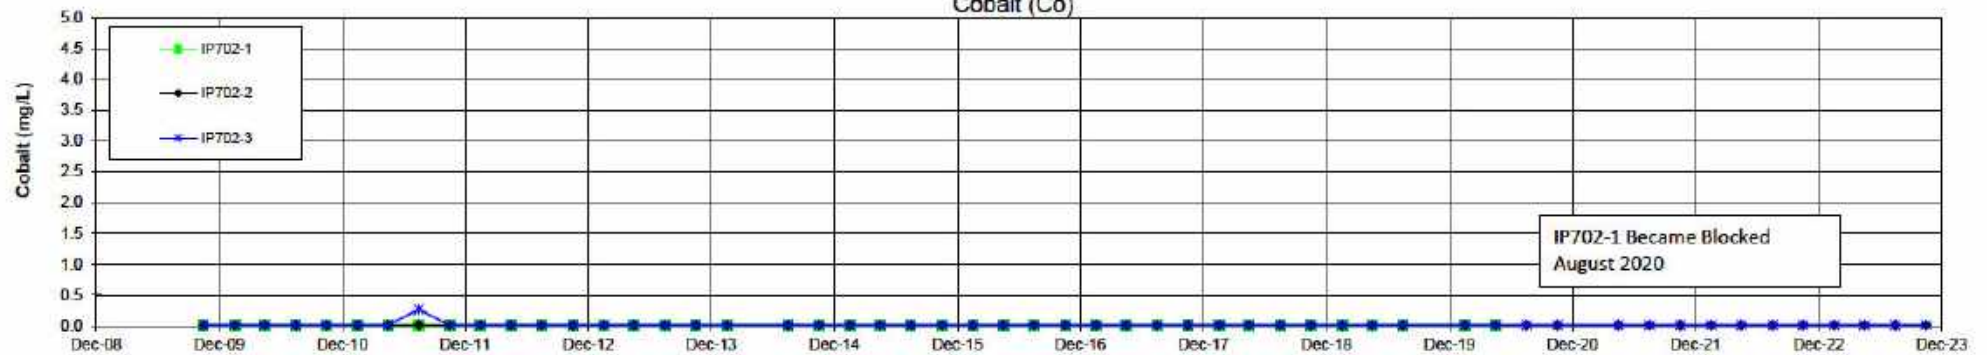
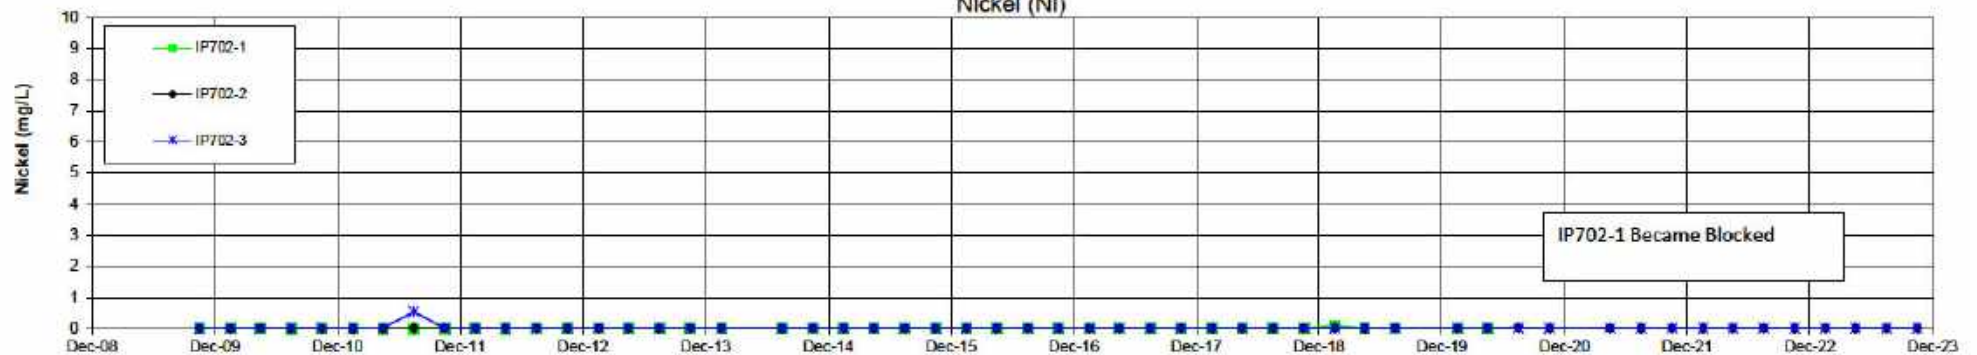
FIGURE: B2

Total Dissolved Solids (TDS)

Cobalt (Co)

Nickel (Ni)

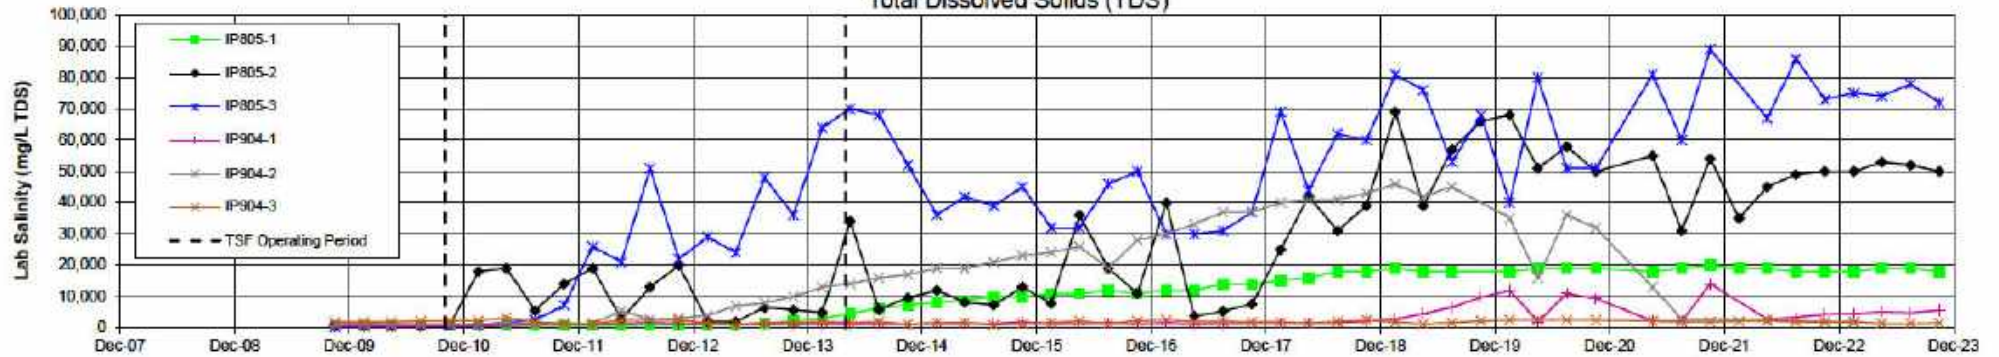
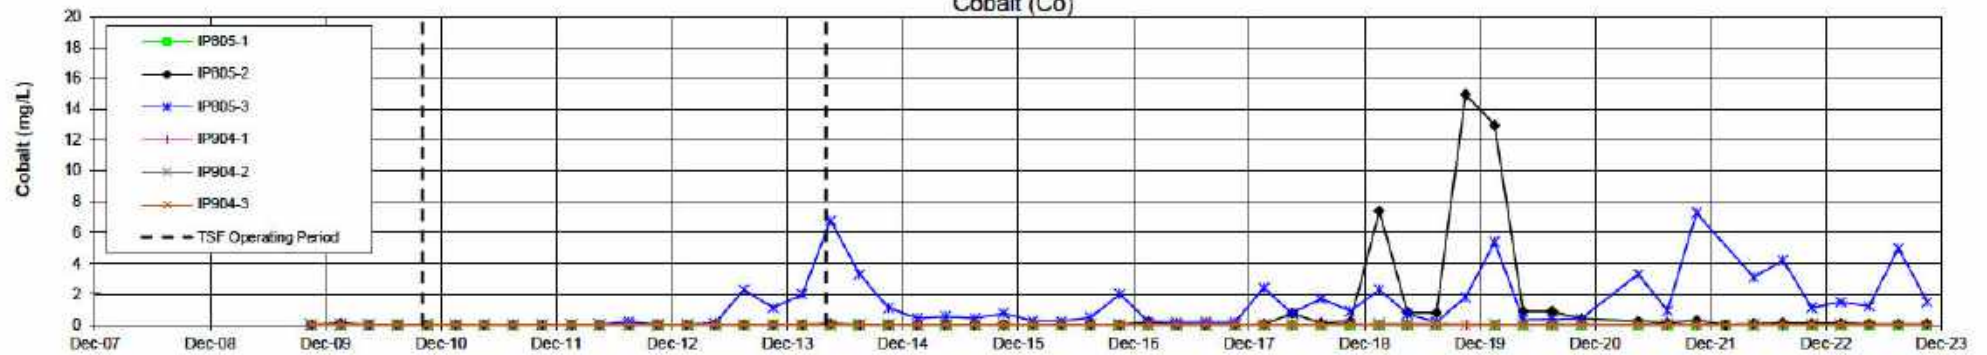
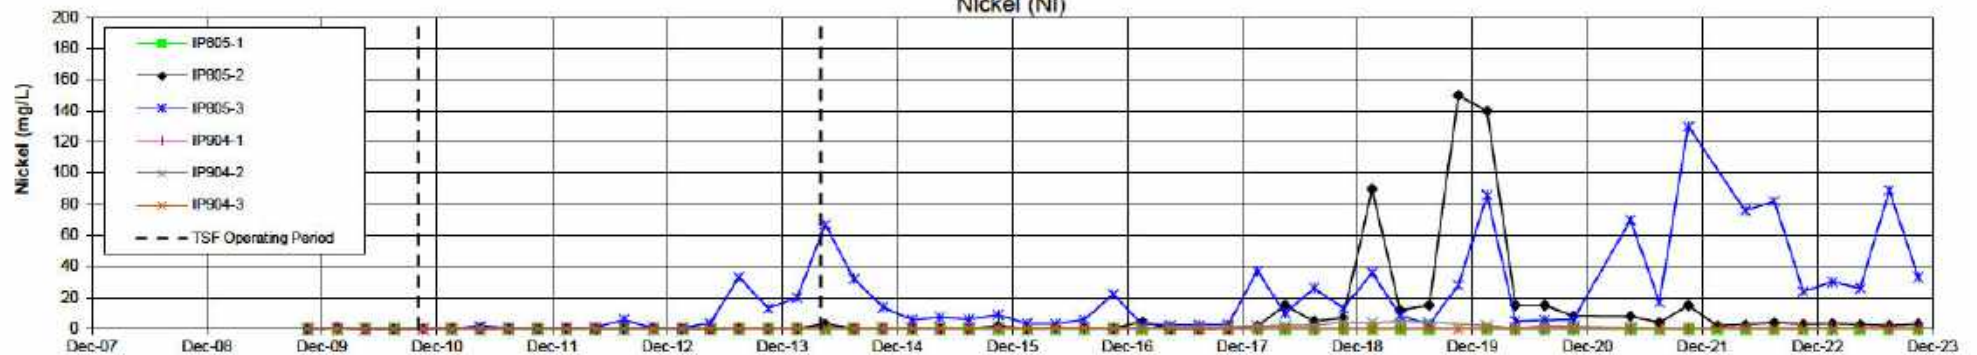
FIGURE: B3

Total Dissolved Solids (TDS)

Cobalt (Co)

Nickel (Ni)

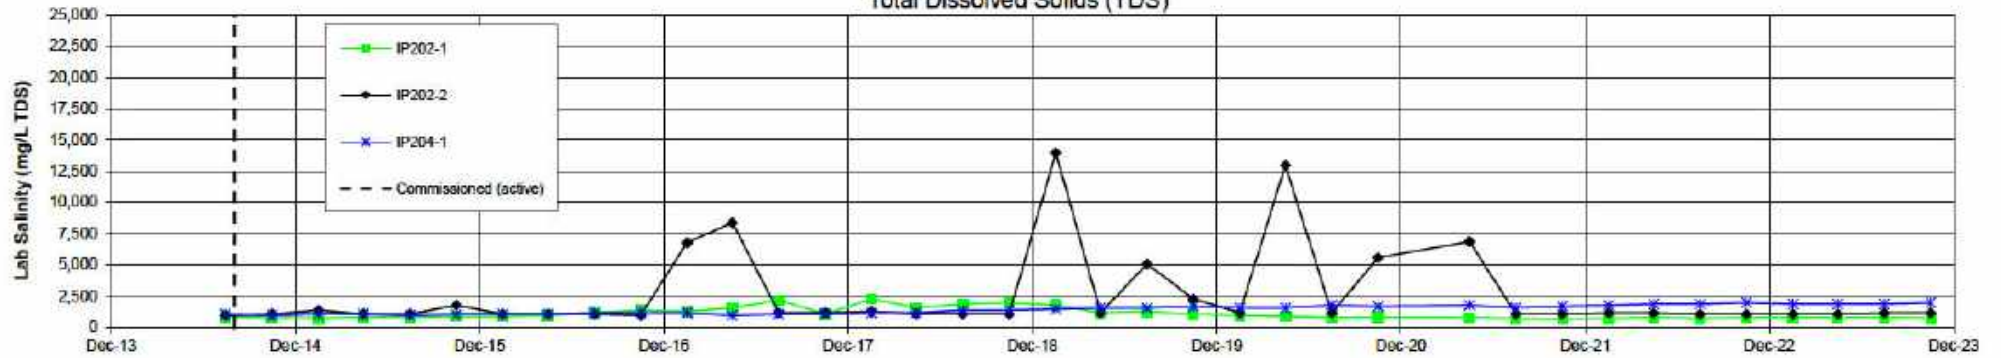
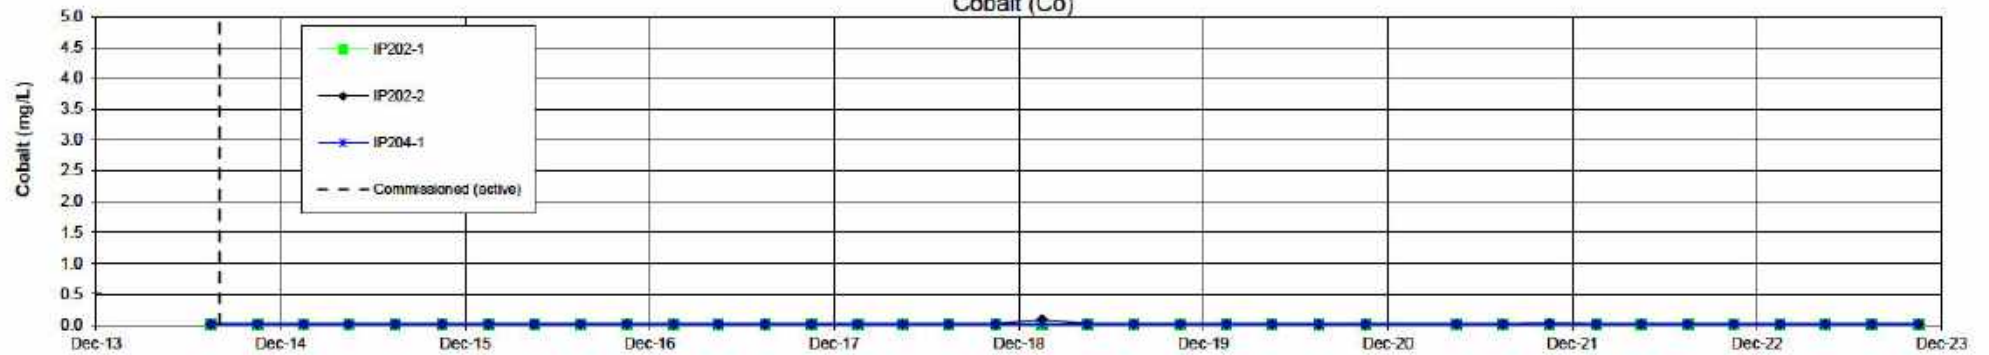
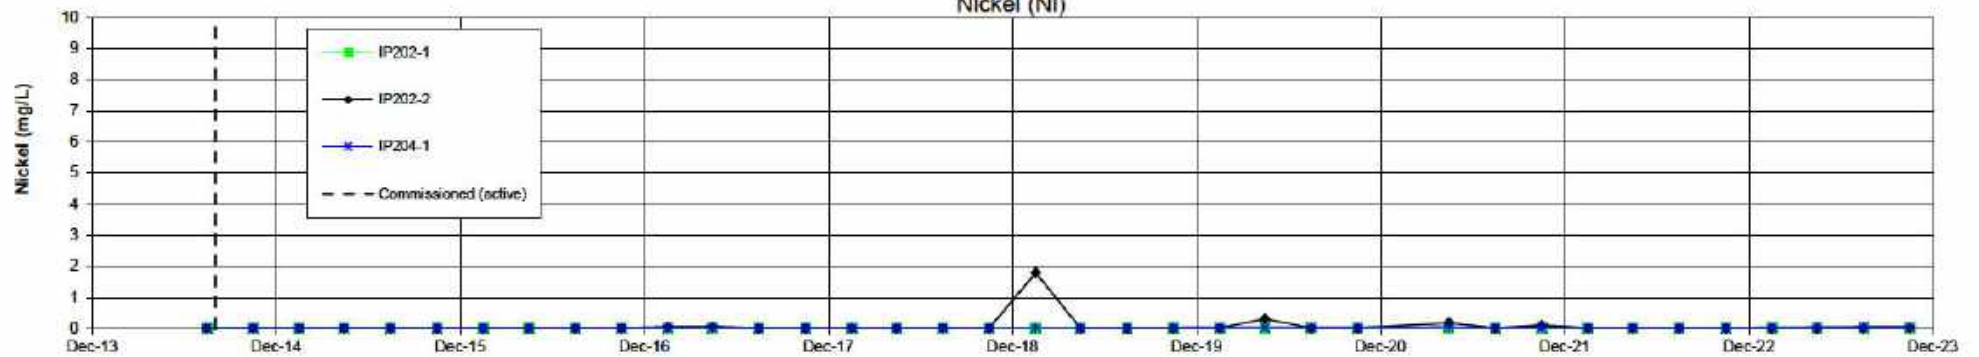
FIGURE: B4

Total Dissolved Solids (TDS)

Cobalt (Co)

Nickel (Ni)

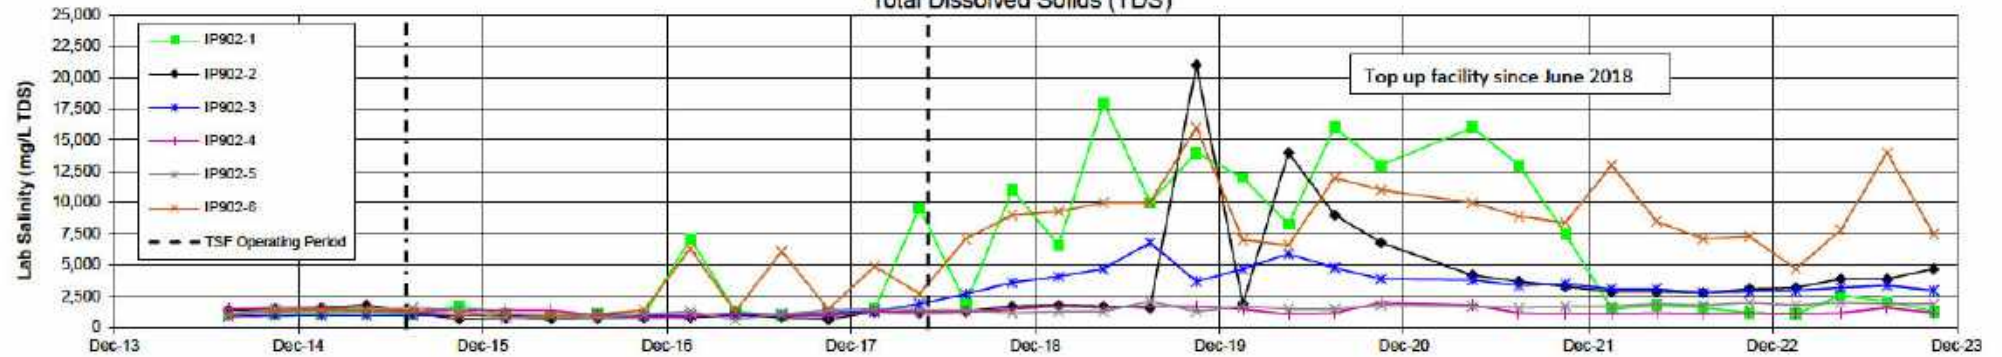
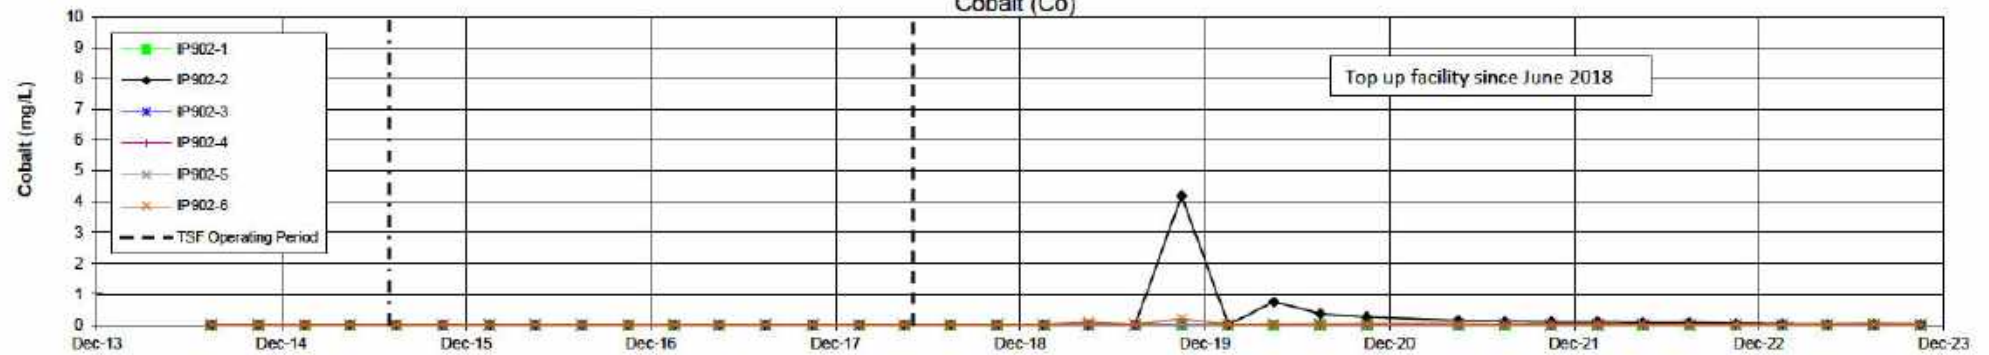
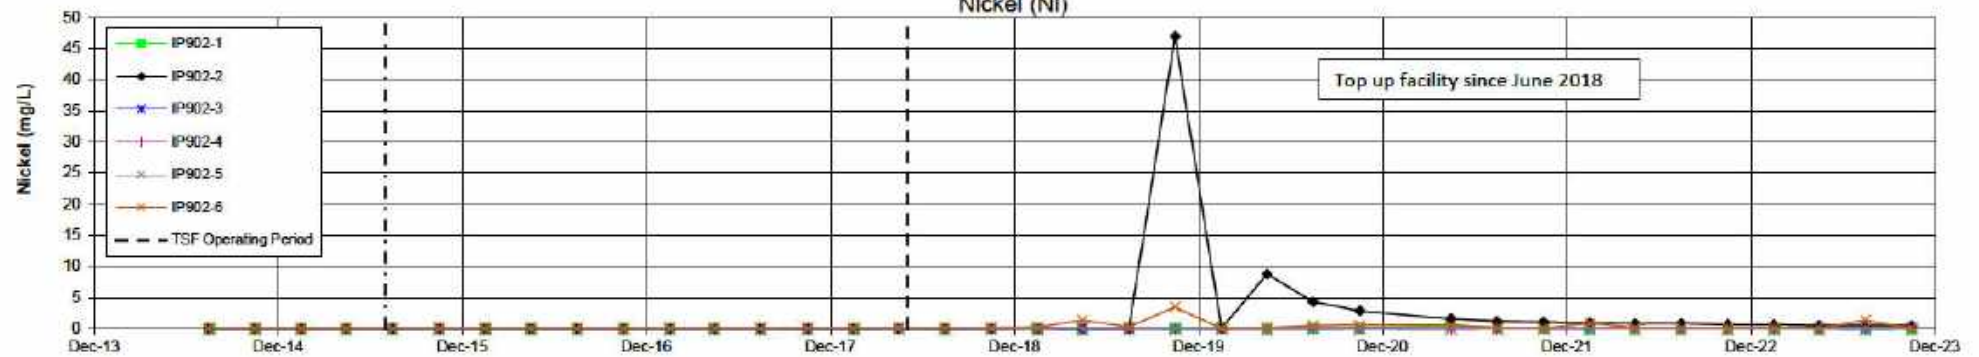
FIGURE: B5

Total Dissolved Solids (TDS)

Cobalt (Co)

Nickel (Ni)

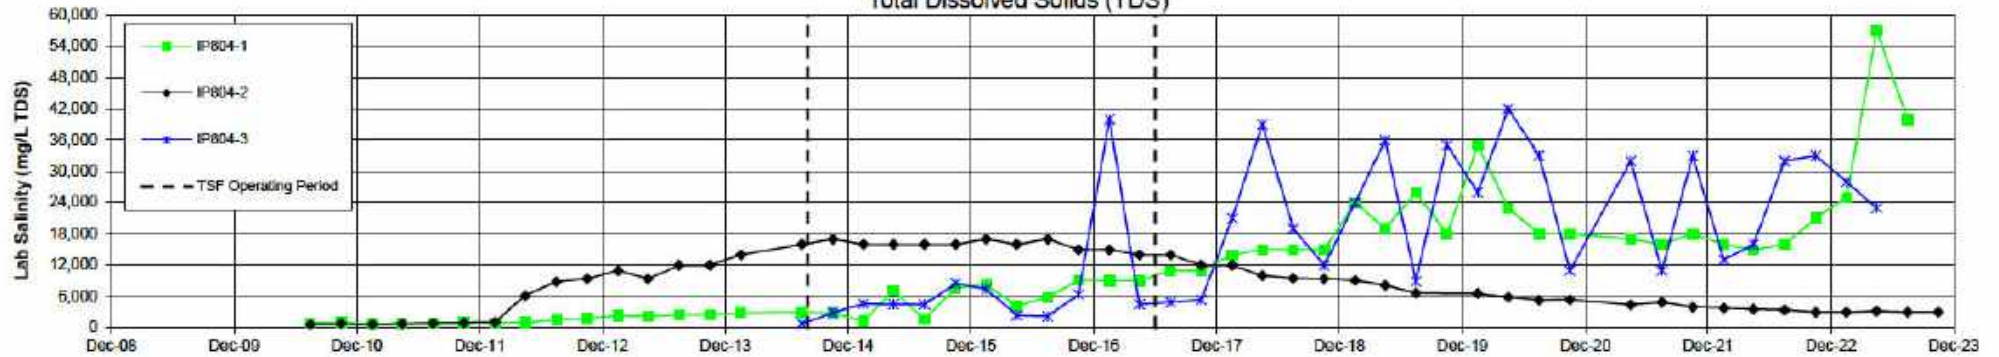
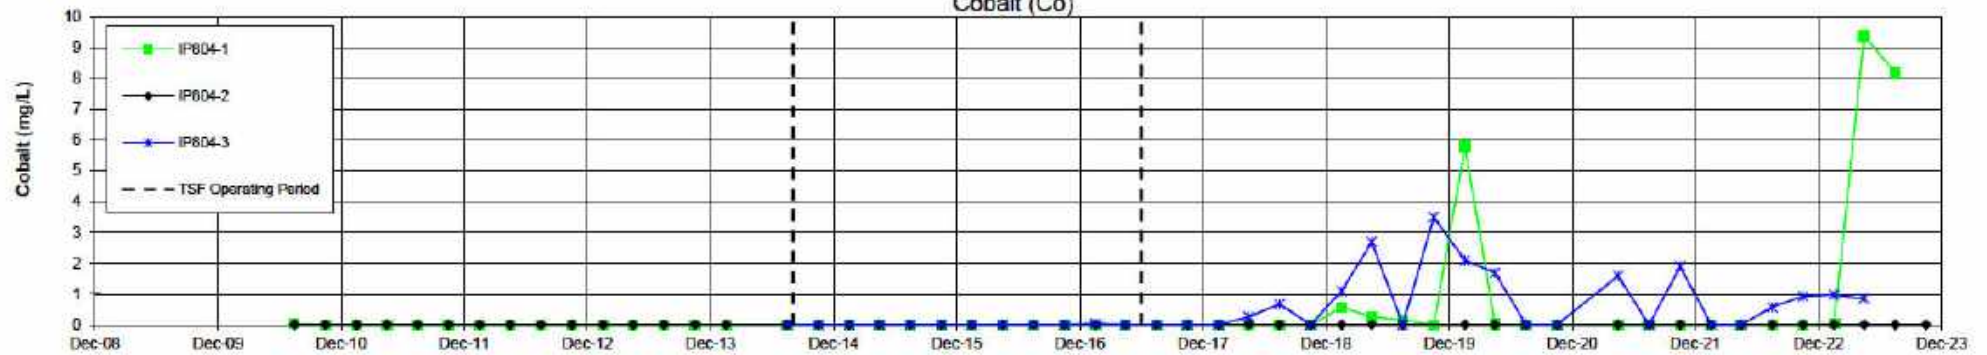
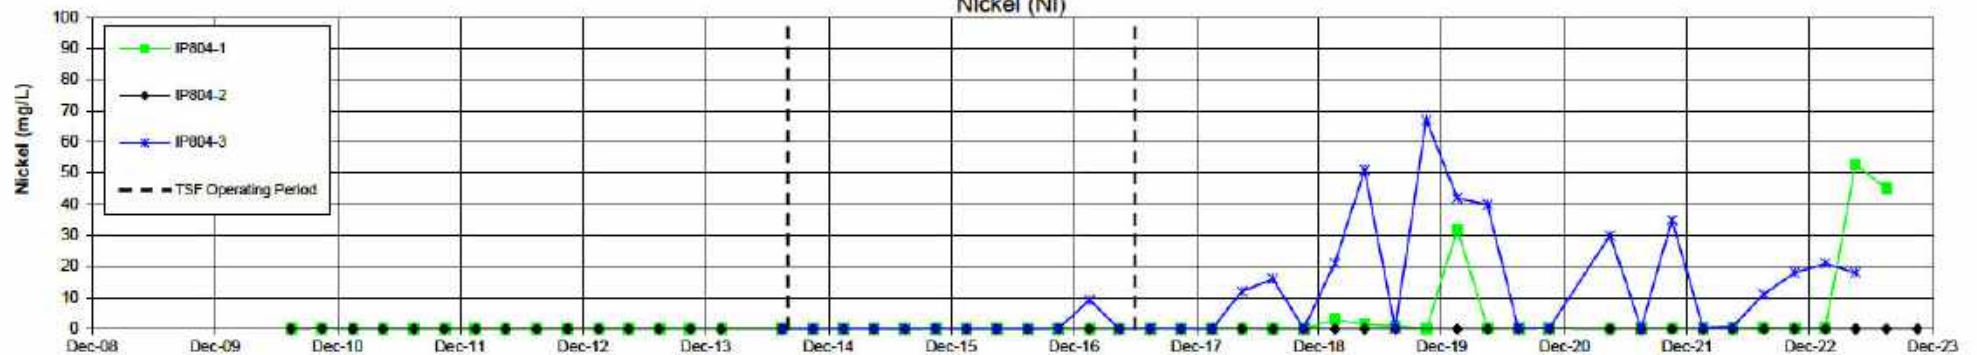
FIGURE: B6

Total Dissolved Solids (TDS)

Cobalt (Co)

Nickel (Ni)

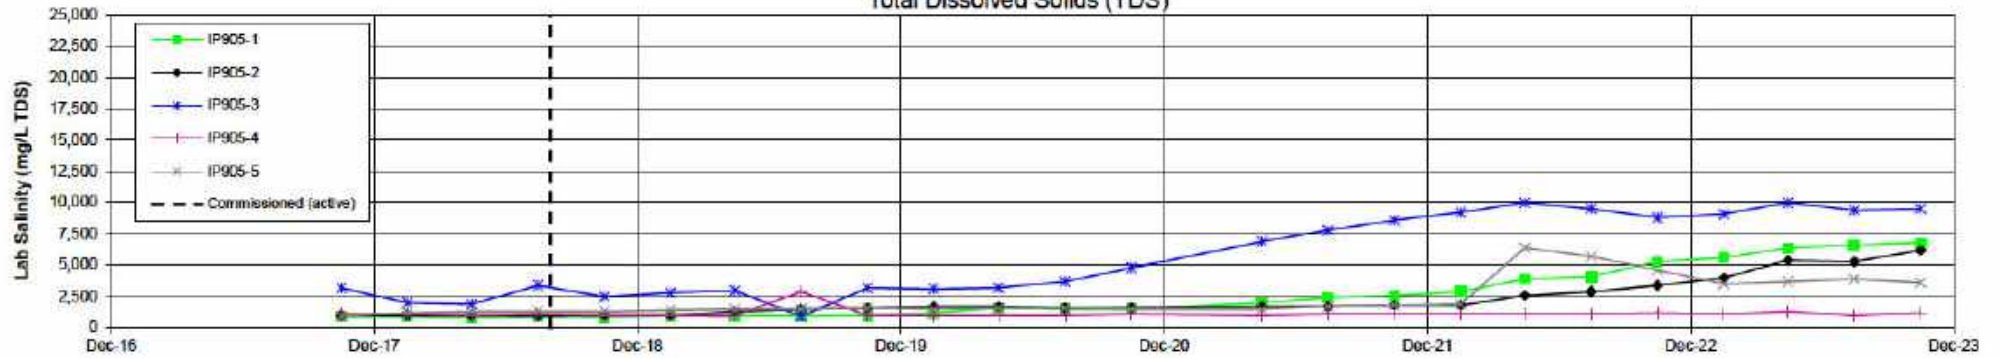
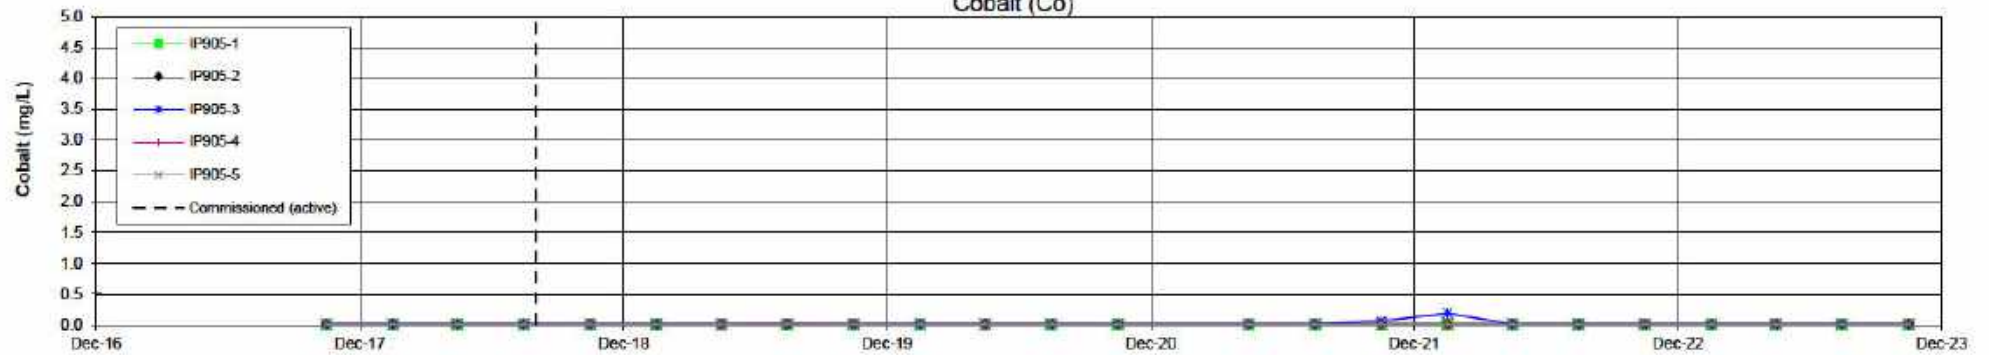
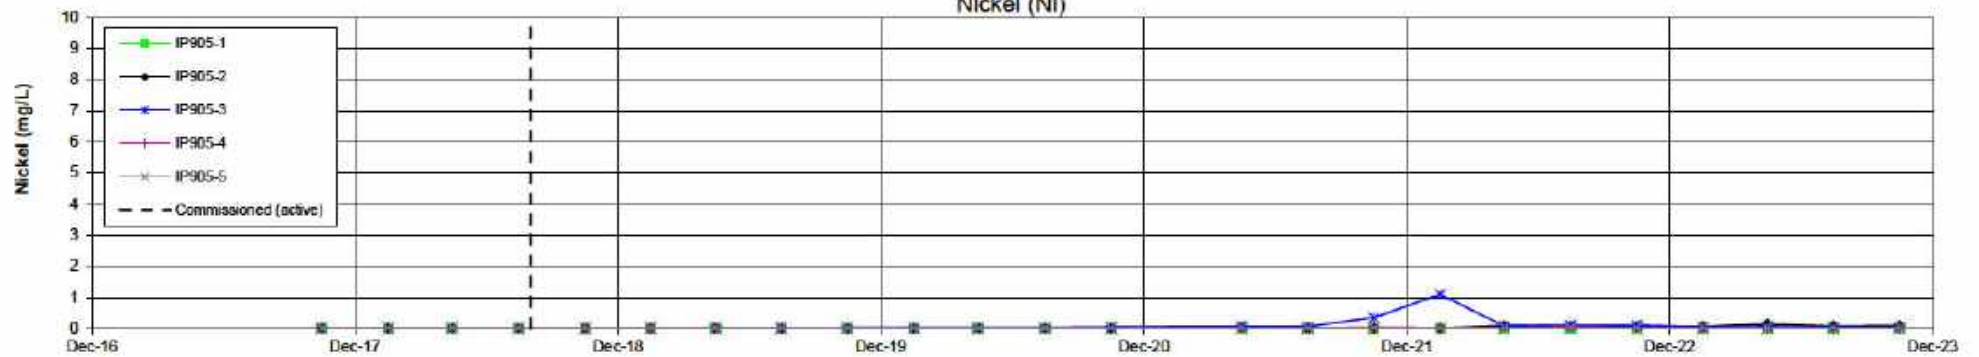
FIGURE: B7

Total Dissolved Solids (TDS)

Cobalt (Co)

Nickel (Ni)

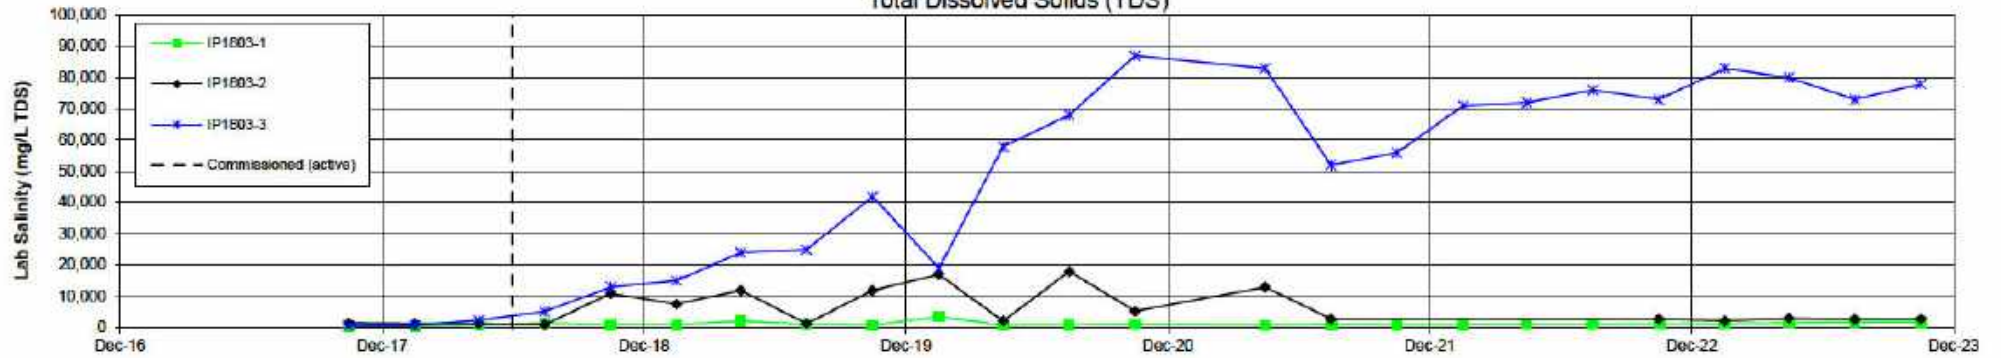
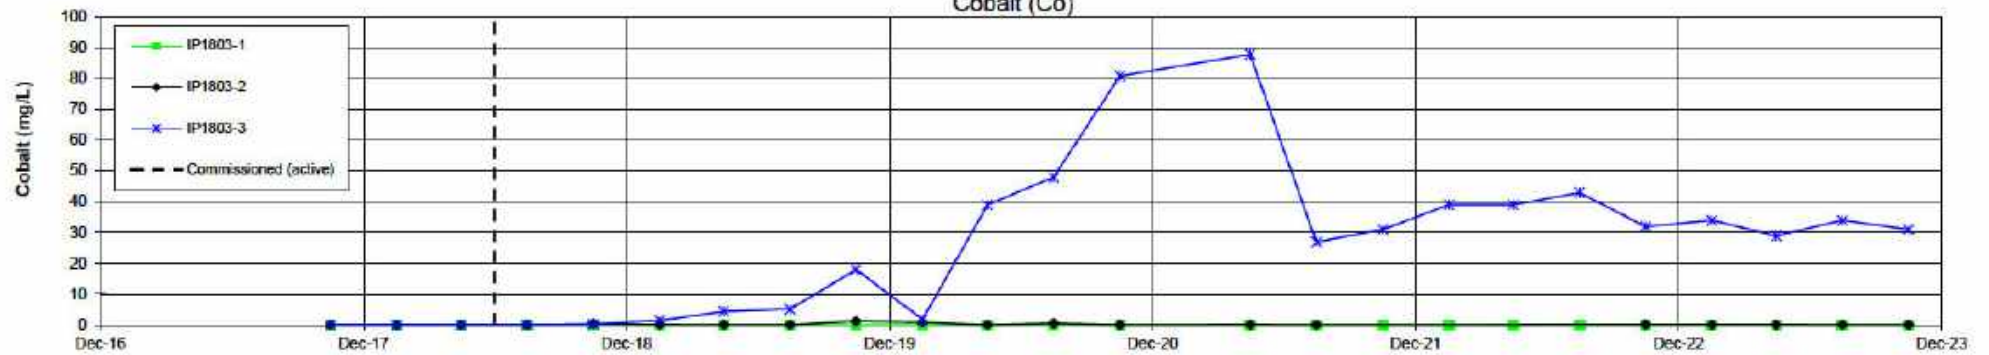
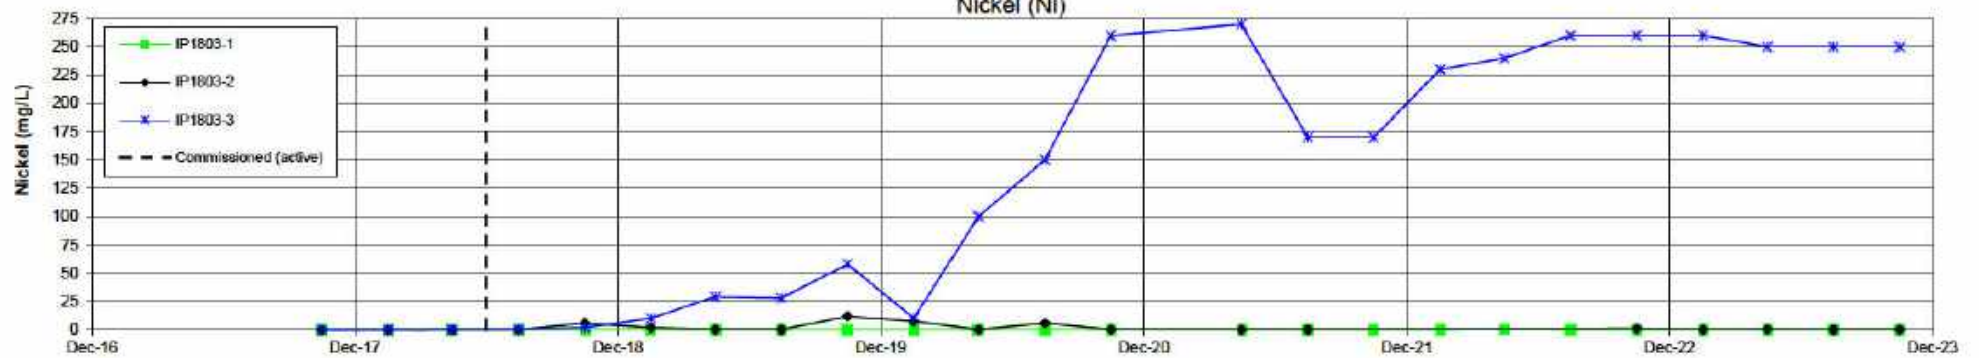
FIGURE: B8

Total Dissolved Solids (TDS)

Cobalt (Co)

Nickel (Ni)

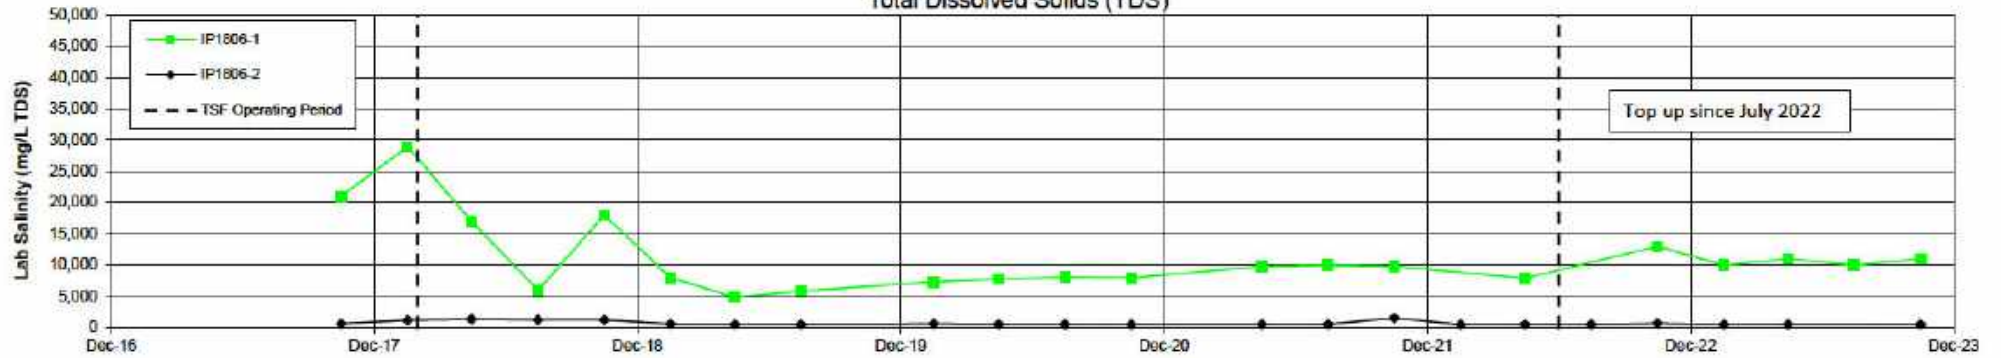
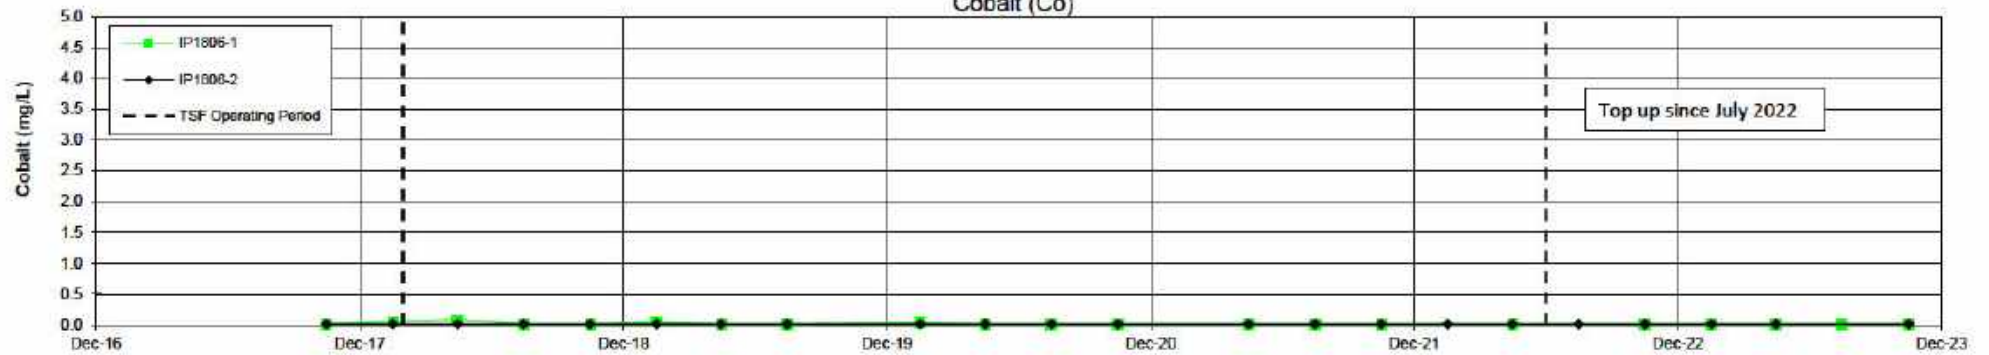
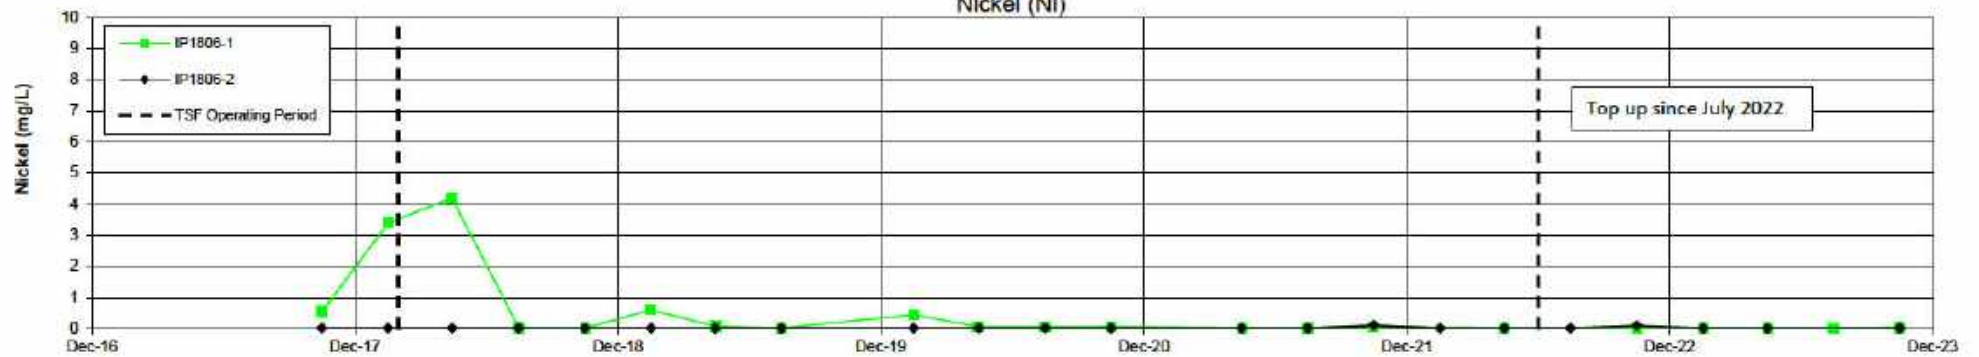
FIGURE: B9

Total Dissolved Solids (TDS)

Cobalt (Co)

Nickel (Ni)

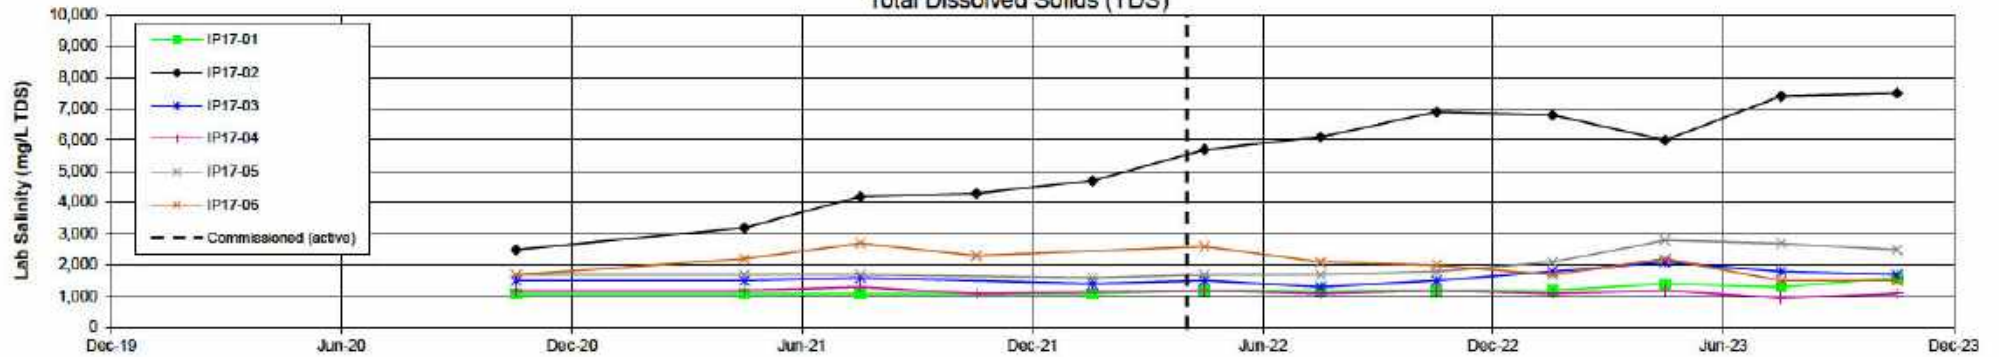
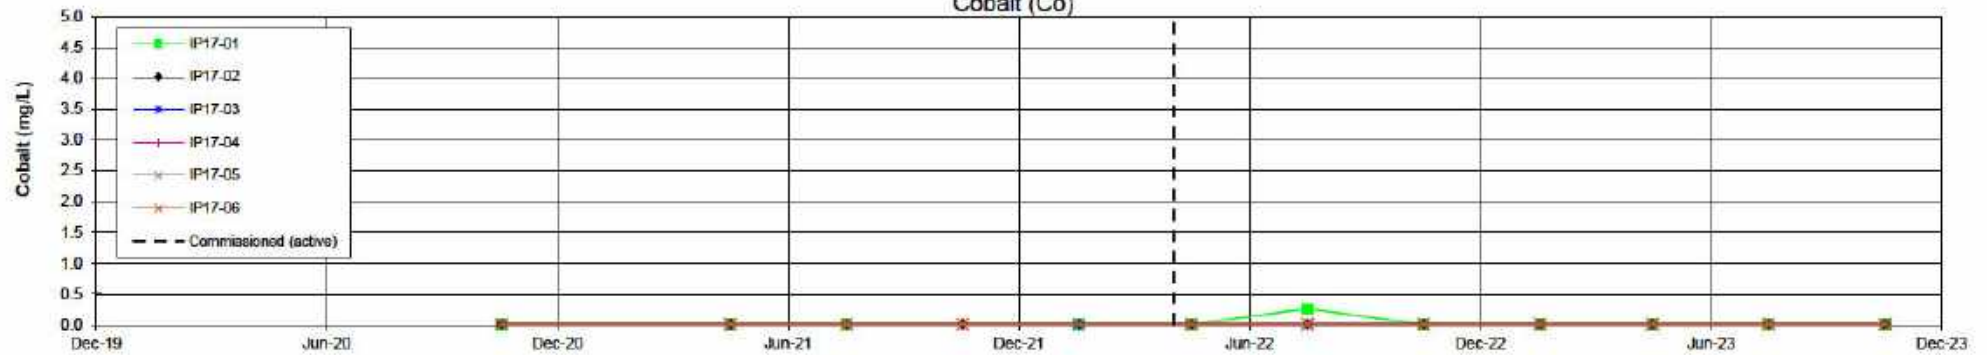
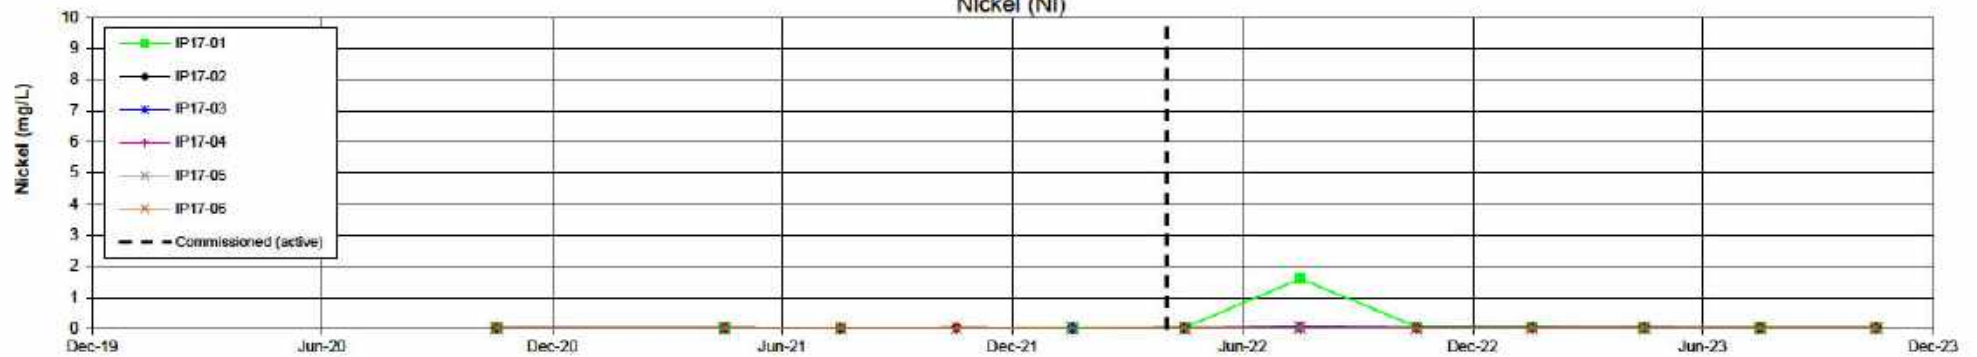
Total Dissolved Solids (TDS)

Cobalt (Co)

Nickel (Ni)

TITLE: 17 Series Seepage Bores (West) Water Quality
FIGURE: B10
