Title: MUJA TAILINGS STORAGE FACILITY DAMS MANAGEMENT PLAN

Document Number: MUJ-PLN-ENV-0001 Revision: 0 Date: 19/07/2024

MANAGEMENT PLAN
MUJA TAILINGS STORAGE FACILITY DAMS MANAGEMENT PLAN

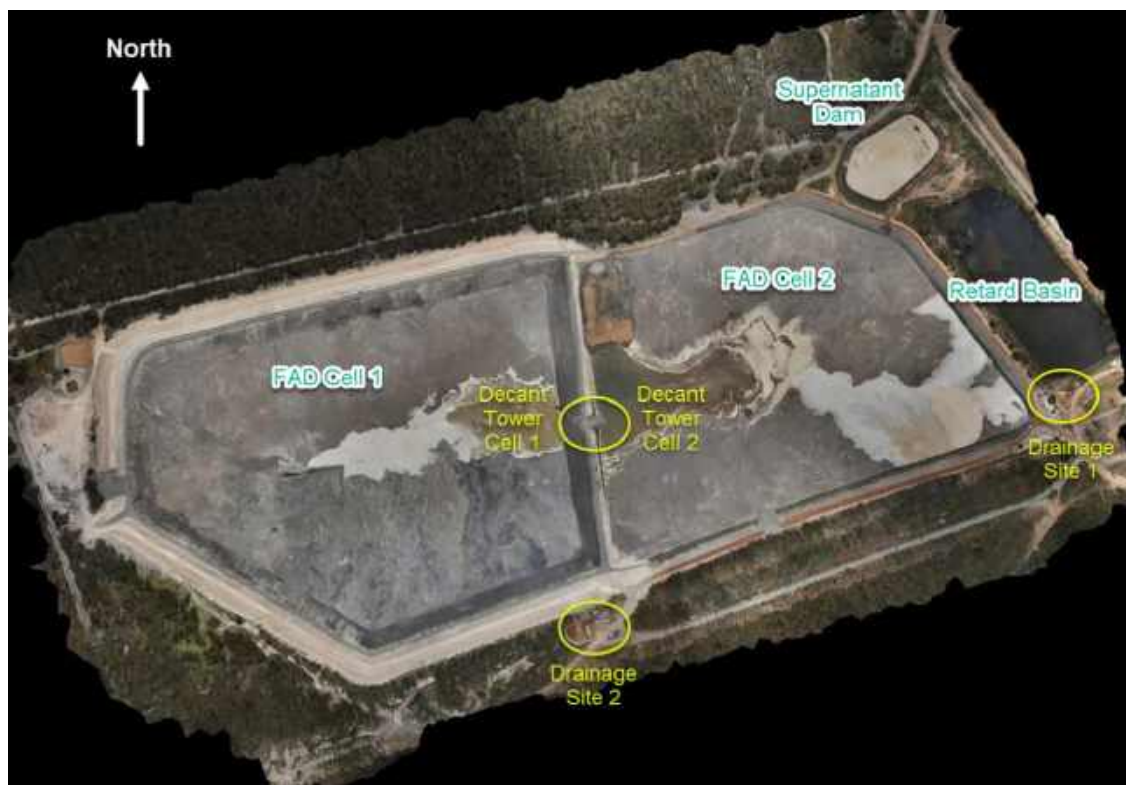
The general arrangement of the FAD is shown in **Figure 1**, indicating the position of cell 1, cell 2 and their associated decant sites, the supernatant dam and the peripheral infrastructure. The original embankments and levees were constructed to a crest level of reduced level (RL) 253 m and comprised of:

- (a) the main embankment, approximately seven metres high, along the south and southwest perimeters. The main embankment was zoned and included a central impermeable core;
- (b) a zoned embankment along the east perimeter;
- (c) a levee of impermeable material in the upstream areas; and
- (d) a 1 m thick clay blanket on the west and south sections of the FAD floor.

Figure 1: FAD general arrangement

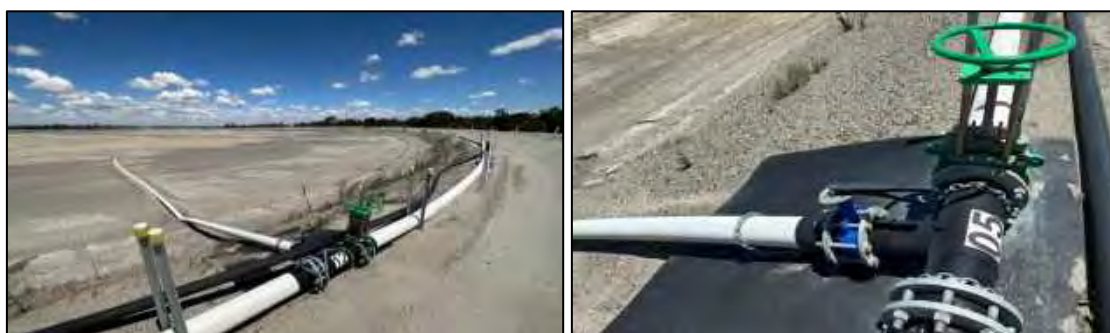
A DN160 HDPE pipe ring main with spigots at regular intervals is installed on cell 1 and cell 2. Each spigot comprised a tee piece, isolation valve and mining hose inserted into a polyvinyl chloride slotted dropper.

Figure 3 and Figure 4: FAD cell 1 spigot set

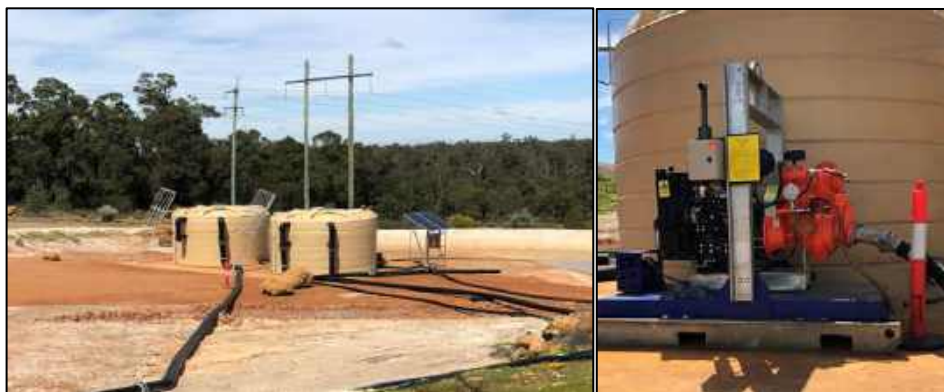
Figure 7 and Figure 8: Drainage site 2 Sykes CPT100i pump

The drainage site 2 is managed using 2 off 50kL tanks and the overflow reports directly to the supernatant dam upon pump activation. The sykes CPT100i pump at drainage site 2 is refuelled and automatically as required (refer to **Figure 7**). The two tanks are connected, and the combined level is monitored using the DCS which reports to the bottom ash control room. The tanks are also fitted with a manual level reading. A visual alert is displayed when the tanks are 75% full.

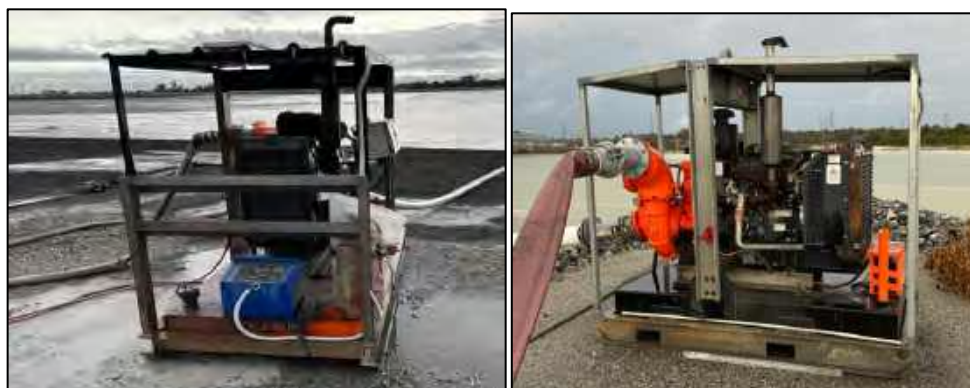
Each cell has a decant tower located centrally along the dividing embankment. This decant tower is comprised of slotted concrete well liners surrounded by aggregate. The decant pipeline was located at the base of the decant tower. Originally, these decant towers operated by gravity, however the decant line has been decommissioned and free water in the FAD is now pumped to the supernatant dam. A diesel pump is located in the middle of the dividing embankment between cell 1 and cell 2 and can pump from the decant tower slotted well liners or from a floating intake in the decant pond.

Figure 9: Decant Cell 1

Figure 10: Decant Cell 2 pump

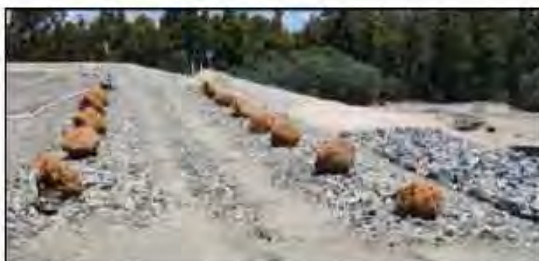
Figure 12: Cell 1 spillway

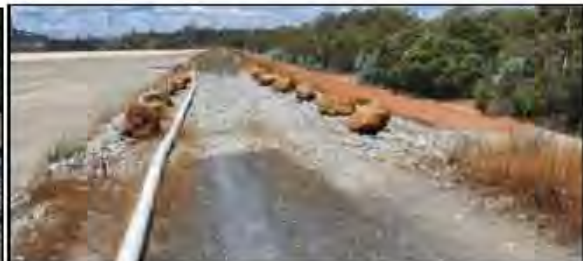
Figure 13: Cell 2 spillway

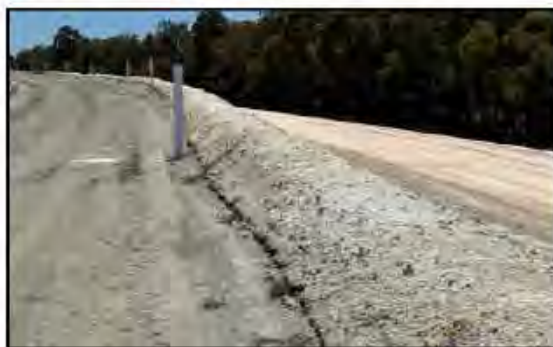
Windrows were constructed along the downstream edge of the embankment crest to a minimum height of 500 mm. The material was placed using a GPS equipped 30-tonne excavator and compacted by bucket tamping. The windrows were well compacted and met the intended design function.

Figure 14: Cell 1 windrows

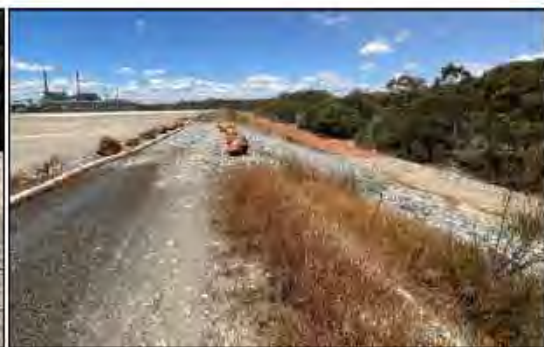
Figure 15: Cell 2 windrows

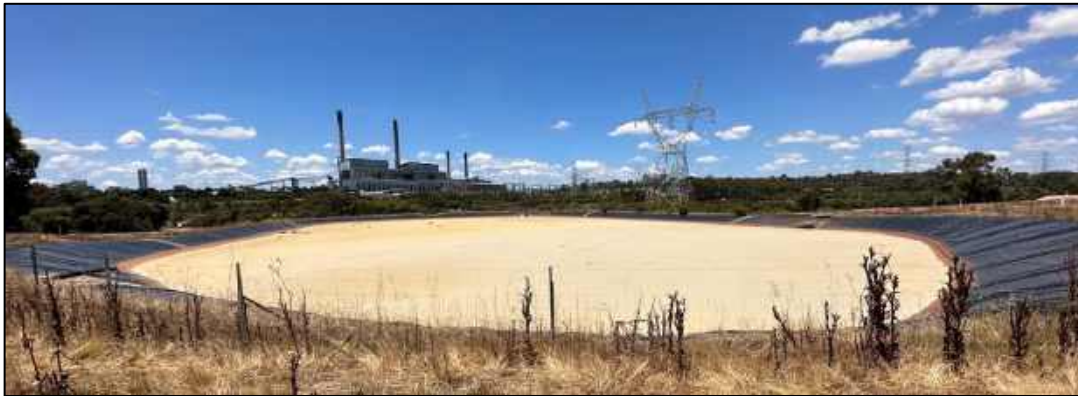
The supernatant dam (**SNDM**) was constructed 2009/2010 and is located to the north-east of the FAD and specifically cell 2, which is used as an operational buffer to collect and temporarily store ash runoff from cell 1 and cell 2. The stored water is transferred to the upstream facilities for treatment and reuse. The supernatant dam has been designed as per the following:

- (a) foundation bed preparation scarified to 150mm and compacted to 95%;
- (b) foundation prepared to 150mm thick compacted clay;
- (c) 150mm compacted clay layer; and
- (d) 1.5mm HDPE geomembrane.

Figure 16: Supernatant dam

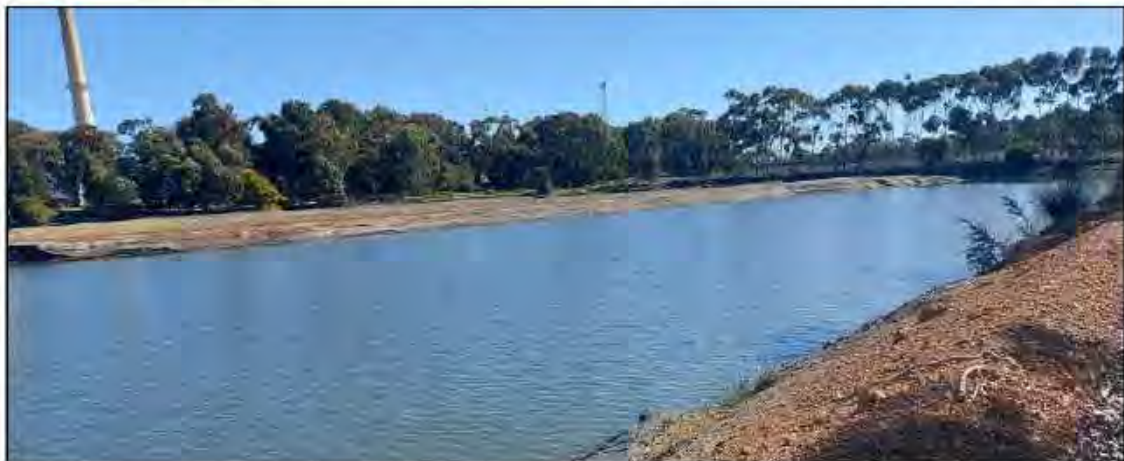
Figure 19: Bottom ash dam (BAD)

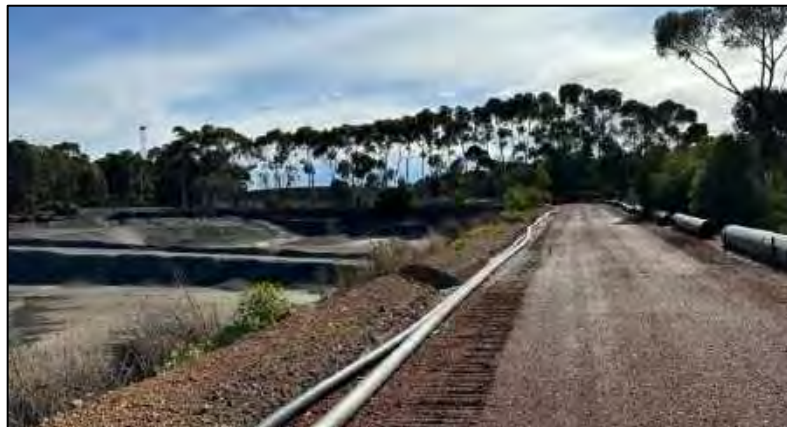
Windrows were constructed along the downstream edge of the embankment crest to a minimum height of 500 mm and logs are erected on the eastern part of the dam. The windrows were well compacted and met the intended design function.

Figure 20: BAD windrows

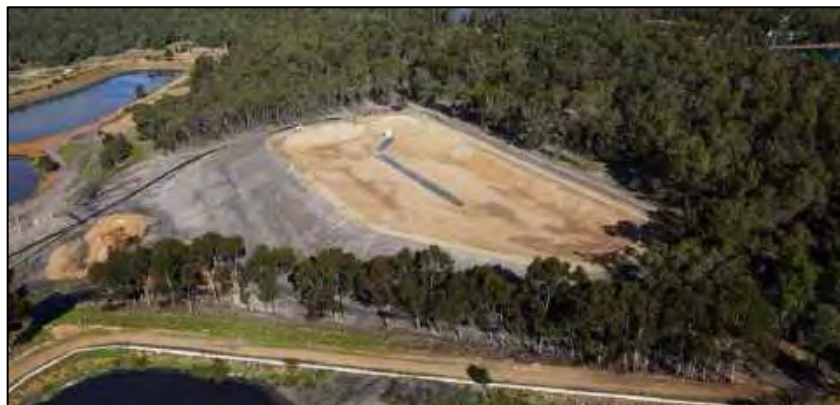
The temporary ash dam (TAD) is located adjacent to the BAD, which is used as an alternate storage location for bottom ash deposition. In 2002, a TAD was constructed in the vicinity of the BAD to receive bottom ash slurry, thereby allowing the BAD to be temporarily taken out of service and drained during the bottom ash excavation process.

Figure 21: Temporary ash dam (TAD) drone photo (2015)

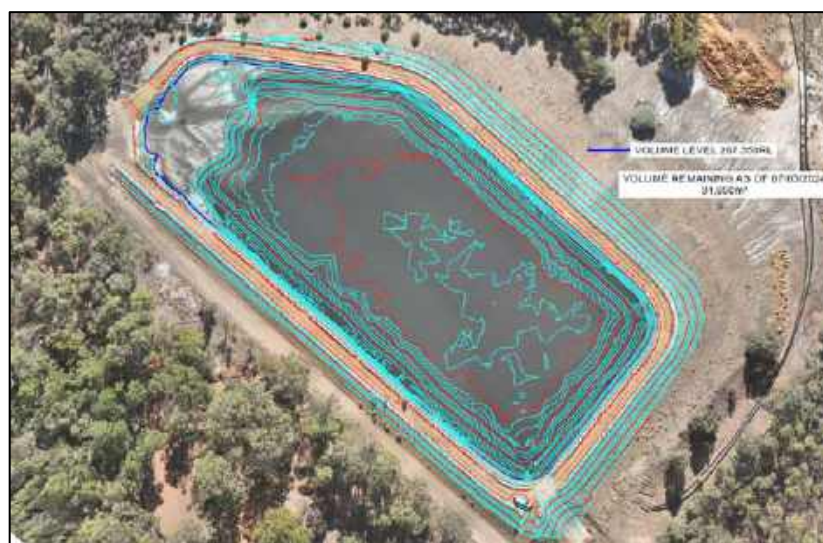
The natural ground slopes down to the east reducing in elevation from approximately 266 m AHD at the north-western corner of the TAD to 254 m AHD on the downslope eastern side of the site. The investigation was initially concentrated on the TAD and was later expanded to a shallow borrow area located approximately 450 m south of the TAD. Please refer to ER2571 GHD preliminary geotechnical investigation TAD May 2014 (DM ID: [6334937](#)).

Figure 22: Muja TAD Survey June 2024 (Reference DM ID: [35093609](#))

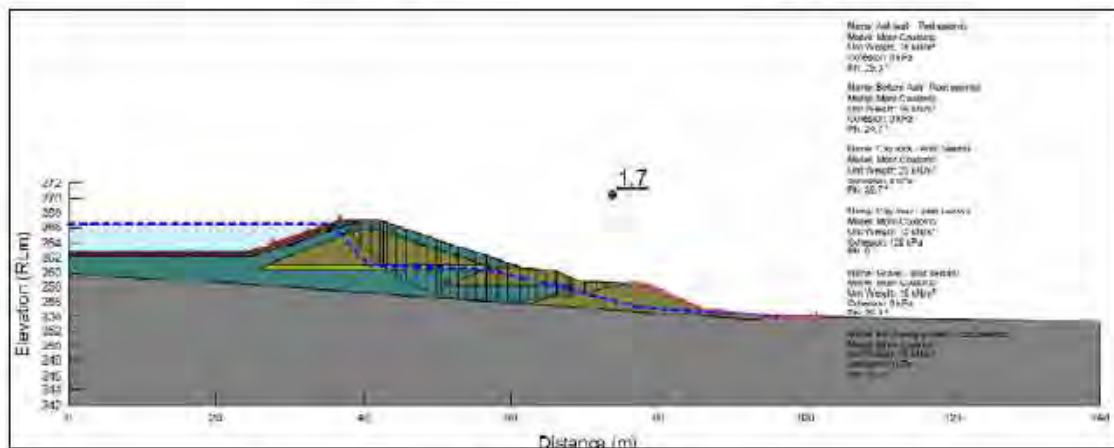
Figure 23: TAD slope stability calculation

Key details of the TAD embankment height and spillway dimensions are summarised in Table 18 and typical cross-sections of the most recent embankment raises are included in Figure 23, Figure 24 and Figure 25.

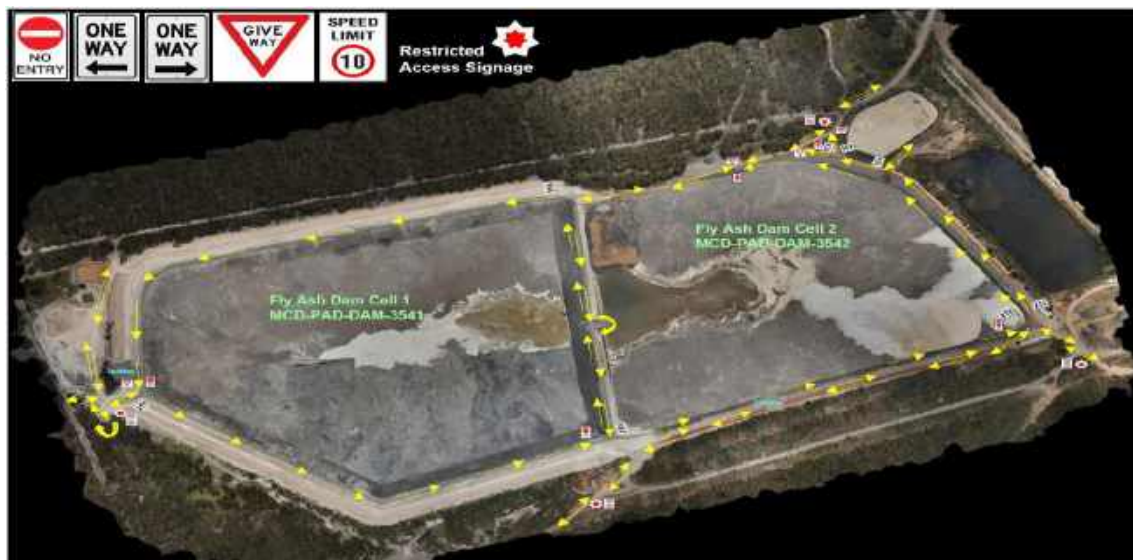
Roads on and around the FAD are designed for the equipment which are using them. Light vehicles are capable of using the roads all year round, however the 15T franna crane is only suited to dry season use. No apparent stability analysis for the crane has been undertaken to demonstrate that the roads are designed for the equipment using them. However, based on inspection, it would appear the roads may be adequate for the equipment in regular use on the TSF. Please refer to drawing M127/C/27/1 Cell 2 embankment geometry (DM ID: [23410068](#)) for FAD cell 2 embankment and road design. After using heavy mobile equipment on roads around the FAD dams, a visual inspection is required to ensure roads haven't been damaged.

Figure 27: Fly ash dam traffic management plan (DM ID: [21848022](#))

Any area specific requirements due to construction works or other activities, including authorisation requirements, call up procedures, traffic management plans, safe work procedures and personal protective equipment must be complied with. The traffic management plan can be found within SIM 5.74 FAD traffic management plan (DM ID: [21848022](#)).

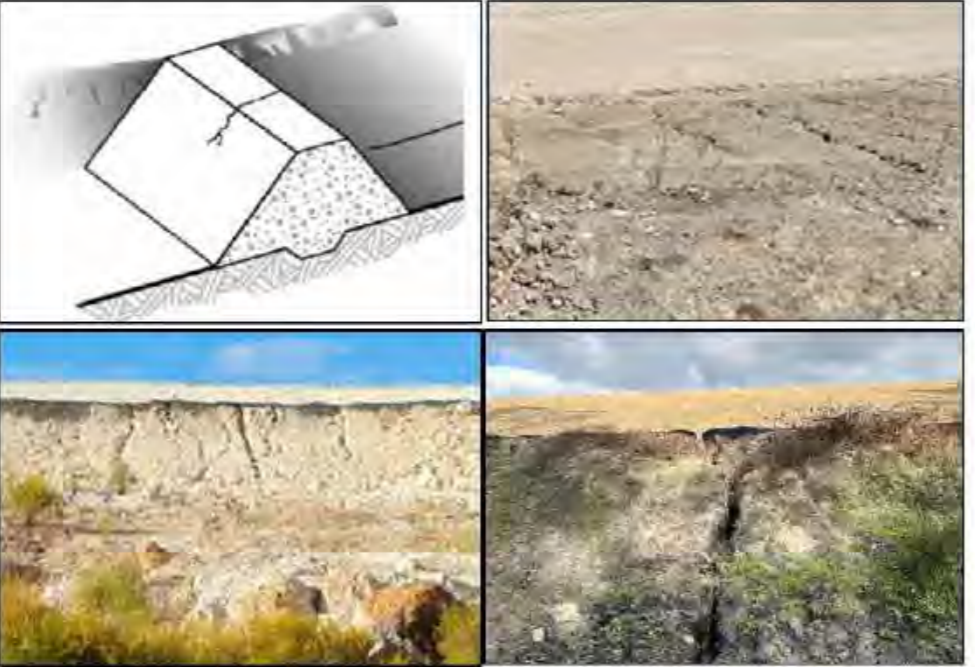
<p>Embankment: Transversal crack on crest, upstream and downstream face</p>	<p>Transverse cracks extend perpendicular to the crest and can indicate differential settlement within the embankment. Such cracks provide avenues for seepage through the dam and could quickly lead to piping, a severe seepage problem that will likely cause the dam to fail.</p>

<p>Short: Isolated cracks are commonly due to drying and shrinkage of the embankment surface and are not usually significant. They are usually less than 1 inch wide and propagate in various directions.</p> <p>Larger (wider than 1 inch): Well-defined cracks may indicate a more serious problem.</p>	<p>Possible embankment or foundation instability.</p> <p>Provides entry point for surface water which can promote erosion.</p> <p>Seepage.</p>	<p>(b) to be consulted: The system engineer / dam engineer:</p> <ul style="list-style-type: none"> (i) seal the cracks to prevent runoff from saturating the embankment; and (ii) investigate the findings to prepare plans and specifications, if necessary, for repairs. <p>(c) to be consulted: The environmental team and operations manager and supervisor.</p>

- (B) **larger (wider than 1 inch):** Well-defined cracks may indicate a more serious problem.
 - (iii) **transversal crack on crest:** Inspect the downstream face of the embankment for transversal cracks;

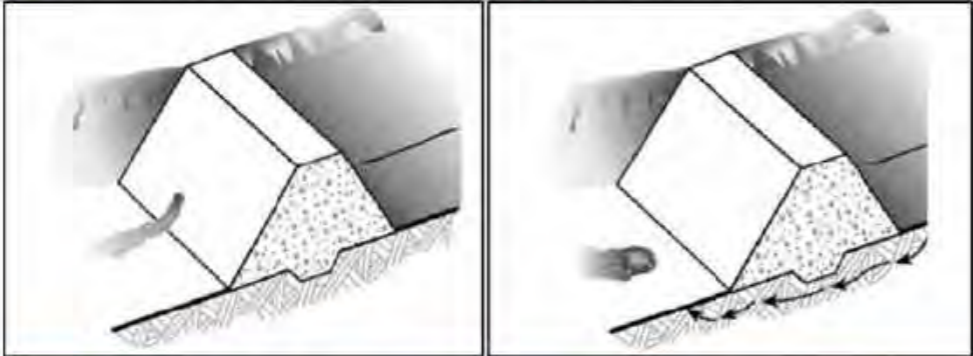
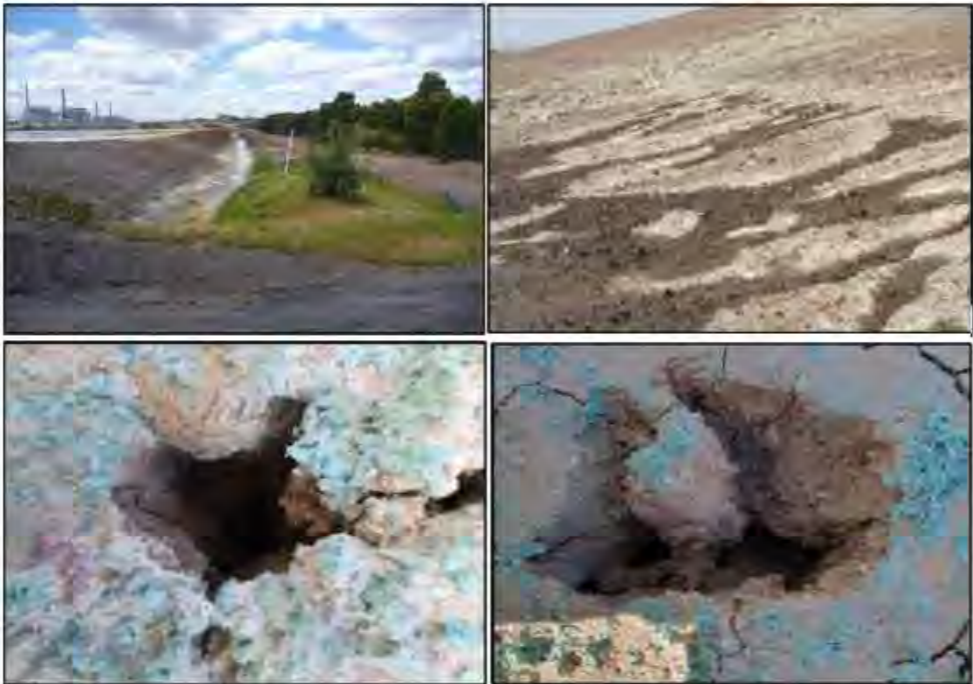
Inspection	Description	Causes	Concerns	Action
<p>Embankment: Wet areas or seepage on downstream face</p>	<p>Seepage can emerge anywhere on the downstream face, beyond the toe, or on the downstream abutments at elevations below normal pool. Seepage may vary in appearance from a "soft," wet area to a flowing "spring." It may show up first as an area where the vegetation is lush and darker green. Cattails, reeds, mosses, and other marsh vegetation often become established in a seepage area. Another indication of seepage is the presence of rust-coloured iron bacteria. Due to their nature, the bacteria are found more often where water is discharging from the ground than in surface water. Seepage can make inspection and maintenance difficult. It can also saturate and weaken portions of the embankment and foundation, making the embankment susceptible to earth slides.</p> <p>If the seepage forces are large enough, soil will be eroded from the foundation and be deposited in the shape of a cone around the seepage outlet. If these "boils" appear, professional advice should be sought immediately. Seepage flow which is muddy and carrying sediment (soil particles) is evidence of "piping," and could very possibly cause failure of the dam. Piping can occur along a spillway and other conduits through the embankment, and these areas should be closely inspected. Sinkholes may develop on the surface of the embankment as internal erosion takes place. Please also refer to inspection "Ponding, seepage, sinkholes and settlement".</p>

<p>Wet areas or seepage may develop because of poor soil compaction, sudden drawdown of the lake level, undercutting of the embankment toe, or saturation and weakening of the embankment or foundation.</p>	<p>Possible slope instability or piping failure. Seepage.</p>	<p>Operators to carry out inspection on the embankment to find any defects. If any of these abnormalities, concerns or defects have occurred the following should be completed or consulted:</p> <p>(a) to be completed: Identify, record and monitor:</p> <ul style="list-style-type: none"> (i) location and photographs; (ii) monitor from past inspections, compare and advise if changes have been found; (iii) the embankments, tow downstream areas of the FAD domain shall be monitored for any signs of seepage. Seepage should be monitored for the following: <ul style="list-style-type: none"> (A) flow rate (if flowing); (B) colour and clarity; (C) changes in flow; (D) unusual vegetation growth or death; (E) changes outside normal operating range to any of the above; (F) new seepage areas; and (G) water contained against external toe of dam wall. (iv) while measuring seepage, flow rates may be difficult due to location of the seepage, an effort should be made to measure the rate of seepage to allow comparison over time. Potential methods to measure seepage or underdrainage include: <ul style="list-style-type: none"> (A) measure time to fill a bucket of known volume; (B) flow meters on return pumps; (C) V-notch weirs; (D) photographs with a common reference point such as a stake; and (E) painted outline of wet areas. <p>(b) to be consulted: The system engineer / dam engineer:</p> <ul style="list-style-type: none"> (i) seal the cracks to prevent runoff from saturating the embankment; and (ii) investigate the findings to prepare plans and specifications, if necessary, for repairs. <p>(c) to be consulted: The environmental team and operations manager and supervisor.</p>

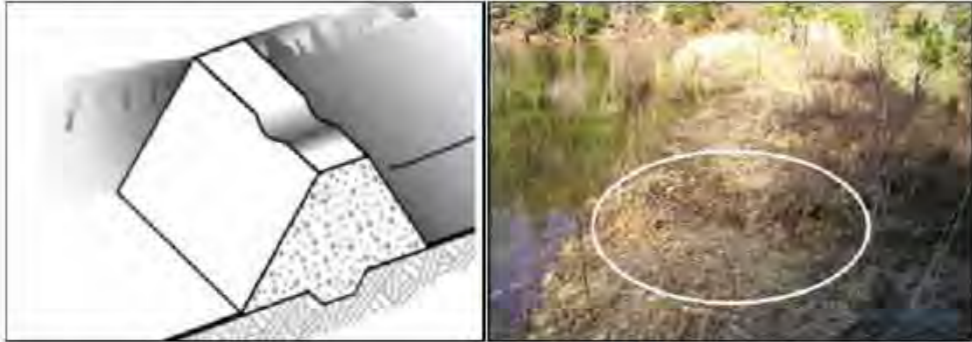
Inspection	Description	Causes	Concerns	Action
<p>Embankment: Low areas or depressions on the crest</p>	<p>Depressions are sunken low areas of the abutment, toe area, or embankment surface. To a certain degree, minor depressions are common and do not necessarily indicate a serious problem.</p> <p>Depressions can create low areas along the crest, cracks through the embankment, structural damage to spillways or other appurtenant structures, damage to internal drainage systems, or general instability of the embankment. They can also inhibit maintenance of the dam and make detection of stability or seepage problems difficult.</p>

<p>Excessive settlement of embankment or foundation - They may be created during construction or may be caused by decay of buried organic materials, internal erosion of the embankment, or settlement (consolidation) of the embankment or its foundation.</p> <p>Weak foundation materials, poor compaction of the embankment during construction, or internal erosion of the embankment fill.</p>	<p>Embankment or foundation instability.</p> <p>Internal erosion of embankment material.</p> <p>Seepage.</p>	<p>Operators to carry out inspection on the embankment to find any defects. If any of these abnormalities, concerns or defects have occurred the following should be completed or consulted:</p> <p>(a) to be completed: Identify, record and monitor:</p> <ul style="list-style-type: none"> (i) location, length, approximate elevation, photographs, sketches, and possibly monitoring stakes; and (ii) monitor from past inspections, compare and advise if changes have been found. <p>(b) to be consulted: The system engineer / dam engineer:</p> <ul style="list-style-type: none"> (i) investigate the findings to prepare plans and specifications, if necessary, for repairs. <p>(c) to be consulted: The environmental team and operations manager and supervisor.</p>

- (B) **larger (wider than 1 inch):** Well-defined cracks may indicate a more serious problem.
 - (iv) **low areas or depressions on the crest:** Inspect embankment downstream and crest for low areas / depression's;

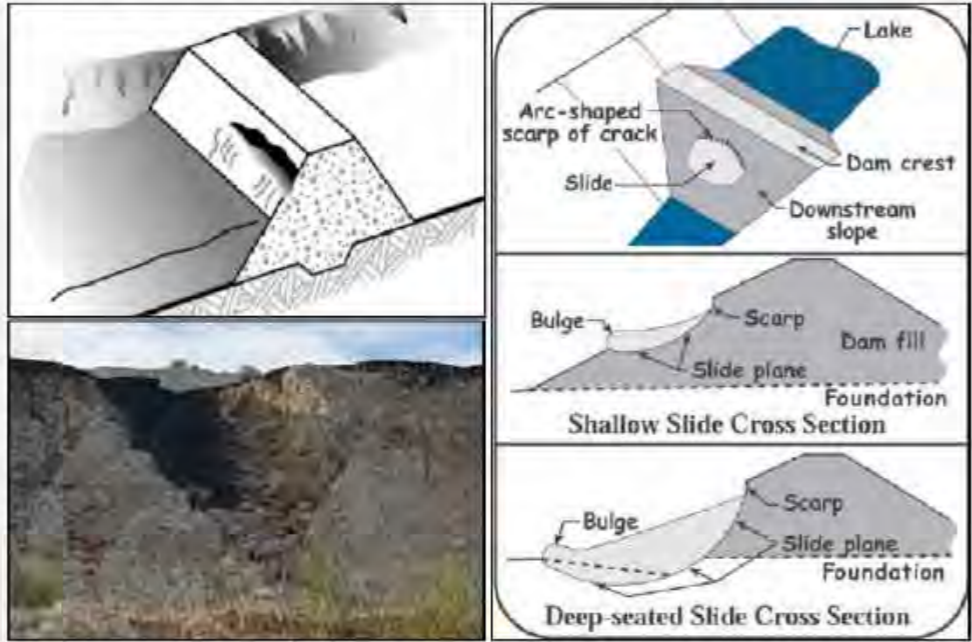
<p>Embankment: Slumps, slides or erosions</p>	<p>A slide / slump in an embankment or in natural soil or rock is a mass movement of material. Some typical characteristics of a slide are an arc shaped crack or scarp along the top and a bulge along the bottom of the slide. Slides / slumps can be divided into two main groups: shallow and deep-seated. Shallow slides generally affect the top 2 to 3 feet of the embankment surface.</p>

<p>Slides may develop because of poor soil compaction, the gradient of the slope being too steep for the embankment material, seepage, sudden drawdown of the lake level, undercutting of the embankment toe, or saturation and weakening of the embankment or foundation.</p> <p>Shallow slides: Are generally not threatening to the immediate safety of the dam and often result from wave erosion, collapsed rodent burrows, or saturated topsoil.</p> <p>Deep-seated slides: Are serious, immediate threats to the safety of a dam. They can extend several feet below the surface of the embankment even below the foundation. A massive slide can initiate the catastrophic failure of a dam. Deep-seated slides are the result of serious problems within the embankment.</p>	<p>Possible slope instability.</p> <p>Seepage.</p>	<p>Operators to carry out inspection on the embankment to find any slumps, slides or erosions. If any of these abnormalities, concerns or defects have occurred the following should be completed or consulted:</p> <p>(a) to be completed: Identify, record and monitor:</p> <ul style="list-style-type: none"> (i) location, length, approximate elevation, photographs, sketches, and possibly monitoring stakes (Note: slump areas or erosion holes deeper than 0.5m); and (ii) monitor from past inspections, compare and advise if changes have been found. <p>(b) to be consulted: The system engineer / dam engineer:</p> <ul style="list-style-type: none"> (i) investigate the findings to prepare plans and specifications, if necessary, for repairs. <p>(c) to be consulted: The environmental team and operations manager and supervisor.</p>

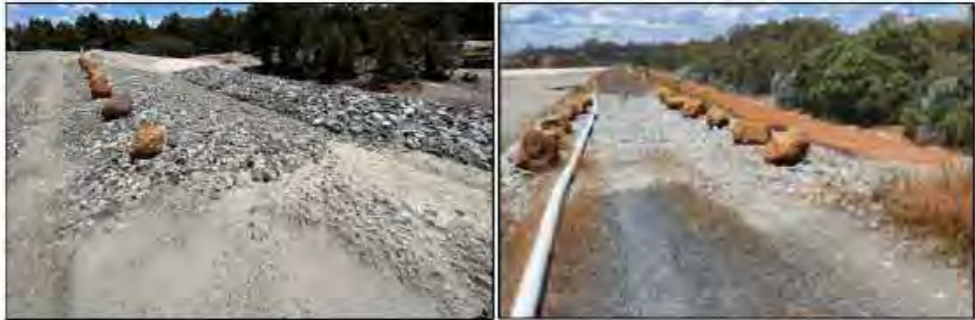
Inspection	Description	Causes	Concerns	Action
<p>Embankment: Spillway</p>	<p>Spillways are a structure that either form part of a dam or are found just beside one. They are used, when a reservoir is full, to pass floodwater safely, and in a controlled way, over a dam, around it or through it. An overflow spillway is most often constructed as part of a gravity dam or a buttress dam. The spillway section is lower than the other sections of the dam allowing water to flow over its top and down its front face.</p> <p>Spillway sections are usually founded on pilings, ledge, natural soils or a combination of these materials. The effect of uncontrolled leakage through the foundation material over time can cause internal erosion of soils or deterioration of rock. Ensure that the spillway remains as level as possible across its entire width to avoid flow concentration.</p>

<p>The loss of foundation material from seepage forces may leave voids beneath the spillway, which decreases the overall support for the spillway.</p> <p>Road access over the spillway may disrupt the spillway design.</p> <p>Spillway blockages.</p> <p>Spillway erosion.</p>	<p>Seepage. Blockages. Erosion.</p>	<p>Operators to carry out inspection on the embankment to find any damage to the spillway which include seepage, blockages, design changes during inspection of the dam. If any abnormalities, concerns or defects have occurred the following should be completed or consulted:</p> <p>(a) to be completed: Identify, record and monitor:</p> <ul style="list-style-type: none"> (i) location and photographs; and (ii) monitor from past inspections, compare and advise if changes have been found. <p>(b) to be consulted: The system engineer / dam engineer:</p> <ul style="list-style-type: none"> (i) investigate the findings to prepare plans and specifications, if necessary, for repairs. <p>(c) to be consulted: The environmental team and operations manager and supervisor.</p>

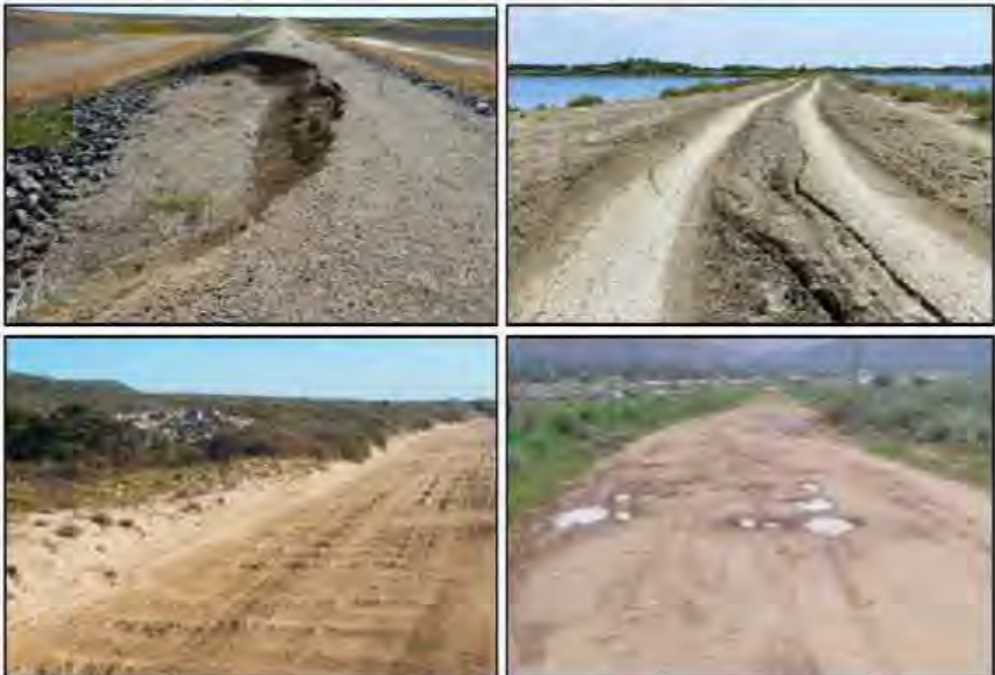
<p>Access roads: Roads</p>	<p>The FAD's access roads constructed around the dam is designed with gravel. A gravel road is a type of unpaved road surfaced with gravel that has been brought to the site from a quarry or stream bed.</p> <p>The problems associated with these roads are gravel loss, shape loss, and rideability. These issues are the result of deterioration factors like inadequate drainage capacity, dust, corrugations, potholes, ruts, loose gravel, and frost damage.</p>

<p>Excessive vehicles.</p> <p>Excessive high speeds from vehicles.</p> <p>Wear and tear, little to no maintenance.</p> <p>Weather.</p> <p>Vegetation.</p>	<p>Damage to embankment (upstream and downstream).</p> <p>Damage to spillway.</p> <p>Seepage.</p>	<p>Operators to carry out inspection on the access roads to find any damage to the roads which include erosion, potholes, deep tyre tracks, corrugation. If any abnormalities, concerns or defects have occurred the following should be completed or consulted:</p> <p>(a) to be completed: Identify, record and monitor:</p> <ul style="list-style-type: none"> (i) location and photographs; and (ii) monitor from past inspections, compare and advise if changes have been found. <p>(b) to be consulted: The system engineer / dam engineer:</p> <ul style="list-style-type: none"> (i) investigate the findings to prepare plans and specifications, if necessary, for repairs. <p>(c) to be consulted: The environmental team and operations manager and supervisor.</p>

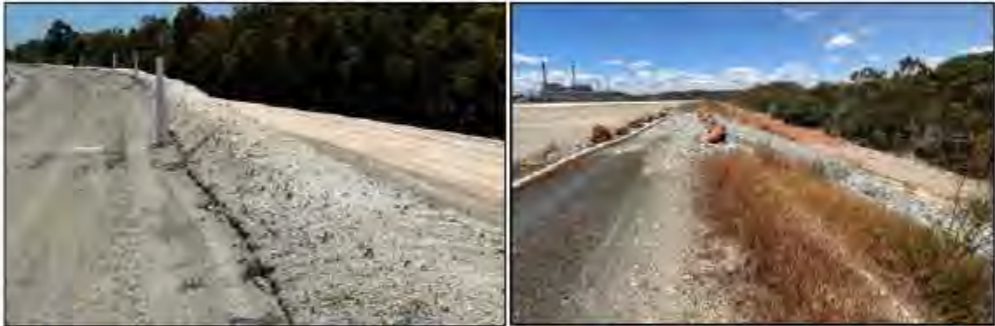
Inspection	Description	Causes	Concerns	Action
<p>Access roads: Windrows</p>	<p>A windrow is a long ridge of loose material, for example on the edge of a dirt road or newly graded earthworks. Windrows are barriers built from earth designed to stop vehicles falling down edges. Damages to windrows can be due to vehicle damage, excessive vegetation and weather conditions.</p>

<p>Excessive vehicles. Excessive high speeds from vehicles. Wear and tear, little to no maintenance. Weather. Vegetation.</p>	<p>Damage to embankment (upstream and downstream). Damage to spillway. Damage to windrows. Seepage.</p>	<p>Operators to carry out inspection on the access roads to find any damage to the windrows. If any abnormalities, concerns or defects have occurred the following should be completed or consulted:</p> <p>(a) to be completed: Identify, record and monitor:</p> <ul style="list-style-type: none"> (i) location and photographs; and (ii) monitor from past inspections, compare and advise if changes have been found. <p>(b) to be consulted: The system engineer / dam engineer:</p> <ul style="list-style-type: none"> (i) investigate the findings to prepare plans and specifications, if necessary, for repairs. <p>(c) to be consulted: The environmental team and operations manager and supervisor.</p>

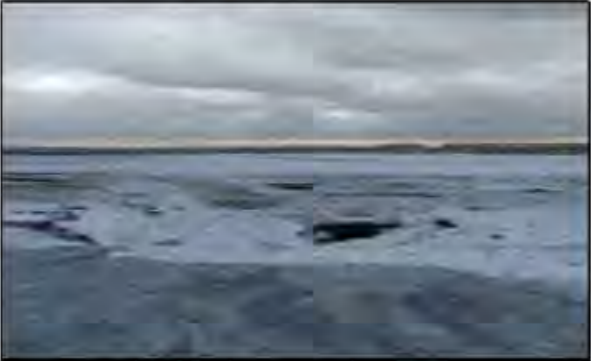
<p>Fly ash surface: Sinkholes and settlement</p>	<p>If the seepage forces are large enough, soil will be eroded from the foundation and be deposited in the shape of a cone around the seepage outlet. If these "boils" appear, professional advice should be sought immediately. Seepage flow which is muddy and carrying sediment (soil particles) is evidence of "piping," and could very possibly cause failure of the dam. Piping can occur along a spillway and other conduits through the embankment, and these areas should be closely inspected. Sinkholes may develop on the surface of the embankment as internal erosion takes place. Please also refer to inspection "Embankment wet areas / seepage on downstream face".</p>

<p>Unsettled flyash Heavy rain / excessive water</p>	<p>Seepage Piezometer triggers</p>	<p>Operators to carry out inspection on the fly ash surface to find any sinkholes and settlement. If any of these abnormalities, concerns or defects have occurred the following should be completed or consulted:</p> <p>(a) to be completed: Identify, record and monitor:</p> <ul style="list-style-type: none"> (i) location, length, approximate elevation, photographs, sketches, and possibly monitoring stakes; and (ii) monitor from past inspections, compare and advise if changes have been found. <p>(b) to be consulted: The system engineer / dam engineer:</p> <ul style="list-style-type: none"> (i) investigate the findings to prepare plans and specifications, if necessary, for repairs. <p>(c) to be consulted: The environmental team and operations manager and supervisor.</p>

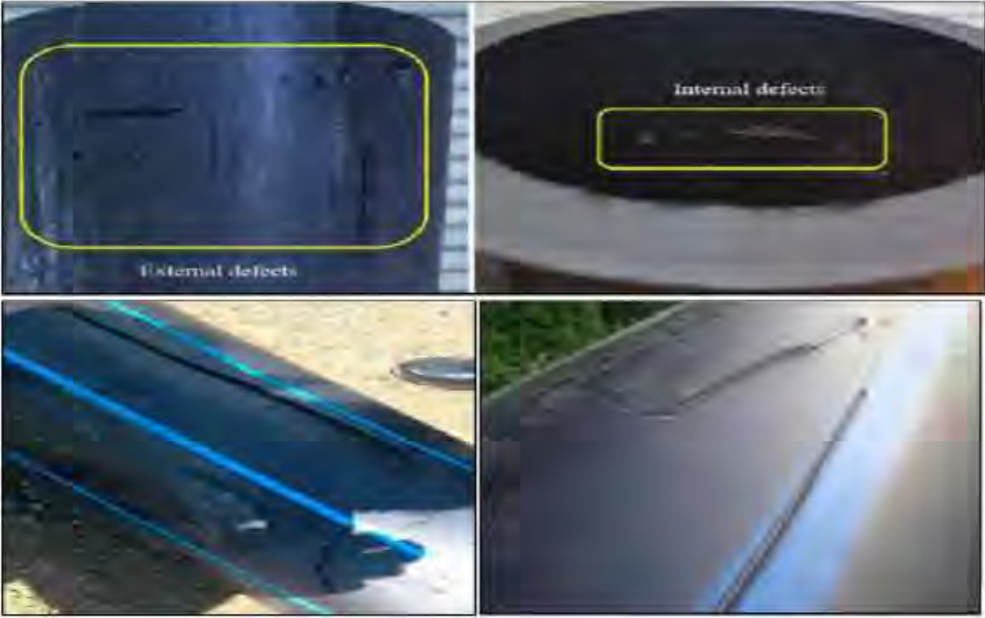
<p>Pipelines: Spigot pipeline Delivery pipeline</p>	<p>Spigot disposal is around the perimeter of the FAD to create a beach between the embankment. This generally means the pond is completely surrounded by beached tailings. The slurry line starts from the silos and ends at the FAD. These pipes are made from Polyethylene (PE) pipes offer durable and flexible solutions. Polyethylene piping is resistant to corrosion in all ground conditions and its flexibility allows it to withstand ground movements.</p>

<p>Fracture or joint failure in outlet pipe. Seepage along outside of pipe (poor installation / welding). Weather. Clogged / blocked slurry pipeline. Traffic damage.</p>	<p>Seepage.</p>	<p>Operators to carry out inspection on the pipelines to find any deficiencies along delivery pipeline corridor, leakage along pipeline, leakage of valves and dysfunctional spigot. If any of these abnormalities, concerns or defects have occurred the following should be completed or consulted:</p> <p>(a) to be completed: Identify, record and monitor:</p> <ul style="list-style-type: none"> (i) location, length, photographs, sketches, and possibly monitoring stakes; and (ii) monitor from past inspections, compare and advise if changes have been found. <p>(b) to be consulted: The system engineer / dam engineer:</p> <ul style="list-style-type: none"> (i) investigate the findings to prepare plans and specifications, if necessary, for repairs. <p>(c) to be consulted: The environmental team and operations manager and supervisor.</p>

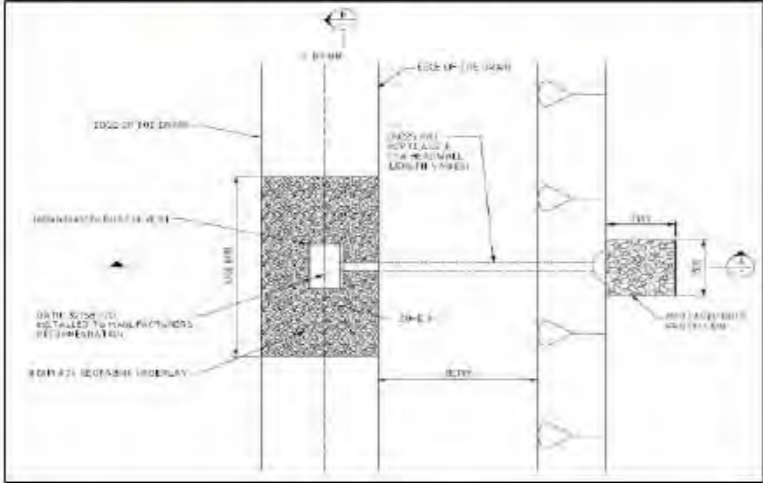
Inspection	Description	Causes	Concerns	Action
<p>Equipment: Surface drains, stormwater collection sumps or pits</p>	<p>Stormwater collection sumps / pits collect excess water and prevent flooding during heavy rain. Stormwater pits are used to hold and control stormwater runoff as the rainwater is slowly discharged through the connected system of drainage pipe. Ensure perimeter drains and sumps are clear of obstructions.</p>

<p>Pipework failure Overfilling / blockages</p>	<p>Seepage</p>	<p>Operators to carry out inspection on the stormwater collection to find any deficiencies on the sumps, pits or surface drains. If any of these abnormalities, concerns or defects have occurred the following should be completed or consulted:</p> <p>(a) to be completed: Identify, record and monitor:</p> <ul style="list-style-type: none"> (i) location and photographs; and (ii) monitor from past inspections, compare and advise if changes have been found. <p>(b) to be consulted: The system engineer / dam engineer:</p> <ul style="list-style-type: none"> (i) investigate the findings to prepare plans and specifications, if necessary, for repairs. <p>(c) to be consulted: The environmental team and operations manager and supervisor.</p>

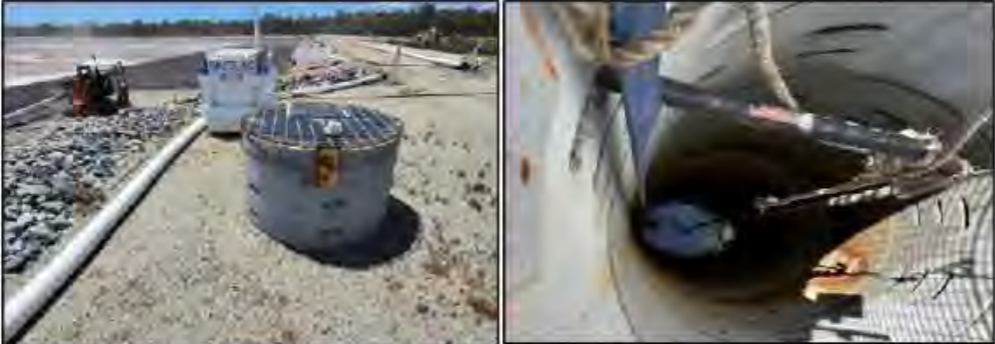
<p>Equipment: Decant and pumps</p>	<p>Each cell has a decant tower located centrally along the dividing embankment. This decant tower is comprised of slotted concrete well liners surrounded by aggregate. The decant pipeline was located at the base of the decant tower.</p> <p>The decant systems of Muja's FAD is designed to cope with the day-to-day management of the "supernatant pond" as well as storm condition surges. The design of the decant allows for a high surge capacity of storm water to compensate for near future storm events. If the pond cannot drain fast enough (decant system or reclaim/evaporation pond ingress restriction), then the freeboard of the FAD may be lost if a near future storm reoccurs.</p> <p>Visual inspection of the decant systems must be observed for deficiency along water return pipeline corridor, blockage of decant structure, deficiency and leakage of water return pump, leakage along pipeline, pipeline inspection (bursts, blockages), decant pool size, behaviour and location, water / storage levels and water return, conduit leaks, siltation, valves and record decant water volumes pumped to the supernatant water dam. Refuelling should also be undertaken as required.</p>

<p>Seepage. Failure of structure. Clogged / blocked. Traffic damage.</p>	<p>Damage to equipment. Equipment failure. Structural failure. Leaking / seepage.</p>	<p>Operators to carry out inspection on the decant tower and pumps. If any defects, abnormalities, concerns or breaches have occurred the following should be completed or considered:</p> <p>(a) to be completed: Identify, record and monitor:</p> <ul style="list-style-type: none"> (i) location and photographs; and (ii) monitor from past inspections, compare and advise if changes have been found. <p>(b) to be consulted: The system engineer / dam engineer:</p> <ul style="list-style-type: none"> (i) investigate the findings to prepare plans and specifications, if necessary, for repairs. <p>(c) to be consulted: The environmental team and operations manager and supervisor.</p>

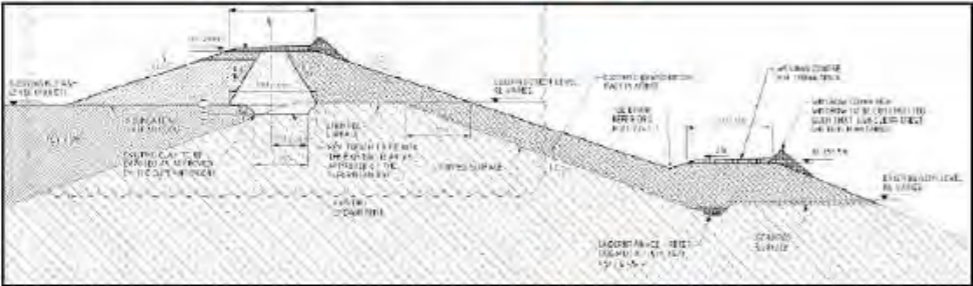
Inspection	Description	Causes	Concerns	Action
<p>Equipment: Underdrainage Sumps and seepage collection system</p>	<p>The leachate collection system utilises a collection of underground installed pipes placed on the upstream tow of cell 1 and the downstream toe of cell 2. The leachate systems installed at cell 1 and cell 2 are different but fulfil similar functions.</p> <p>Cell 1 upstream underdrainage pipe (DM ID: 29089078)</p>

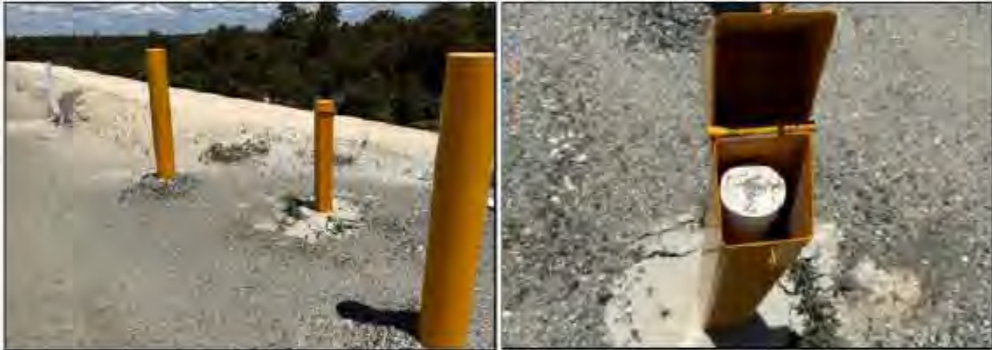
Inspection	Description	Causes	Concerns	Action
<p>Equipment: Piezometer Standpipes</p>	<p>The standpipe piezometer is the most basic type of piezometer. It consists of filter tip joined to a riser pipe that extends to the surface. Water flows through the filter tip into the riser pipe. Readings are obtained with a water level indicator. Piezometer tubes should be protected with a cap or lid to prevent material or objects from inadvertently dropping down the tube, which could interfere with water level measurements. Piezometer tubes should be painted and otherwise marked to be highly conspicuous so that they are not damaged by mobile equipment. They cannot be read if the water level is near the ground surface (dry).</p>

<p>Damages from maintenance. Animal / vehicle movement. Weather.</p>	<p>Damage to the standpipe. Blockages in standpipe.</p>	<p>Operators to carry out inspection on the piezometers to find any damage to the piezometers boxes, damage to the ground water monitoring wells, damage to the survey pins and damage to the bollards protecting them. If any abnormalities, concerns or defects have occurred the following should be completed or consulted:</p> <p>(a) to be completed: Identify, record and monitor:</p> <ul style="list-style-type: none"> (i) location and photographs; and (ii) monitor from past inspections, compare and advise if changes have been found. <p>(b) to be consulted: The system engineer / dam engineer:</p> <ul style="list-style-type: none"> (i) investigate the findings to prepare plans and specifications, if necessary, for repairs. <p>(c) to be consulted: The environmental team and operations manager and supervisor.</p>

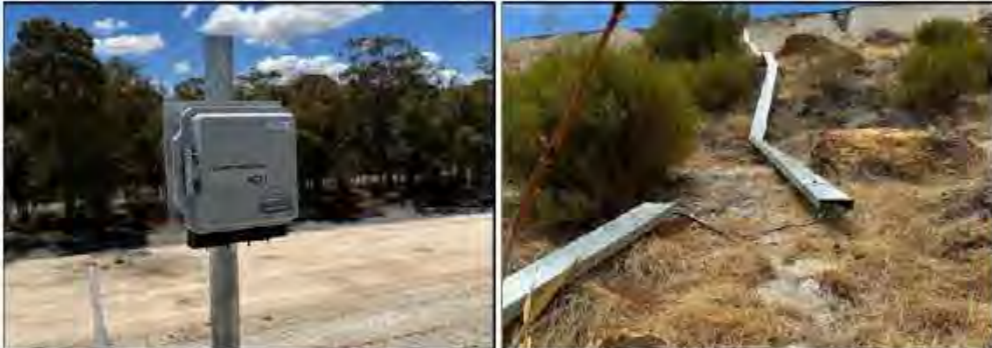
<p>Equipment: Piezometer Vibrating wires</p>	<p>The vibrating wire piezometer is the most commonly deployed type of piezometer. Suitable for most applications, it can be installed in a borehole, embedded in fill, or suspended in a standpipe. Readings are obtained with a portable readout or a data logger.</p> <p>Look for rust, waterproof enclosure failing and damage to the datalogger, stands, wiring and battery failure. All of these disrupt the data from the piezometers which can give us incorrect or no reading.</p>

<p>Damages from maintenance. Animal / vehicle movement. Weather.</p>	<p>Damage to electrical equipment. Damage to dataloggers.</p>	<p>Operators to carry out inspection on the piezometers to find any damage to the piezometers boxes, damage to the ground water monitoring wells, damage to the survey pins and damage to the bollards protecting them. If any abnormalities, concerns or defects have occurred the following should be completed or consulted:</p> <p>(a) to be completed: Identify, record and monitor:</p> <ul style="list-style-type: none"> (i) location and photographs; and (ii) monitor from past inspections, compare and advise if changes have been found. <p>(b) to be consulted: The system engineer / dam engineer:</p> <ul style="list-style-type: none"> (i) investigate the findings to prepare plans and specifications, if necessary, for repairs. <p>(c) to be consulted: The environmental team and operations manager and supervisor.</p>

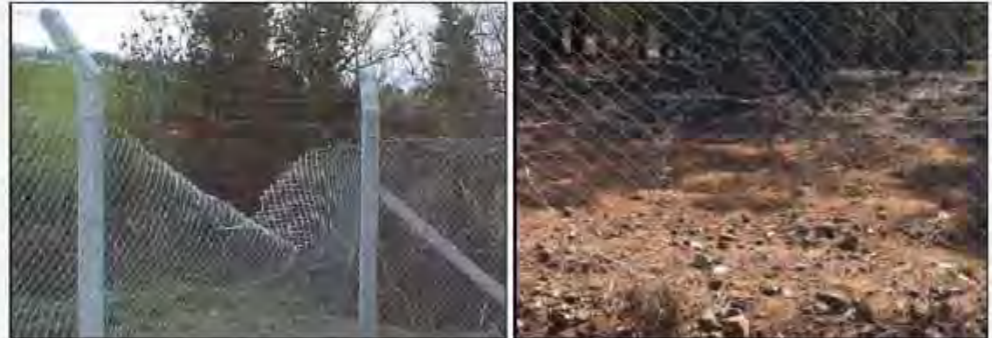
<p>Security and vandalism</p>	<p>Muja's FAD has been identified as a critical infrastructure and needs to be secure. There are concerns for vandalism or security issues which including but not limited to broken fencing, damaged equipment or graffiti.</p>

<p>Unauthorised personnel entering site damaging equipment or vandalism. Authorised personnel damaging equipment or vandalism.</p>	<p>Vandalism. Damaged equipment. Broken fencing.</p>	<p>Security to carry out inspection on the security of the dam to find any damage or vandalism to the dam. If any abnormalities, concerns or defects have occurred the following should be completed or consulted:</p> <p>(a) to be completed: Identify, record and monitor:</p> <ul style="list-style-type: none"> (i) location and photographs; and (ii) monitor from past inspections, compare and advise if changes have been found. <p>to be consulted: Security and operations manager and supervisor.</p>

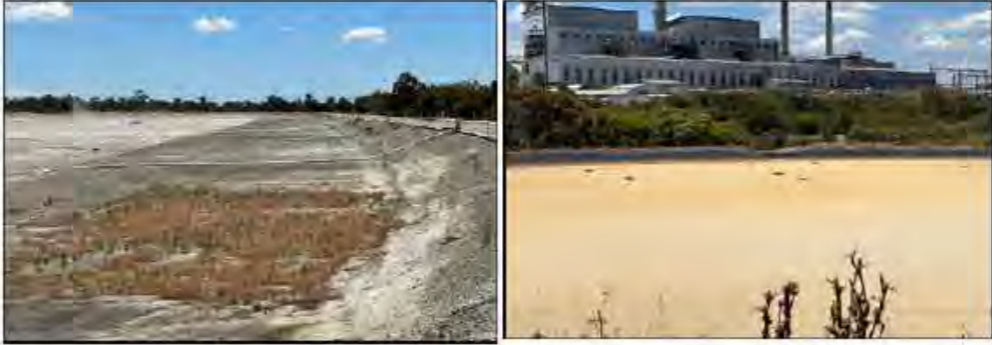
Inspection	Description	Causes	Concerns	Action
<p>Vegetation</p>	<p>Surrounding areas: The area surrounding the FAD is predominantly state forest and the nearest sensitive receptor is identified by DWER to be 2.5km from the power station. Dust around the FAD is managed with the use of water tankers and sprayers and chemical dust control solutions.</p> <p>Bare areas: On an embankment are void of protective cover (e.g. grass, asphalt, riprap etc.). They are more susceptible to erosion which can lead to localized stability problems such as small slides and sloughs.</p> <p>Trees and brush: Should not be permitted on embankment surfaces or in vegetated earth spillways. Extensive root systems can provide seepage paths for water. Trees that blow down or fall over can leave large holes in the embankment surface that will weaken the embankment and can lead to increased erosion, as is the case in the failed earth embankment dam shown here. Brush obscures the surface limiting visual inspection, providing a haven for burrowing animals, and inhibiting the growth of grass vegetation. Tree and brush growth adjacent to concrete walls and structures may eventually cause damage to the concrete and should be removed.</p> <p>Improper vegetation: Vegetation that hides the embankment surface, preventing early detection of cracks and erosion. Any residual roots that are larger than 3 inches in diameter must be removed. All roots should be removed down to a depth of at least 6 inches and replaced with a compacted clay material; then 4 inches of topsoil should be placed on the disturbed areas of the slope. Finally, these areas must be seeded and mulched to establish a proper grass cover.</p>

<p>Hides the detection of cracks and can cause cracks and slumps / slides of the embankment.</p> <p>Embankment vegetation are providing increased seepage paths. Associated root systems develop and penetrate into the dam embankment. When the vegetation dies, the decaying root systems can provide paths for seepage.</p> <p>Provides habitat for rodents and other animals.</p>	<p>Possible slope instability.</p> <p>Seepage.</p>	<p>Operators to carry out inspection on the vegetation on or around the dam to find any vegetation (flora, fauna and heritage) changes. If any abnormalities, concerns or defects have occurred the following should be completed or consulted:</p> <p>(a) to be completed: Identify, record and monitor:</p> <ul style="list-style-type: none"> (i) location, photographs and sketches; and (ii) monitor from past inspections, compare and advise if changes have been found. <p>(b) to be consulted: The system engineer / dam engineer:</p> <ul style="list-style-type: none"> (i) investigate the findings to prepare plans and specifications, if necessary, for repairs. <p>(c) to be consulted: The environmental team and operations manager and supervisor.</p>
