Title: MUJA TAILINGS STORAGE FACILITY DAMS MANAGEMENT PLAN

Document Number: MUJ-PLN-ENV-0001 Revision: 0 Date: 19/07/2024

MANAGEMENT PLAN
MUJA TAILINGS STORAGE FACILITY DAMS MANAGEMENT PLAN

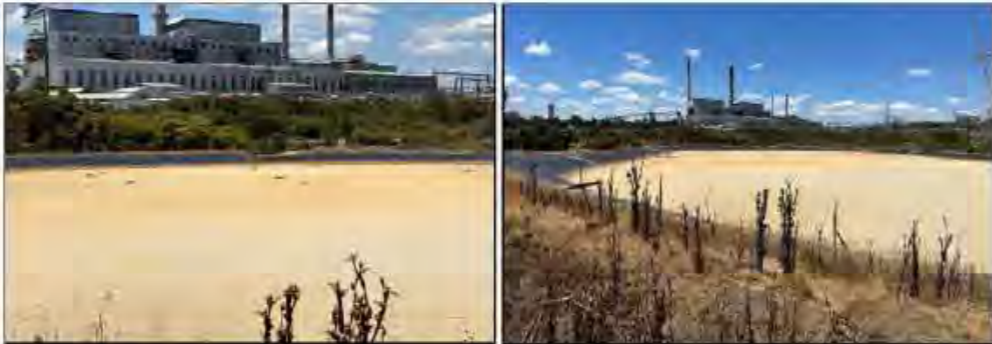
<p>Supernatant dam HDPE liner</p>	<p>The supernatant dam is double lined with HDPE liner, this liner is used because it is stiffer and this makes it better at resisting tears and punctures.</p> <p>Even though HDPE liners are more versatile they still require ongoing inspections to ensure there is no natural or unnatural wear and tear which may include rips, holes, vegetation and deterioration.</p>

<p>Natural wear and tear.</p> <p>Weather.</p> <p>Animal / vegetation.</p> <p>Maintenance.</p>	<p>Seepage.</p>	<p>Operators to carry out inspection on the Supernatant dam to find any HDPE liner defects. If any abnormalities, concerns or defects have occurred the following should be completed or consulted:</p> <p>(a) to be completed: Identify, record and monitor:</p> <ul style="list-style-type: none"> (i) location and photographs; and (ii) monitor from past inspections, compare and advise if changes have been found. <p>(b) to be consulted: The system engineer / dam engineer:</p> <ul style="list-style-type: none"> (i) investigate the HDPE liner to prepare plans and specifications, if necessary, for repairs. <p>(c) to be consulted: The environmental team and operations manager and supervisor.</p>

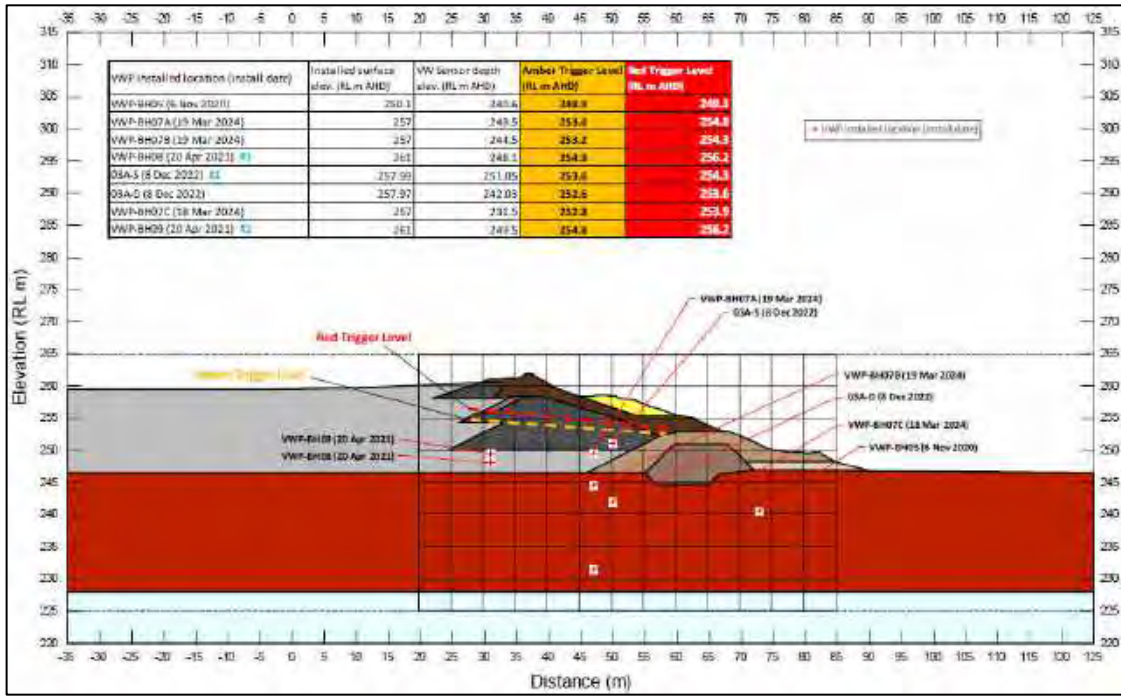
Figure 31: As-built FAD Cell 1 south-east wall embankment cross-section A - VWP trigger level profile

The trigger parameter and appropriate responses are summarised in **Table 21**. The alert levels should be used with great care and should always be supported by visual inspection of the FAD. Piezometers can get blocked or damaged and provide a false sense of security. These alert levels should be updated after each embankment raise or piezometer raise, after any remedial works of when there are any significant changes in the FAD operation.

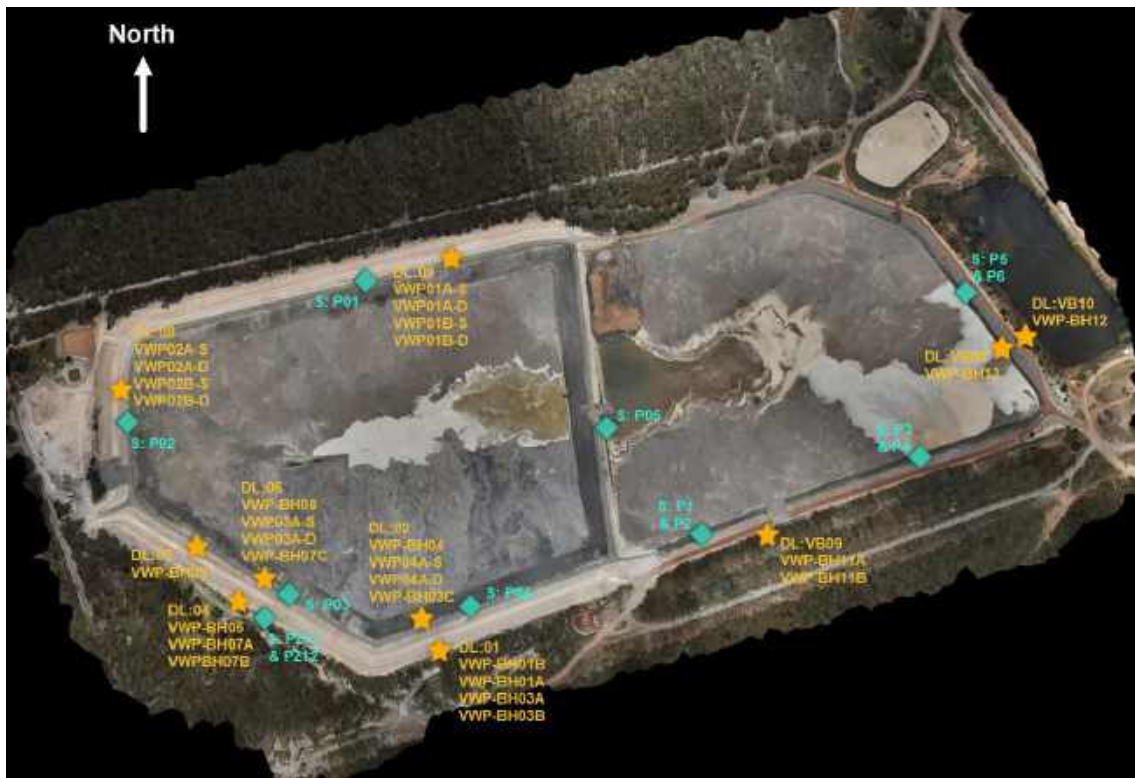
Figure 34: FAD vibrating wire and manual dipping piezometers cells 1 and 2

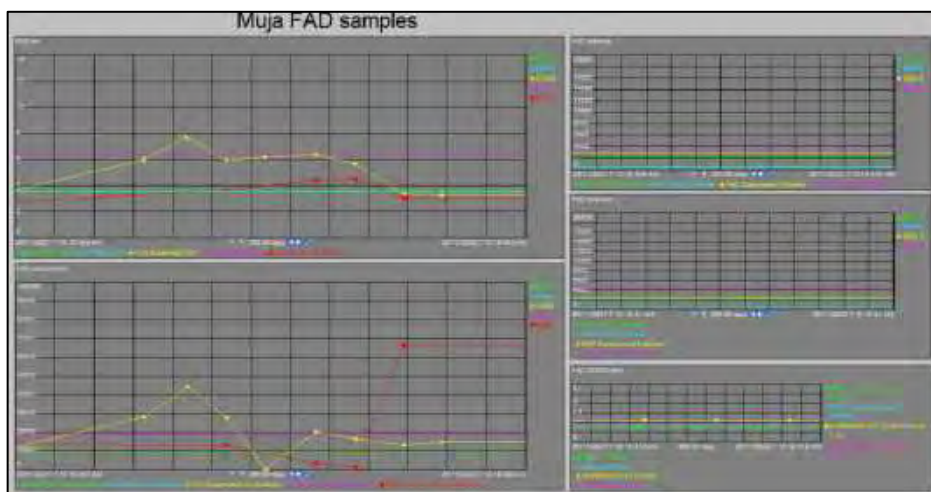
Figure 35: Starlins report screen

To comply with the environmental licence DER2014/002698-1 (DM ID: [25007266](#)) condition 3.1.1, refer to **section 1.3**. The chemists complete a monthly sample review from the groundwater monitoring boreholes for the Supernatant dam with all reports / data saved in the Pi Procebook / Pi Vision. Numeric data can be pulled from Starlims which is a laboratory information management system on request.

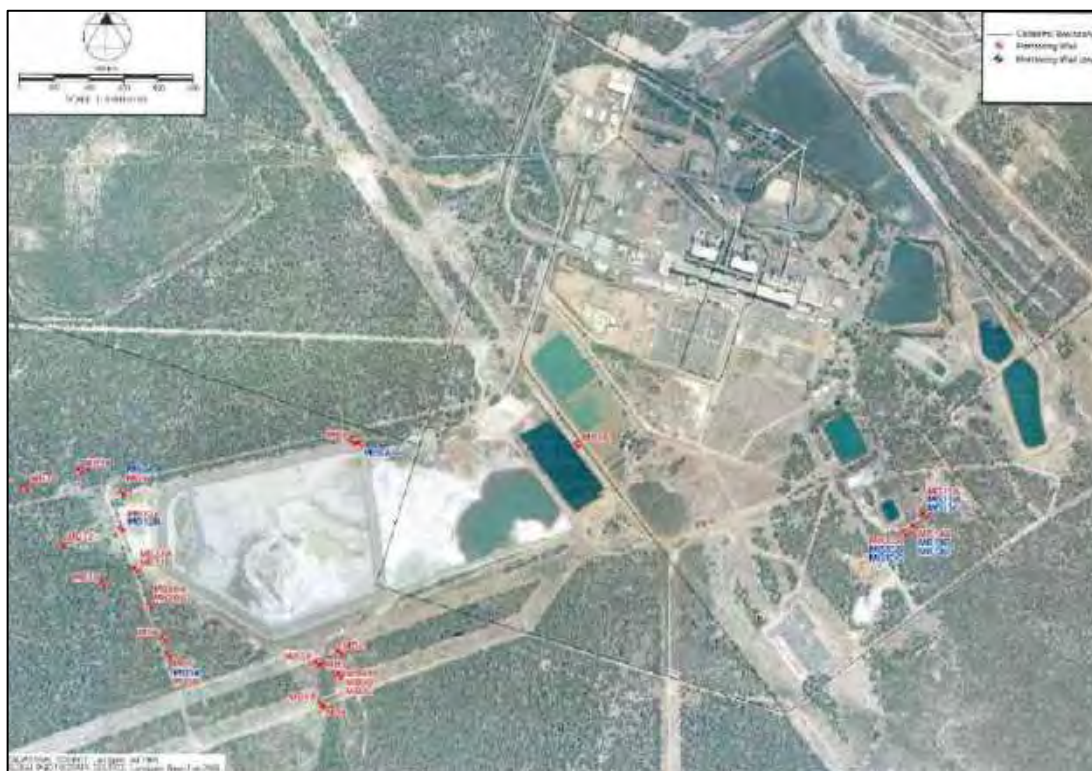
Figure 36: Location of groundwater monitoring boreholes for the FAD

A total of 24 groundwater monitoring bores have been installed around the FAD as shown in **Figure 36**. The groundwater monitoring requirements as per DWER licence L4706/1972/17 are summarised in **Table 24**.

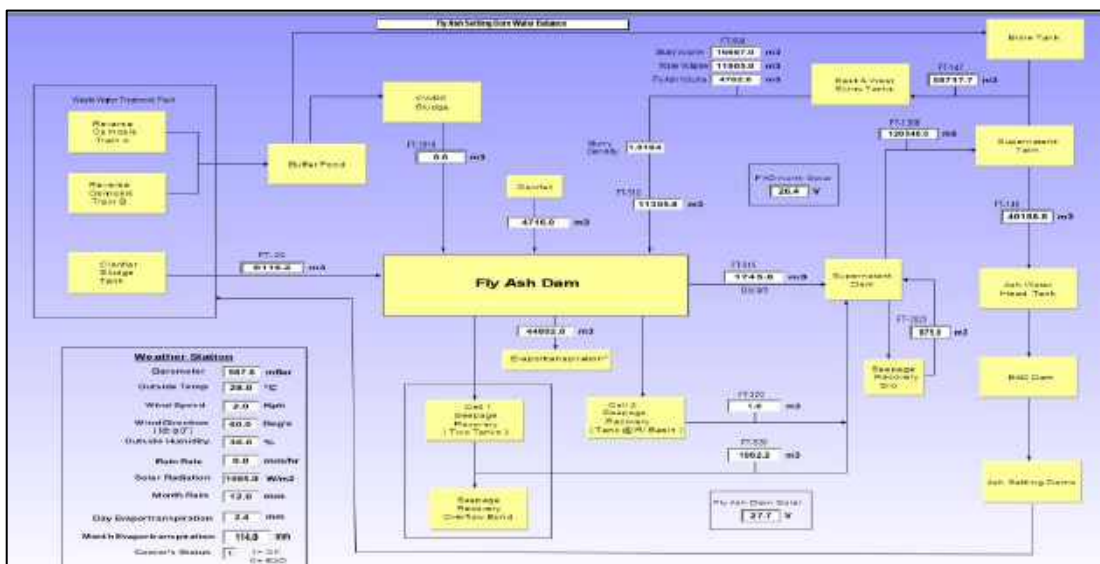
Figure 37: Main water balance page

The T3000 shows real time data, this data is shown on the T3000 water balance pages which shows the following criteria:

- (a) rain fall;
- (b) evaporation;
- (c) decant water recovery volumes;
- (d) cell 2 seepage recovery;
- (e) cell 1 seepage recovery;
- (f) water treatment sludges – lime;
- (g) water treatment sludges - CWRP ferric; and
- (h) fly ash.
