Amendment Report

Application for Licence Amendment

Licence Number	L8422/2010/2					
Licence Holder	Edna May Operations Pty Ltd					
ACN	136 365 001					
File Number	DER2017/000298-1					
Premises	Edna May Gold Project					
	Warrachuppin Road					
	WESTONIA WA 6423					
	Legal description					
	M77/88, M77/110, M77/124, G77/122 and L77/18					
Date of Report	3 November 2021					
Decision	Amendment Granted

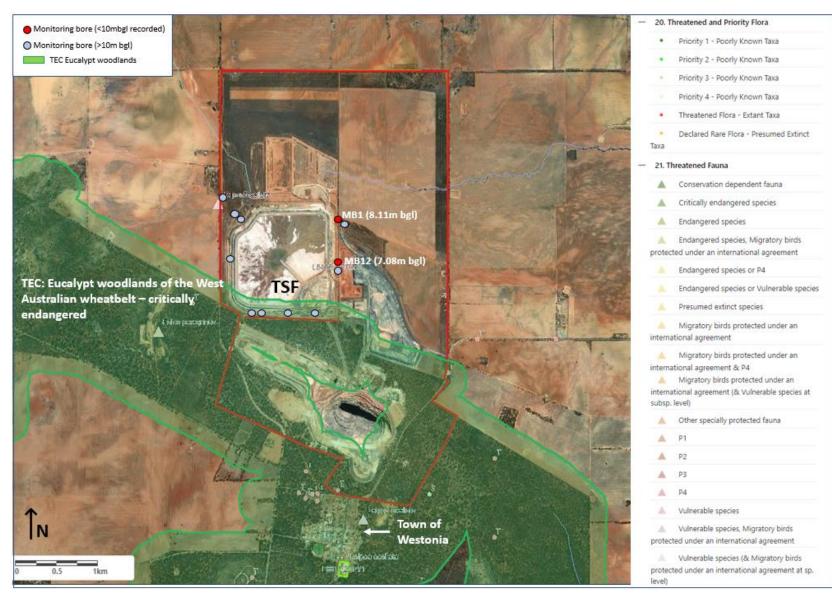
Figure 1: Distance to sensitive receptors (prepared by DWER Environmental Officer)

Human receptors	Distance from prescribed activity				
Town of Westonia	Directly abuts the southern prescribed premises

boundary (Figure 1) 2km south of the TSF
Residential Premises	2km south of the TSF 100m south of the premises boundary
Environmental receptors	Distance from prescribed activity
Groundwater	25 – 30m bgl (Ramelius 2021) Annual environmental report 2020 indicates groundwater mounding in bores MB01 (8.11m bgl) and MB12 (7.08mbgl) (Figure 1) Saline: TDS 14,600mg/L to 27,000mg/L
Threatened Ecological Communities (TEC) Eucalypt woodlands of the Western Australian Wheatbelt (Priority 3 – critically endangered)	Immediately south of TSF (Figure 1)
Threatened and priority flora (not specified)	Closest listed as 450m south east of the TSF
Threatened and priority fauna (malleefowl)	Siting 25m from prescribed premises boundary at closest point
Minor seasonal creekline	Within prescribed premises boundary (400m north- east of TSF)

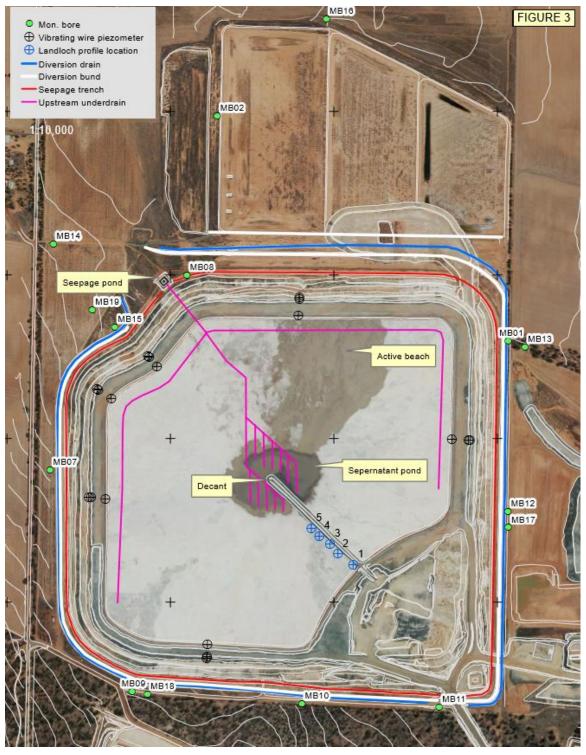
Figure 2 IWL/TSF drainage system and monitoring bores

Eighteen vibrating wire piezoemeters were installed at six locations in the IWL/TSF embankment (Figure 2) and have been reported by Rockwater (2018) as recording very low or negative pore pressures, indicating dry embankments.

- An underdrainage system beneath the centre of the IWL/TSF and around the upstream toe of the IWL embankment;
- A cut-off trench underneath the upstream toe of the main embankment to restrict horizontal seepage; and
- A 2m deep seepage interception trench located between the IWL/TSF embankment and the surface water diversion bund (Figure 2).

Monitoring of ambient groundwater quality is currently required as part of condition 22 (Table 7). This includes 11 monitoring bores (Figure 2) surrounding the TSF. A standing water level limit of 3m bgl and a WADCN limit of <0.5mg/L are currently on the licence. Standing water levels are measured monthly and groundwater quality quarterly.

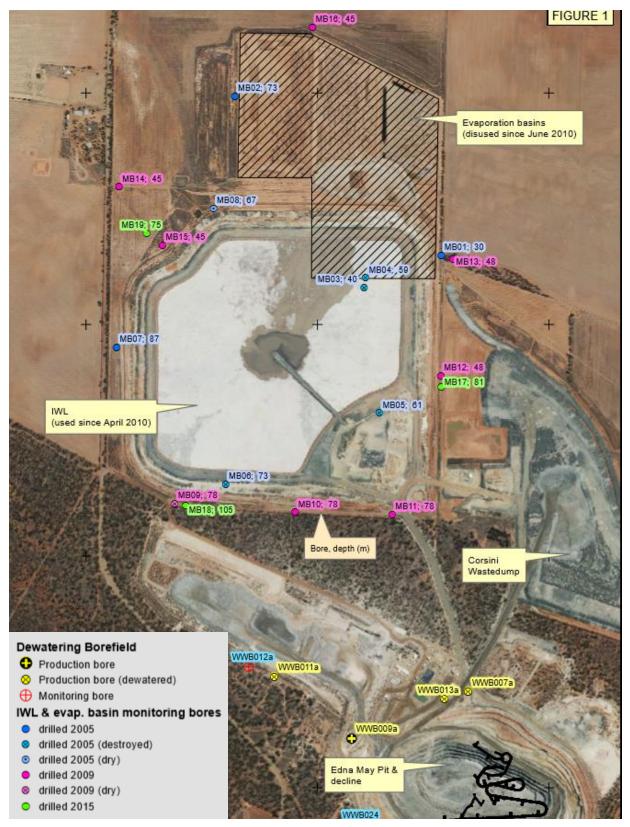
Figure 3 IWL/TSF monitoring bores (additional detail)

Rockwater (2018) suggests that it's unlikely water levels around the IWL/TSF would rise enough for contamination to be brought to the near surface due to the large cone of depression (see MB18 – Figure 3) produced by dewatering of Edna May pit. However, groundwater monitoring bore MB12, along the eastern IWL/TSF margin, returned a standing water level 6.38m bgl in April 2017 and 7.08m bgl in 2020 (originally 40.03m bgl in 2009). Standing water levels in MB13 and MB17 have risen by 2.17 and 1.12m bgl (2020) since their original installation. Water levels in all other monitoring bores have dropped.

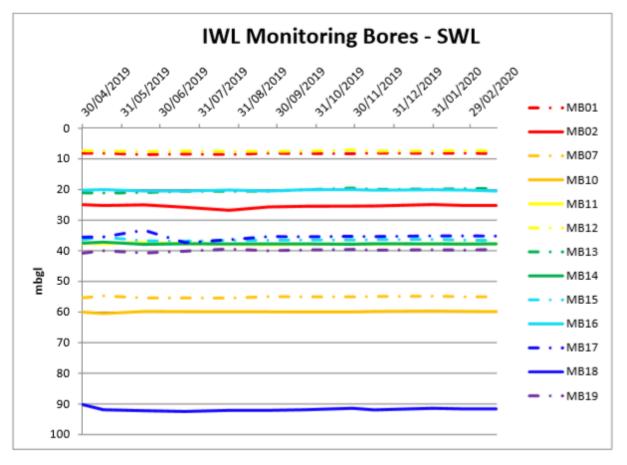
Figure 4 IWL/TSF Groundwater levels 2019 - 2020

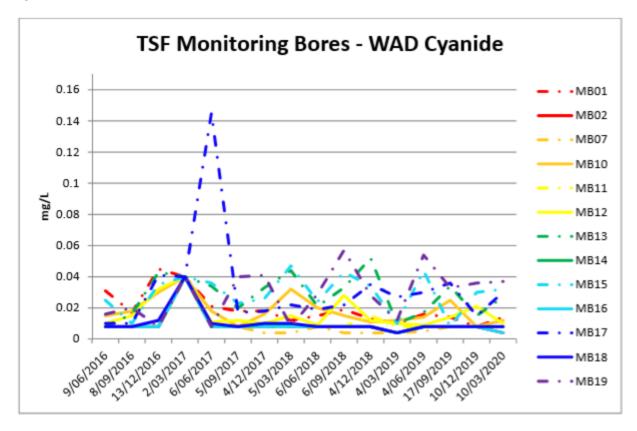
Figure 5 IWL/TSF groundwater quality – weak acid dissociable cyanide 2016 - 2020
