Application for Licence Amendment

Licence Number	L5107/1988/13
Licence Holder	Northern Star (HBJ) Pty Ltd
ACN	30 127 026 519
File Number	DER2015/002027-6
Premises	South Kalgoorlie Operations – Jubilee Gold Mine Legal description – Lot 15 on Plan 58833, Lot 50 on Plan 226299 and Lot 51 on Plan 226303, Feysville, Lot 103 on Plan 40395 Lot 105 on Plan 40396, Karamindie, and mining tenements M26/118, M26/143, M26/204 and M15/456
Date of Report	28 November 2022
Decision	Revised licence granted

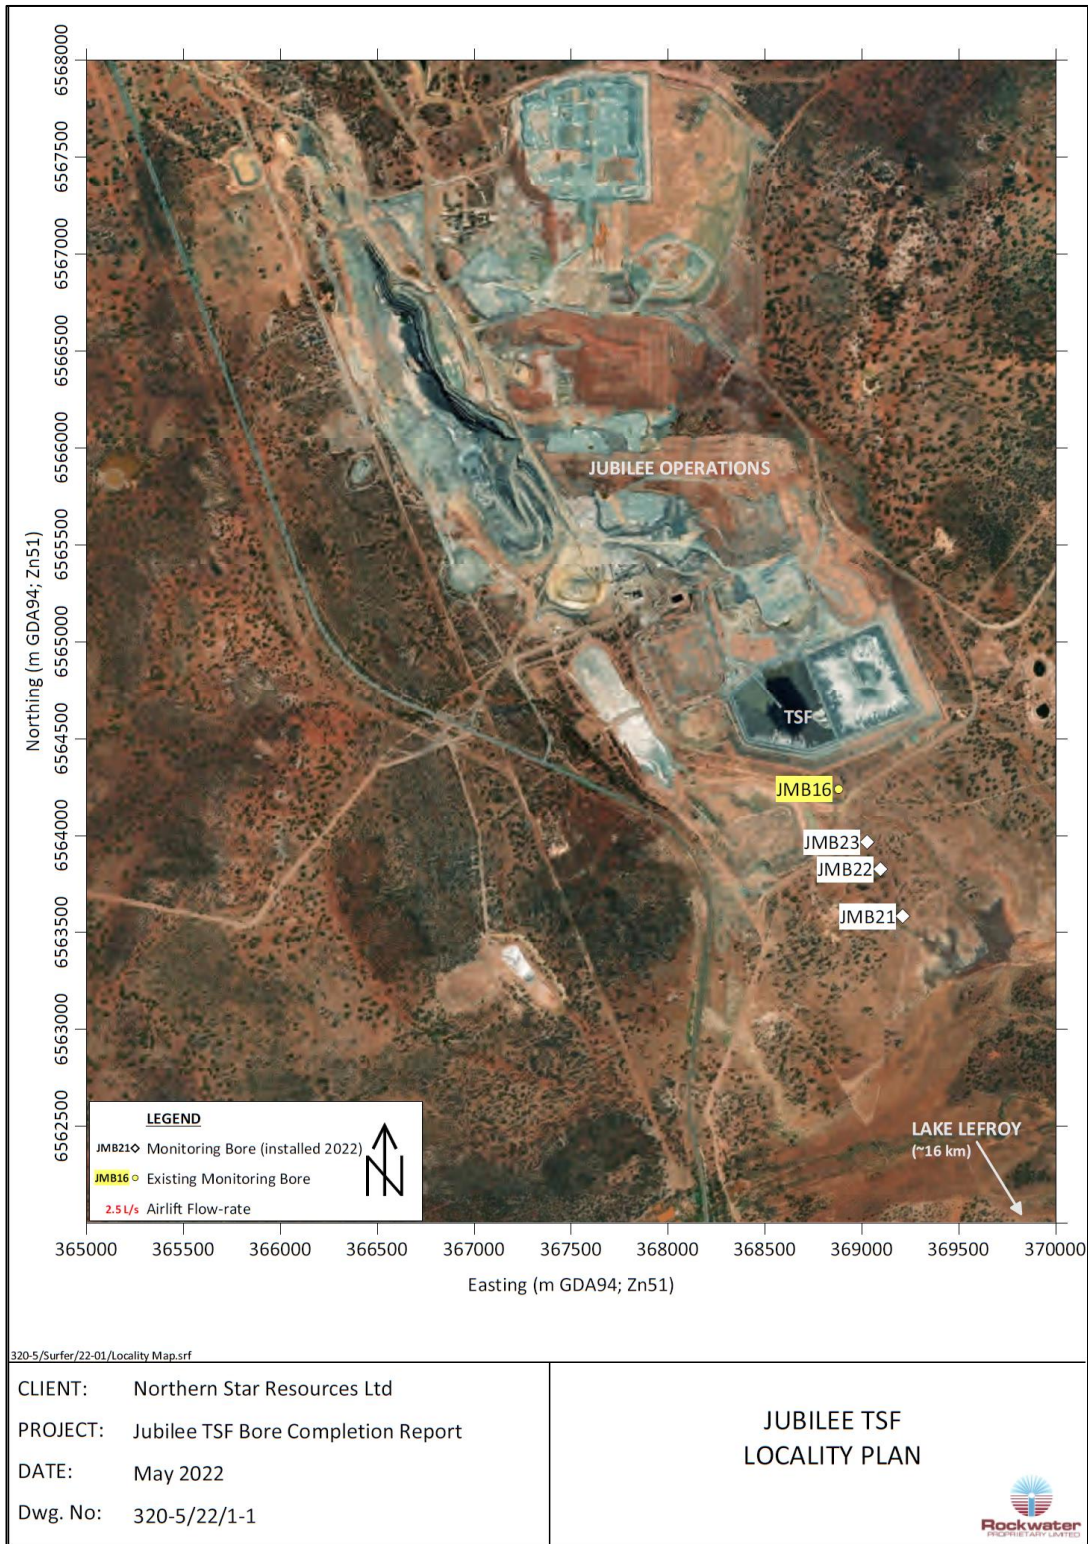
The tailings monitoring bores were drilled up to 60 m depth and intercepted water between 11 and 24 m depth. Drilling at each of the monitoring bore locations intersected fresh ultramafic bedrock overlain by highly weathered regolith. Fresh bedrock was intersected between 18 and 20 m depth in each of the bores, with JMB21 and JMB23 showing significant broken ground. Monitoring bore JMB22 showed some minor broken ground, which did not yield significant volumes of water; generally, less than 0.5 L/s. The location of the three additional monitoring

Figure 3: Jubilee TSF monitoring bore location

bores (JMB21 – JMB23) are shown in Figure 3.

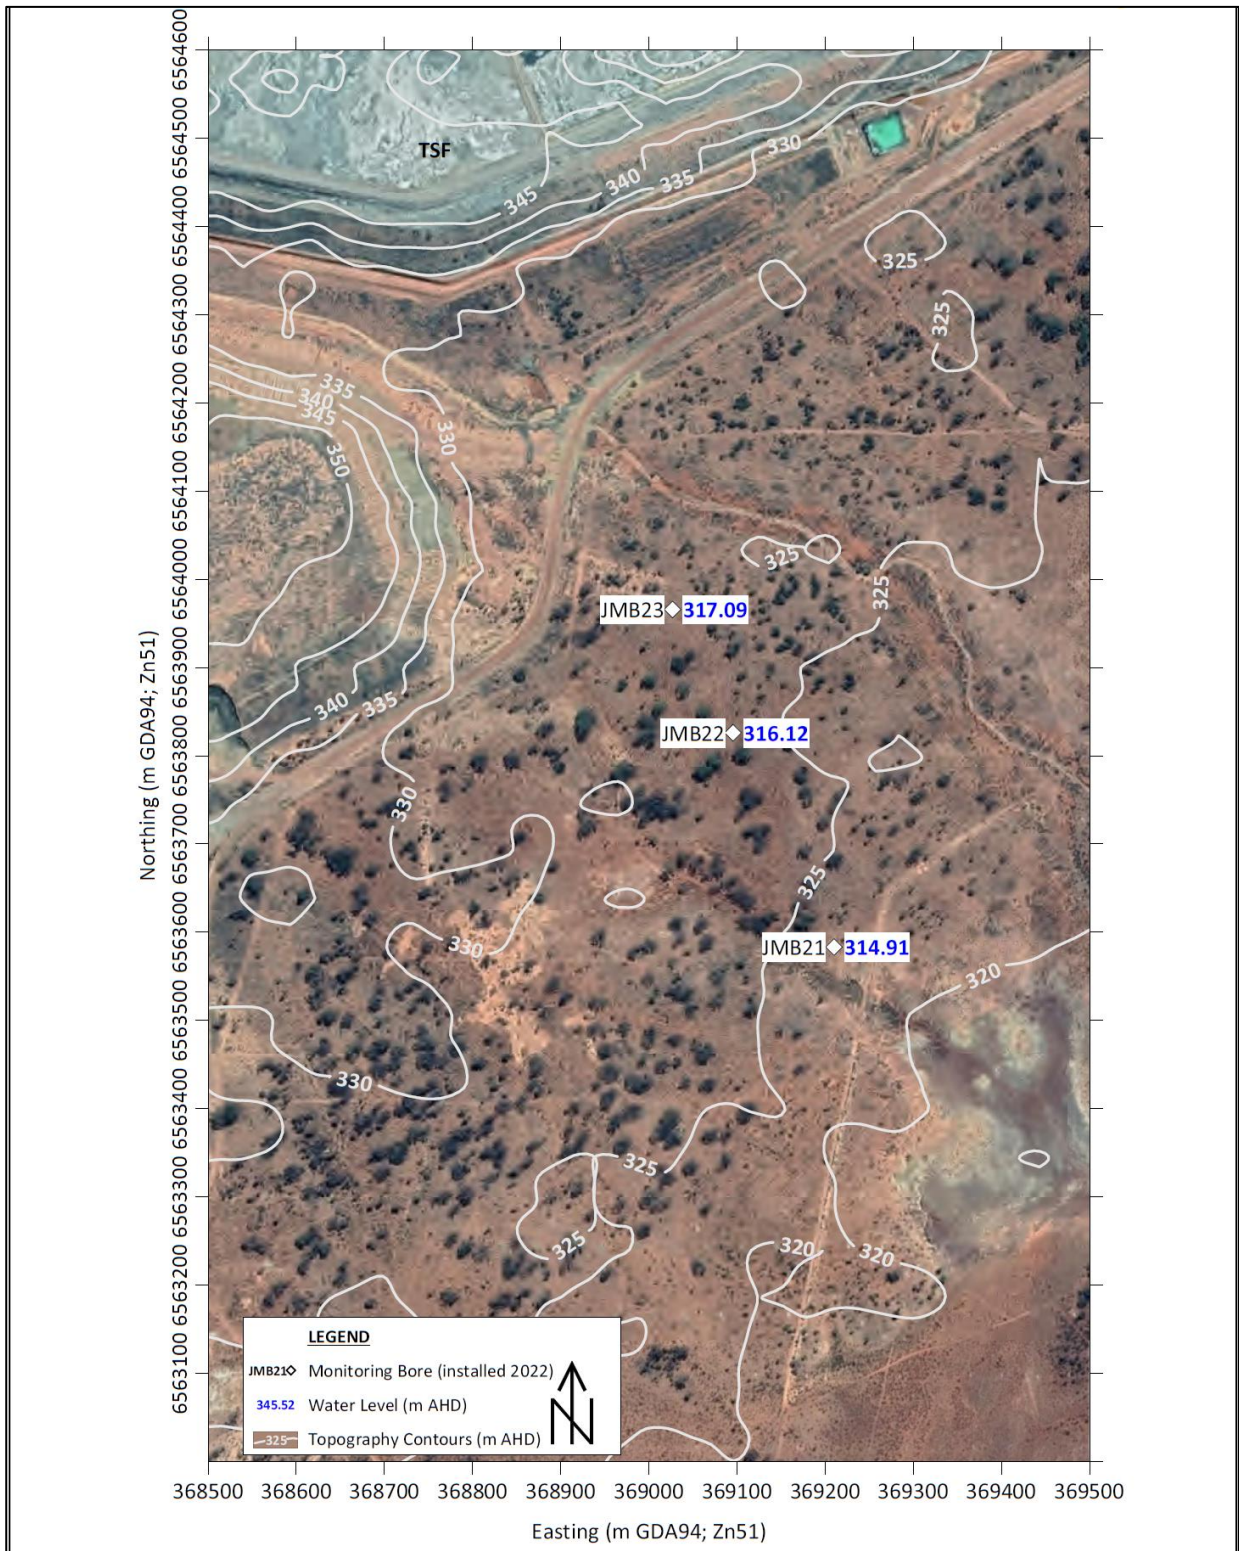
Groundwater levels in the three monitoring bores are presented in Figure 4. Ground water levels are highest in the north-west, JMB23, closer to the TSF (317.09 m AHD). The monitoring bore, JMB21, is 2 m lower than JMB23, which is typical of surficial aquifer regional flow in the area towards Lake Lefroy, located 16 km south/south-east of Jubilee and could indicate seepage from the TSF.

Figure 4: Jubilee TSF3 monitoring bore location and water level (m AHD)
