## Application for Licence Amendment

### Part V Division 3 of the *Environmental Protection Act 1986*

<b>Licence Number</b>	L5206/1987/10
<b>Applicant</b>	Wiluna Operations Pty Ltd
<b>ACN</b>	166 954 525
<b>File number</b>	2012/006906-1
<b>Premises</b>	Wiluna Mine Site WILUNA WA 6646 Mining tenements: M53/30, M53/32, M53/468, L53/62, L53/20, M53/64, G53/18 and G53/19 and part tenements M53/40, M53/44, M53/50, M53/26, M53/6, M53/95, M53/96, M53/200, M53/69, M53/24 L53/50 and L53/77 As defined by the coordinates in Schedule 4 of the licence.
<b>Date of report</b>	13 March 2025
<b>Decision</b>	Revised licence granted

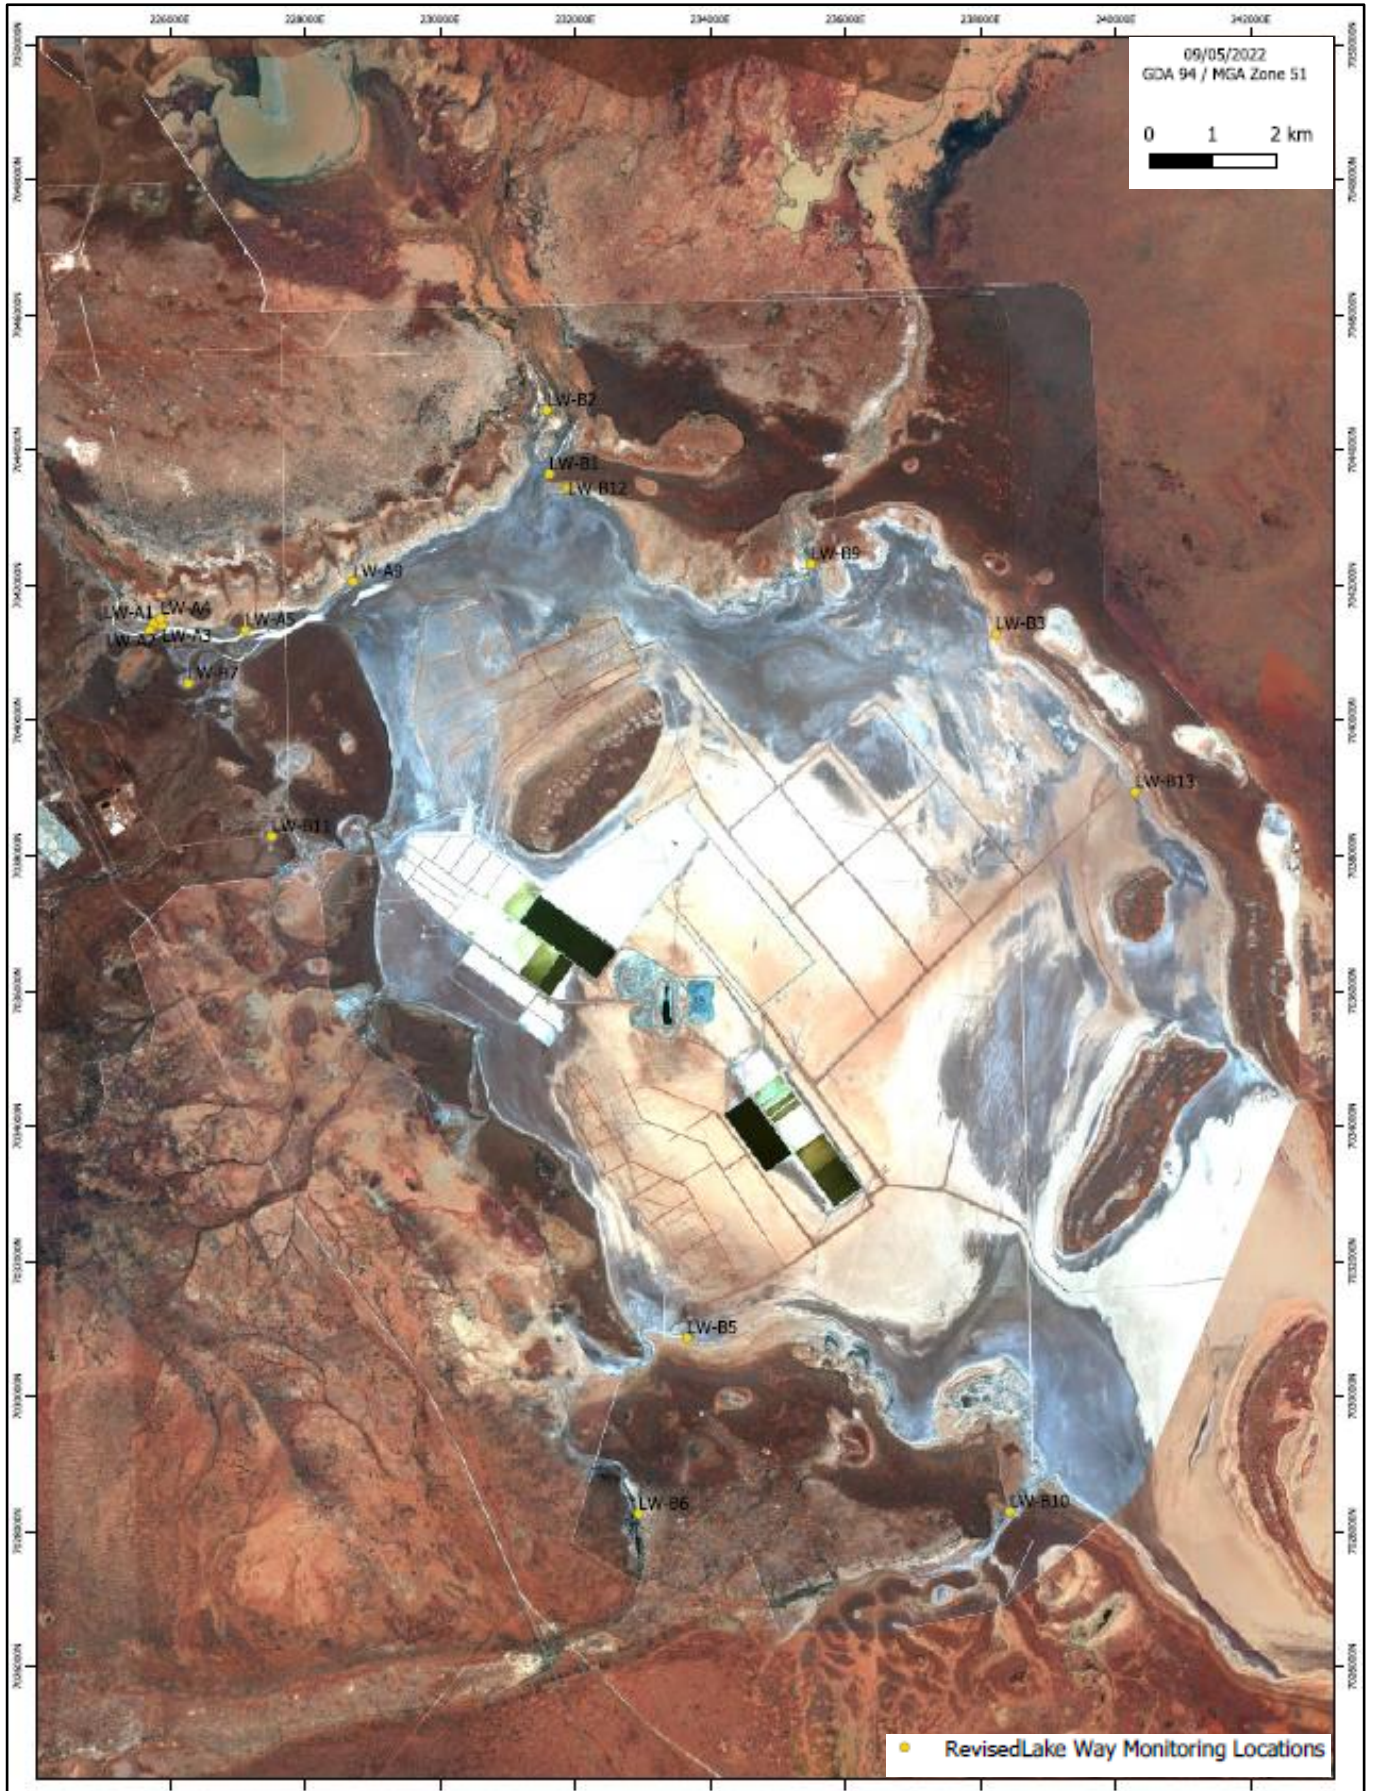
Figure 6. Lake Way proposed monitoring locations

Ambient environmental quality monitoring under the existing licence is undertaken for surface water and sediments at 21 monitoring sites to the north, west and east sides of Lake Way. In 2021, the licence holder contacted the department stating that several monitoring locations surrounding Lake Way were no longer accessible due to a request from the Traditional Owners to protect the cultural values of this registered aboriginal cultural heritage place (section 2.2.22.2.2). The department advised that an amendment of the licence should be sought to avoid non-compliance with the conditions of the licence. The licence holder now seeks to address this issue and proposed a reduction of the licensed monitoring locations from 21 to 16, as shown in Table 1. The proposal includes the removal of five and the addition of one monitoring locations. The locations of the proposed monitoring locations (impact and background) is shown in Figure 6. A figure outlining the areas that cannot be accessed due to cultural sensitivities was requested during the course of the assessment. However, the licence holder states that clear boundaries between accessible and non-accessible areas could not be obtained from the Traditional Owners.

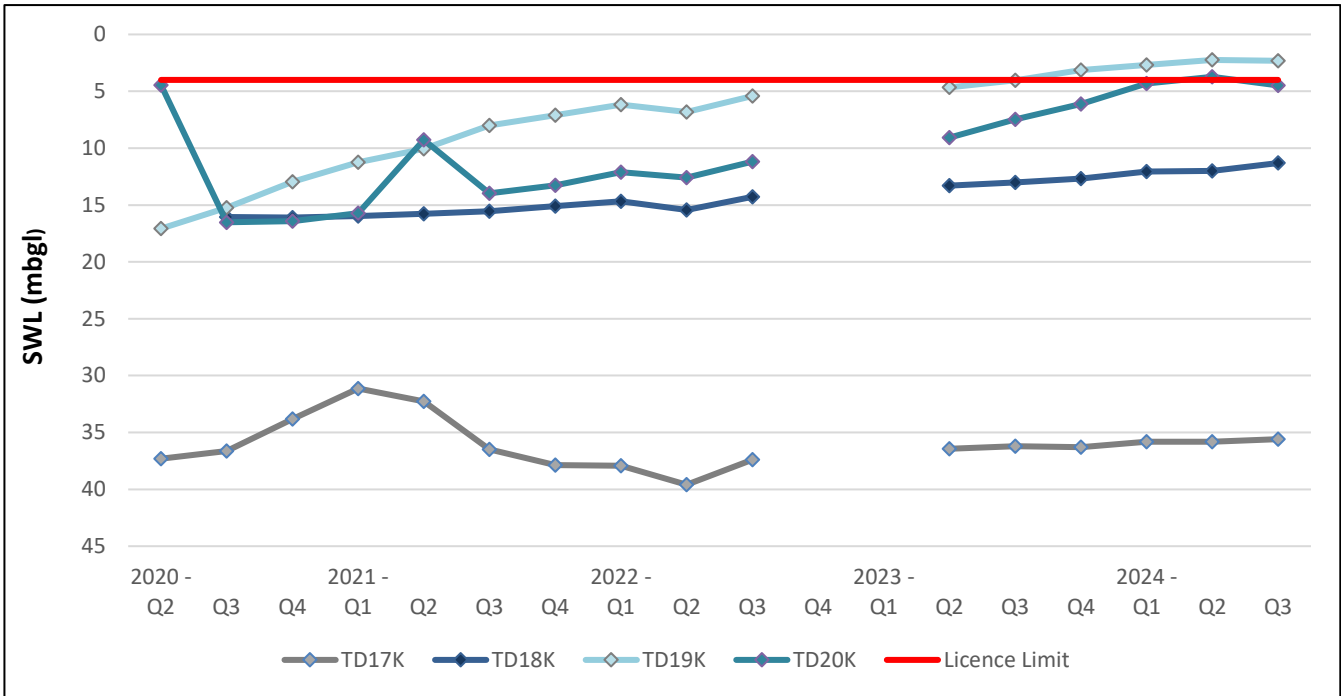
Figure 7. Standing water levels monitoring data between 2020 and 2024

Standing water levels from quarter two of 2020 to quarter three of 2024 are shown on Figure 7. Groundwater monitoring bores TD19K and TD20K located to the south of the TSF show clear upward trend. Groundwater levels at monitoring bores TD19K breached the 4 mbgl in quarter three of 2023 and the first three quarters of 2024. Monitoring bore TD20K groundwater levels on the other hand were breached the 4 mbgl limit in quarter two of 2024. While a slight upward trend could also be observed at monitoring bore TD18K, located north-east of the premises, though water levels remained relatively deep. This suggests that groundwater mounding is prevalent to the south-east of the facility.
