Application for Licence Amendment

Licence Number	L5529/1988/12
Licence Holder	Mt Magnet Gold Pty Ltd
ACN	008 669 556
File Number	DER2016/001228-1
Premises	Mt Magnet Gold MOUNT MAGNET WA 6623 M58/30, M58/121, M58/136, M58/172, M58/181, M58/185, M58/187, M58/191, M58/193, M58/202, M58/205 and M58/234
Date of Report	22 December 2021
Decision	Revised licence granted

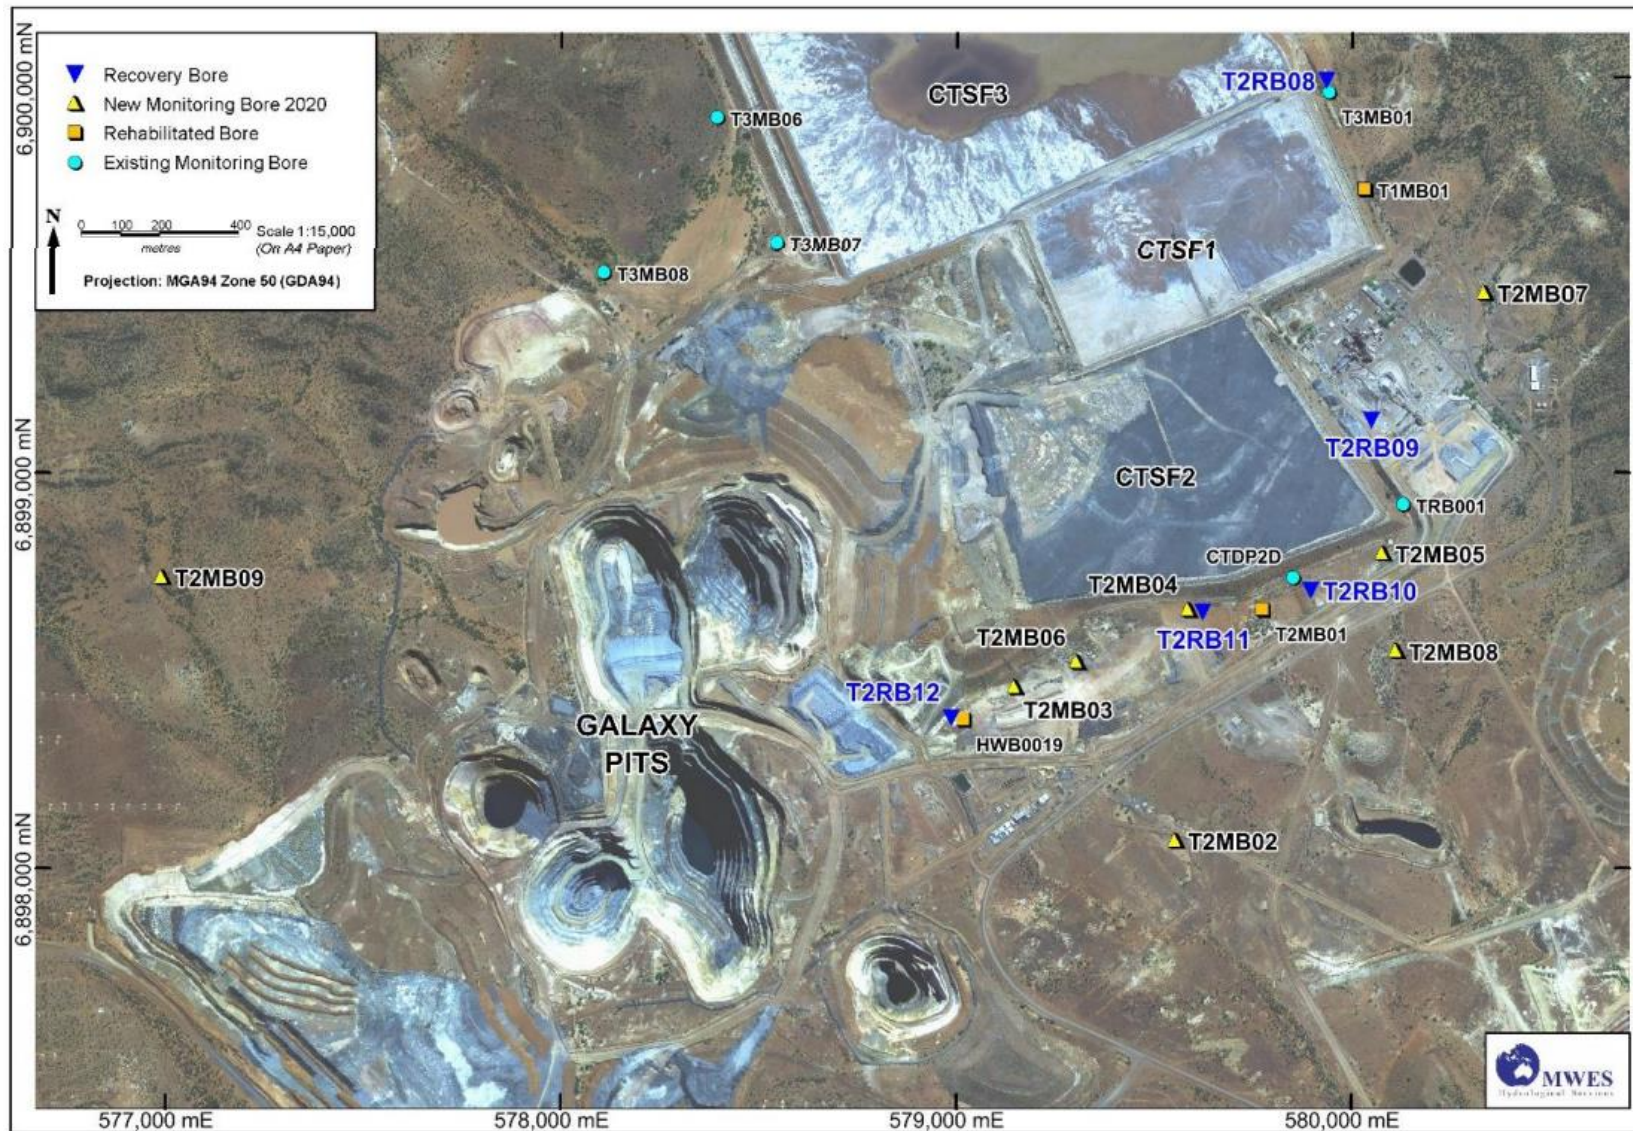
Figure 1 Groundwater monitoring bores and seepage recovery bores proposed for addition to licence

- Installed eight groundwater monitoring bores, T2MB02 – TDMB09 in August 2020 (MWES, 2020), including a bore on the western side of the galaxy pits (Figure 1);
- Conducted monthly groundwater monitoring from September 2020 to November 2021 of the newly installed monitoring bore network. Results were submitted and compared to drinking water guidelines (MWES, 2021; see section 3.3.2 for a discussion of results);
- Installed five seepage recovery bores T2RB08 – T2RB12 in July 2021 (Figure 1) and attempted seepage recovery over a 90 day period (MWES, 2021; see section 3.3.2 for a discussion of seepage recovery).

Principal Hydrogeologist suggested the contaminant/seepage plume may be moving at the base of the regolith, along the surface of fresh bedrock. Seven monitoring bores, T2MB02 – T2MB08, were drilled along seepage paths assumed from an electromagnetic (EM) survey (Figure 4). T2MB09 was installed on the western side of the Galaxy pits, to monitor for potential impacts to the nearby PDSWA (Figure 1).

Mt Magnet conducted monthly monitoring of eight newly installed groundwater monitoring wells (Figure 1) from August 2020 to November 2021. All results for T2MB09 (closest to the PDSWA) were compared with 2021 Australian Drinking Water Guidelines (ADWG) and were within acceptable criteria except for iron, manganese and total dissolved solids which exceeded the aesthetic limit but were within the health limit (see Appendix 1).

The second closest well to the PDSWA from the tailings storage facility is T2MB03 (on the eastern side of the galaxy pits, see Figure 1). It is noted that T2MB03 is within close proximity of CTSF2, only being 200m south-west of CTSF2 and screened across the weathered regolith/fresh rock interface. Results exceeded the ADWG 2021 health guidelines for total cyanide, boron, chromium VI, nitrate and selenium. Results exceeded the aesthetic limit for total dissolved solids, iron and manganese. A summary of exceedances for T2MB03, compared to seepage, are presented in Table 6 below.

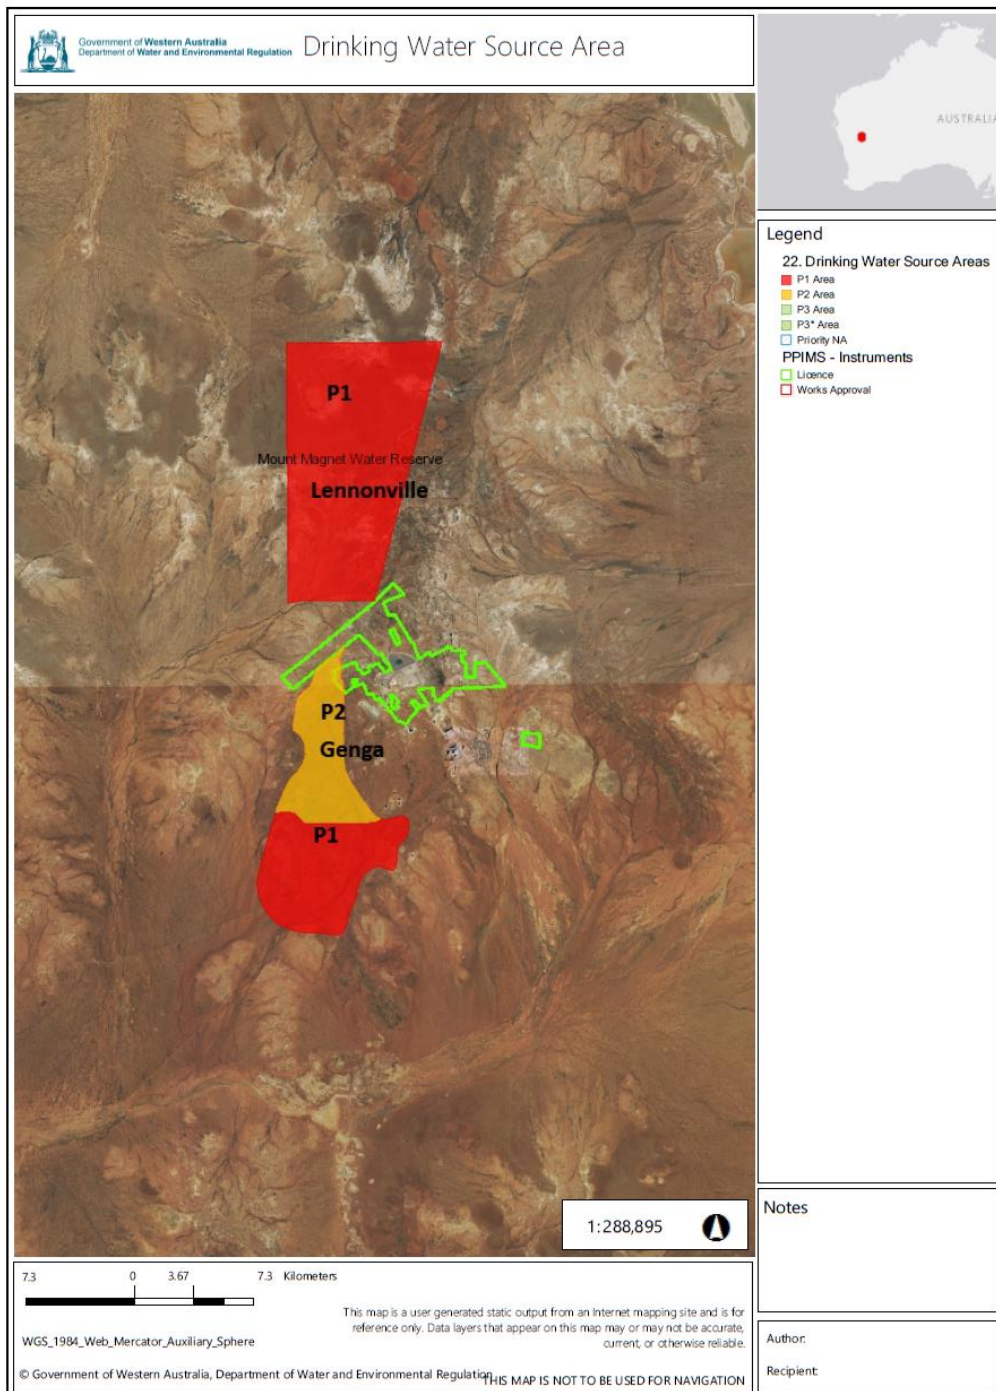
Figure 2: Distance to sensitive receptors

The Mount Magnet Water Reserve is a PDWSA, proclaimed under the Country Areas Water Supply Act 1947 (*CAWS Act*) and consists of the Genga and Lennonville water reserves. The premises partially lies within the Genga water reserve to the west, and borders on the Lennonville water reserve on the northern boundary (Figure 2)

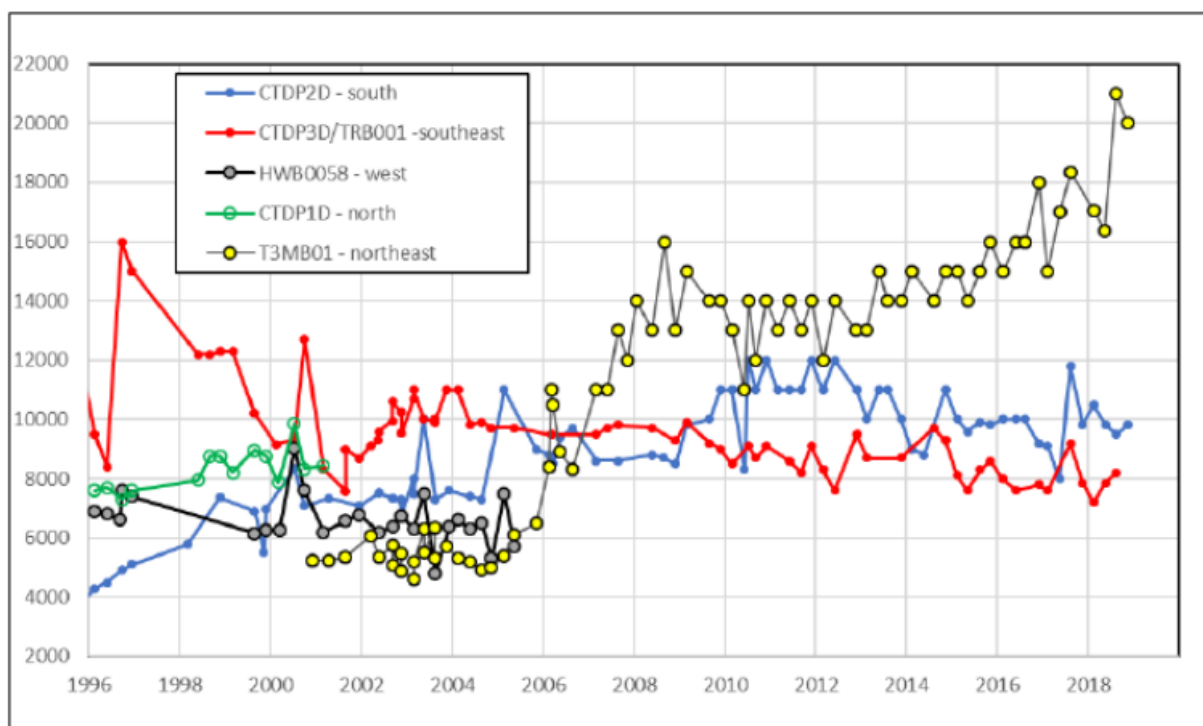
Figure 3 Salinity (mg/L) recorded as TDS in selected monitoring bores

No tailings have been deposited into CTSF1 and CTSF2 since 2000 and 2001, respectively¹. Previous operations of CTSF1 and CTSF2 have resulted in high rates of seepage. Baseline water levels prior to development were recorded between 34 and 62 metres below ground level. The water level below CTSF1 and CTSF2 rose to the natural surface within 12 months of commencing operations (MWES, 2019). Historical data indicated multiple bores were detecting seepage from CTSF1 and CTSF2 during operations. CTDP1D, CTDP2D and HCB058 showed increased salinity and detectable cyanide, directly linked to tailings seepage impacts. Salinity levels of selected monitoring bores recorded are shown in Figure 3. For context, the local baseline groundwater salinity is approximately 4000 mg/L TDS.

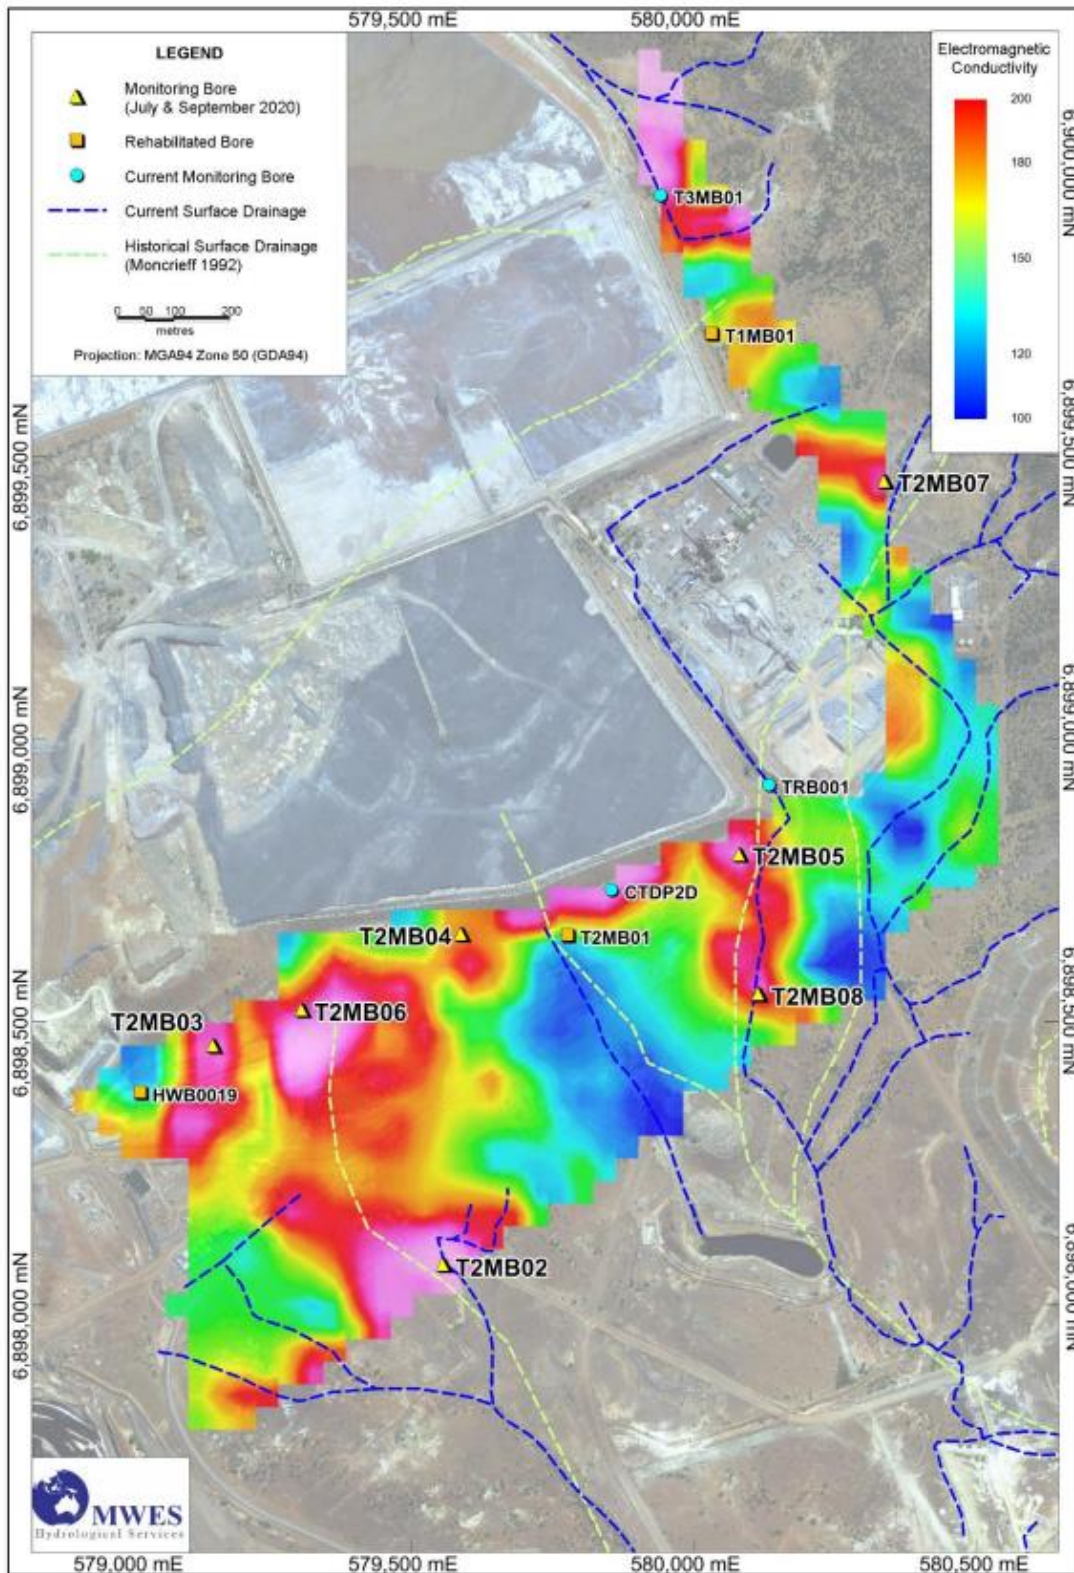
Figure 4 Well locations in relation to electromagnetic survey
