Application for Licence Amendment

Licence Number	L8008/2004/3
Licence Holder	FQM Australia Nickel Pty Ltd
ACN	135 761 465
File Number	DWERVT16538
Premises	Ravensthorpe Nickel Operations RAVENSTHORPE WA 6346 Legal description – Mining tenements L74/54, M74/108, M74/114, M74/115, M74/116, M74/123, M74/142, M74/144, M74/145, M74/167, M74/168, M74/173, M74/174, M74/175 and G74/08 as depicted by the premises maps attached to the revised licence
Date of Report	7 May 2025
Decision	Revised licence granted

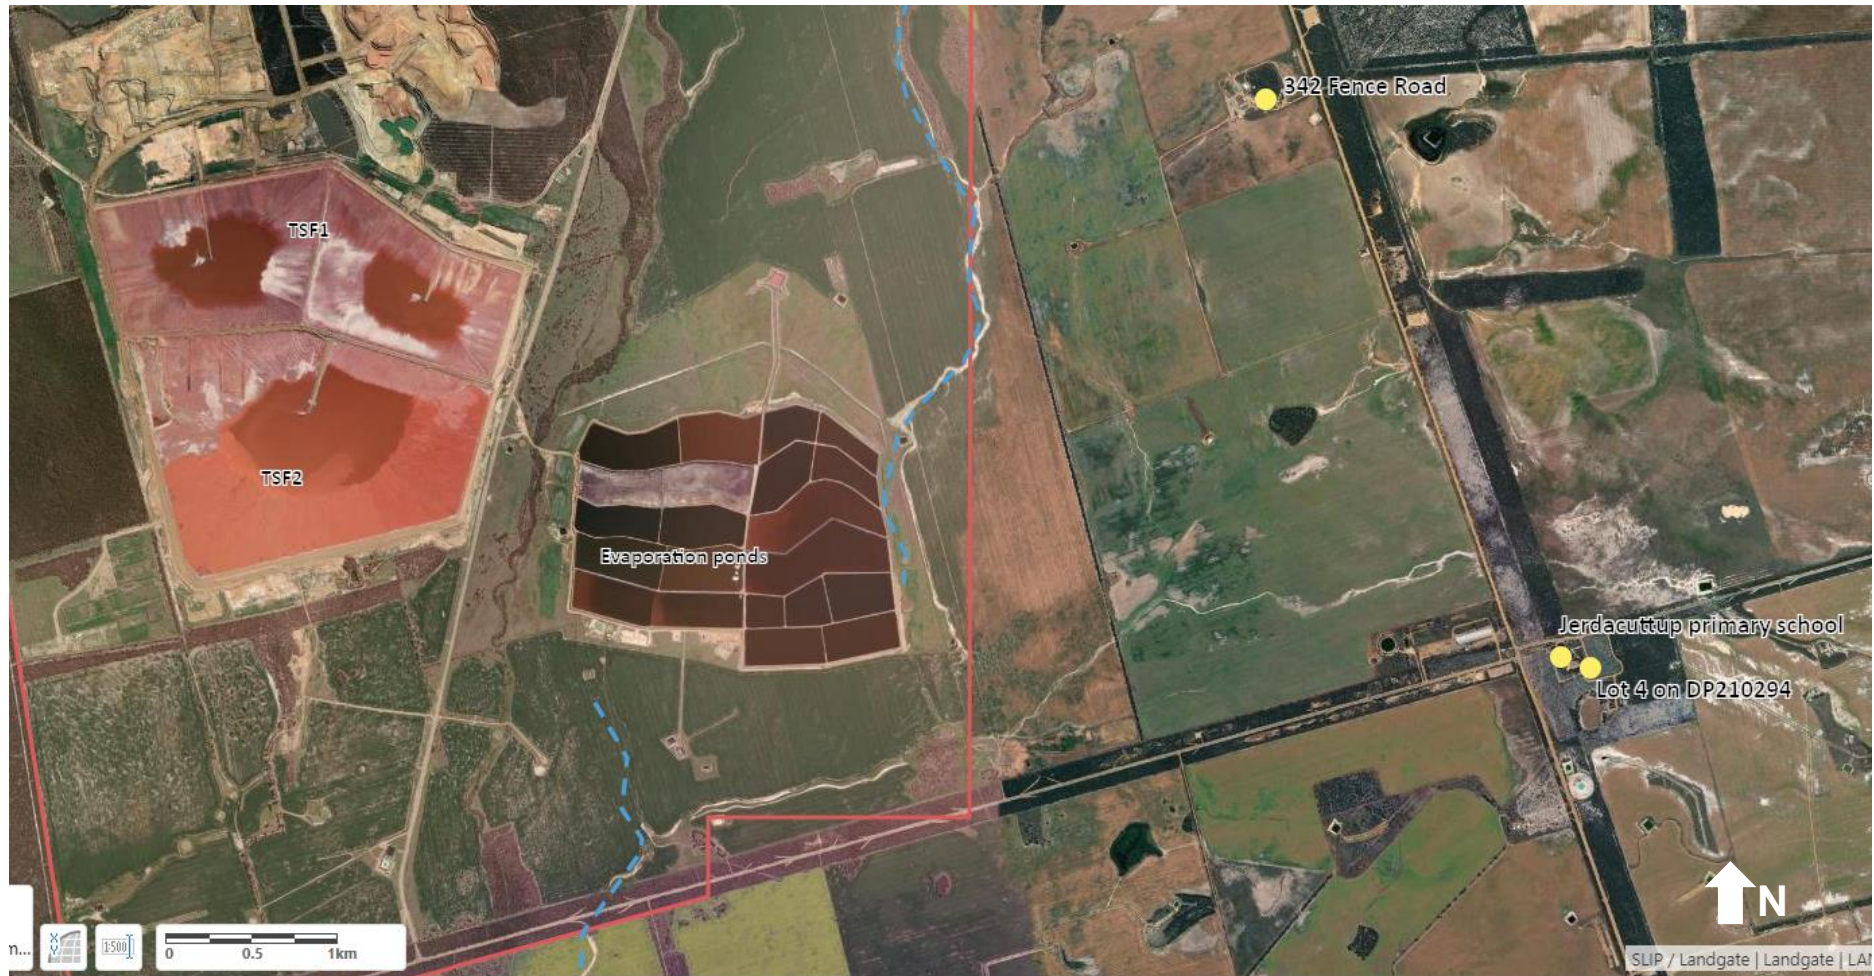
Figure 7: Nearby human receptors

<ul style="list-style-type: none"> 342 Fence Road (Lot 779 on DP 209227): <ul style="list-style-type: none"> 4.3 km east from TSF1/2; and 7 km south east from the landfill. Lot 789 on DP 209229: complaint – dust and nearby potable water tank: <ul style="list-style-type: none"> 6.5 km south of TSF1/2; and 11.7 km south from the landfill.
<u>Aboriginal heritage</u> Gnamma hole (ID 18950)	<p>The heritage listing intersects with the northern portion of the site, including the existing processing plant and operational area (see Figure 6).</p> <p>The registered heritage listing is:</p> <ul style="list-style-type: none"> 1.2 km east of the proposed landfill; and 3.2 km north of TSF1 (TSF2 is south of TSF1). <p>Gnamma holes are natural cavities commonly found in hard rock and can act as a source of water for Aboriginal communities. It is unknown if the gnamma holes within this location are in use.</p> <p>Topography of the area indicates a higher landform is situated in-between TSF2 and the heritage site which could act as a buffer for surface water impacts.</p> <p>See Figure 6.</p> <p>This site is unlikely to be impacted from the proposed amendment and will therefore not be considered further in this risk assessment.</p>
