Application for Licence Amendment

Licence Number	L8337/2009/2
Licence Holder	Genesis Minerals (Leonora) Pty Ltd
ACN	667 073 681
Application Number	APP-0030600
Premises	Gwalia Mine LEONORA WA 6438 Legal description - Mining Tenements: G37/25, G37/26, G37/27, M37/17, M37/25, M37/55, M37/137, M37/170, M37/200, M37/247, M37/251, M37/333, M37/391, M37/689, M37/903, M37/1026, M37/1027, M37/1150, L37/33, L37/34, L37/35, L37/36, L37/56, L37/58 and L37/66. LEONORA WA 6438 as depicted in Schedule 1. As defined by the Premises map attached to the revised Licence
Date of Report	25/03/2026
Decision	Revised licence granted

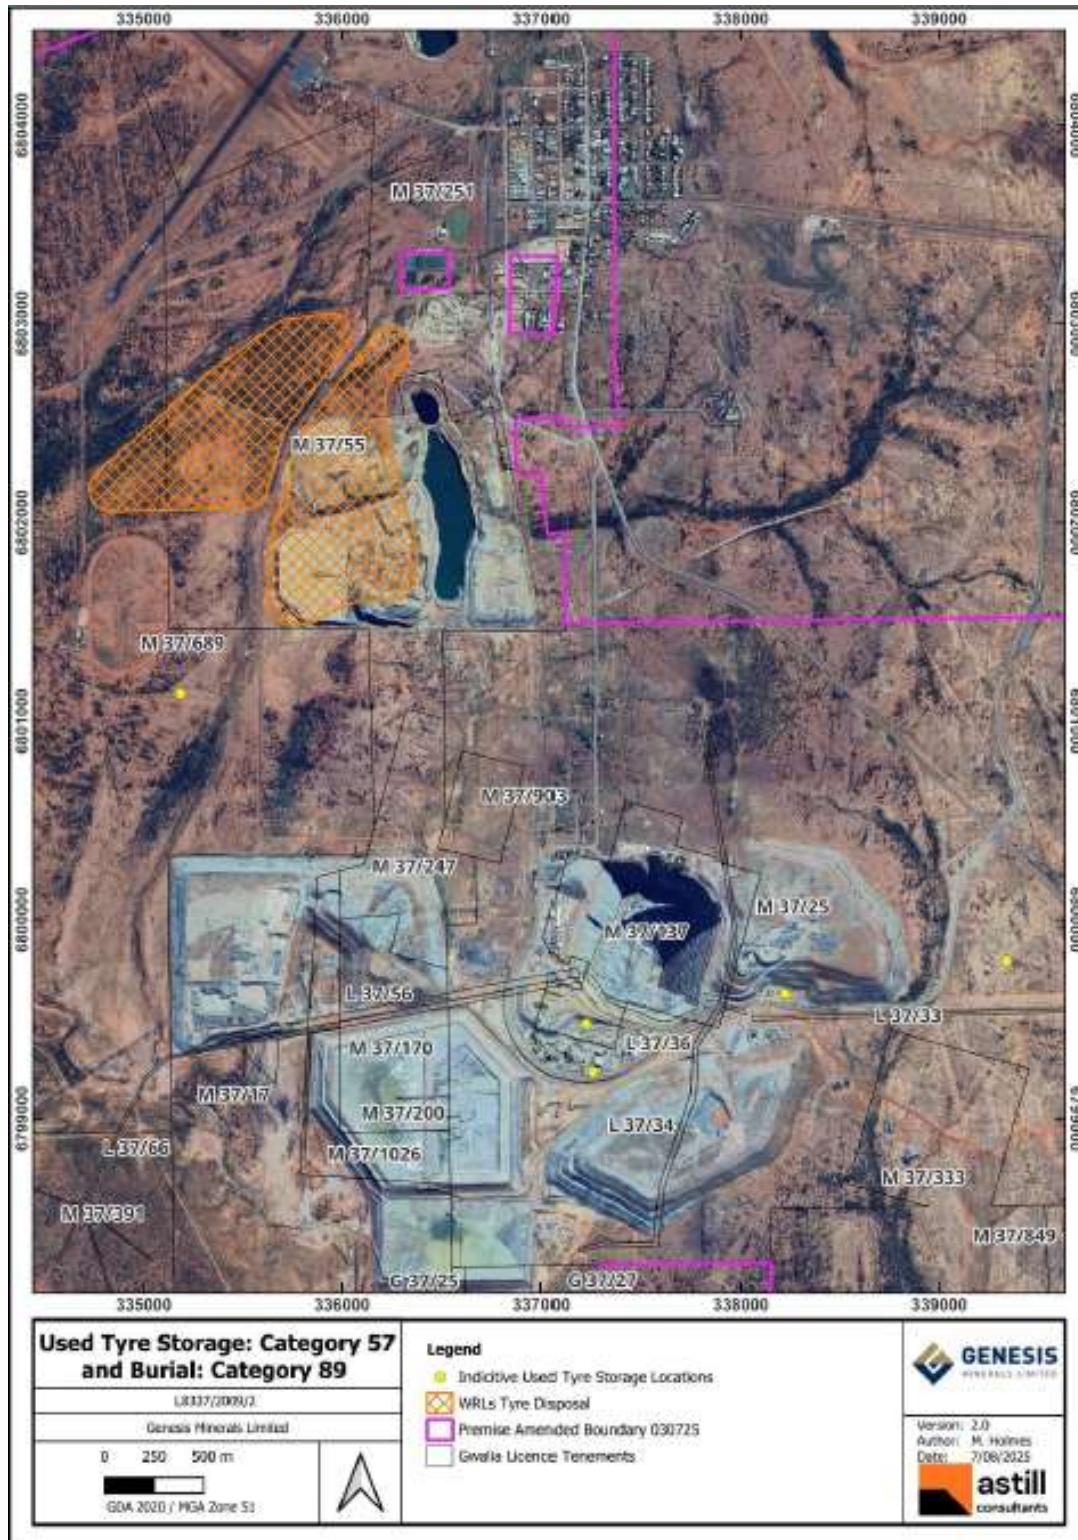
The licence holder has requested to include category 57 to the licence to authorised the storage of up to 500 tyres at various locations (i.e. workshops and laydown areas) within the prescribed premises (Figure 2).

Figure 2: Used tyre storage locations and tyre landfill.

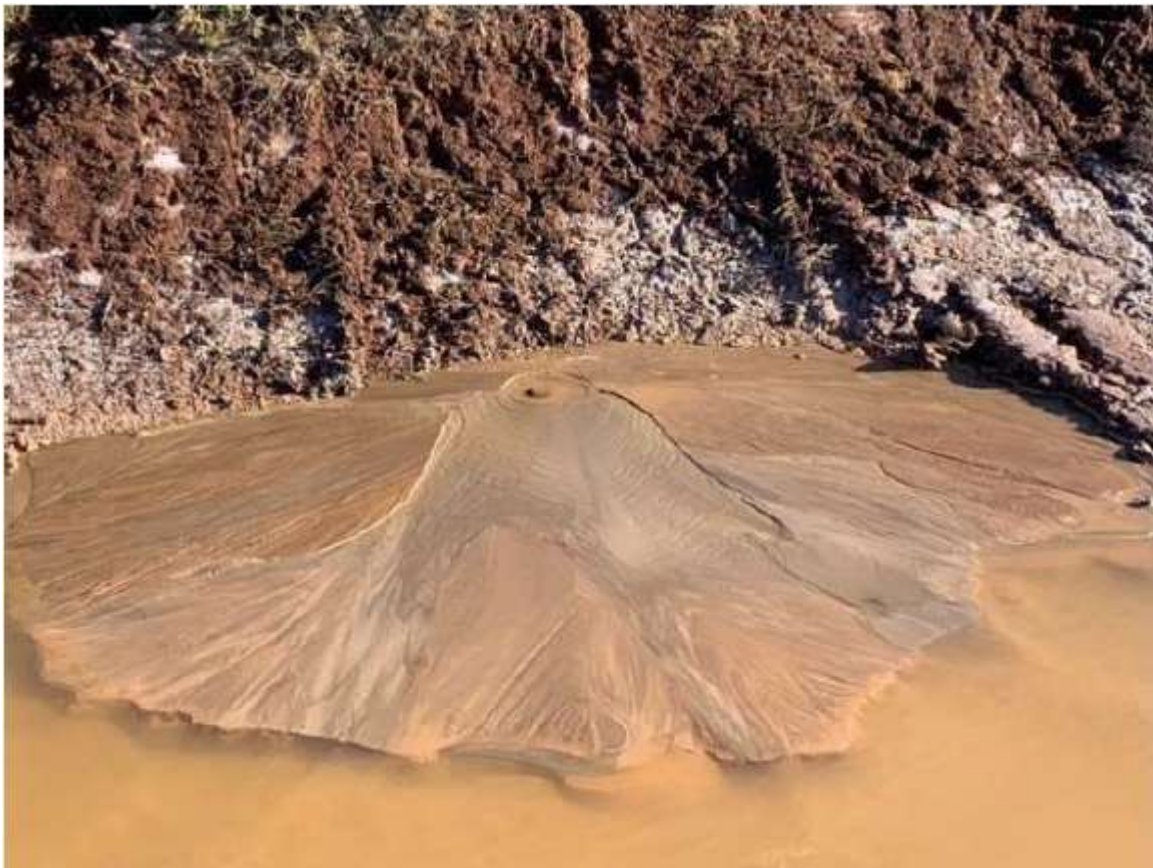
- The presence of a significant sand-boil (Figure 3) in the toe-drain near RB03. The department notes that this suggests that significant seepage is already taking place from this part of the TSF embankment. Pennington Scott (2025) notes that RB03 is situated within the sand boil area near the TSF4 toe drain and it is considered an area of known artesian seepage;

Figure 3: Sand boil in the toe drain near RB03 in January 2021 (Golders 2021, Sourced from Pennington Scott 2025)

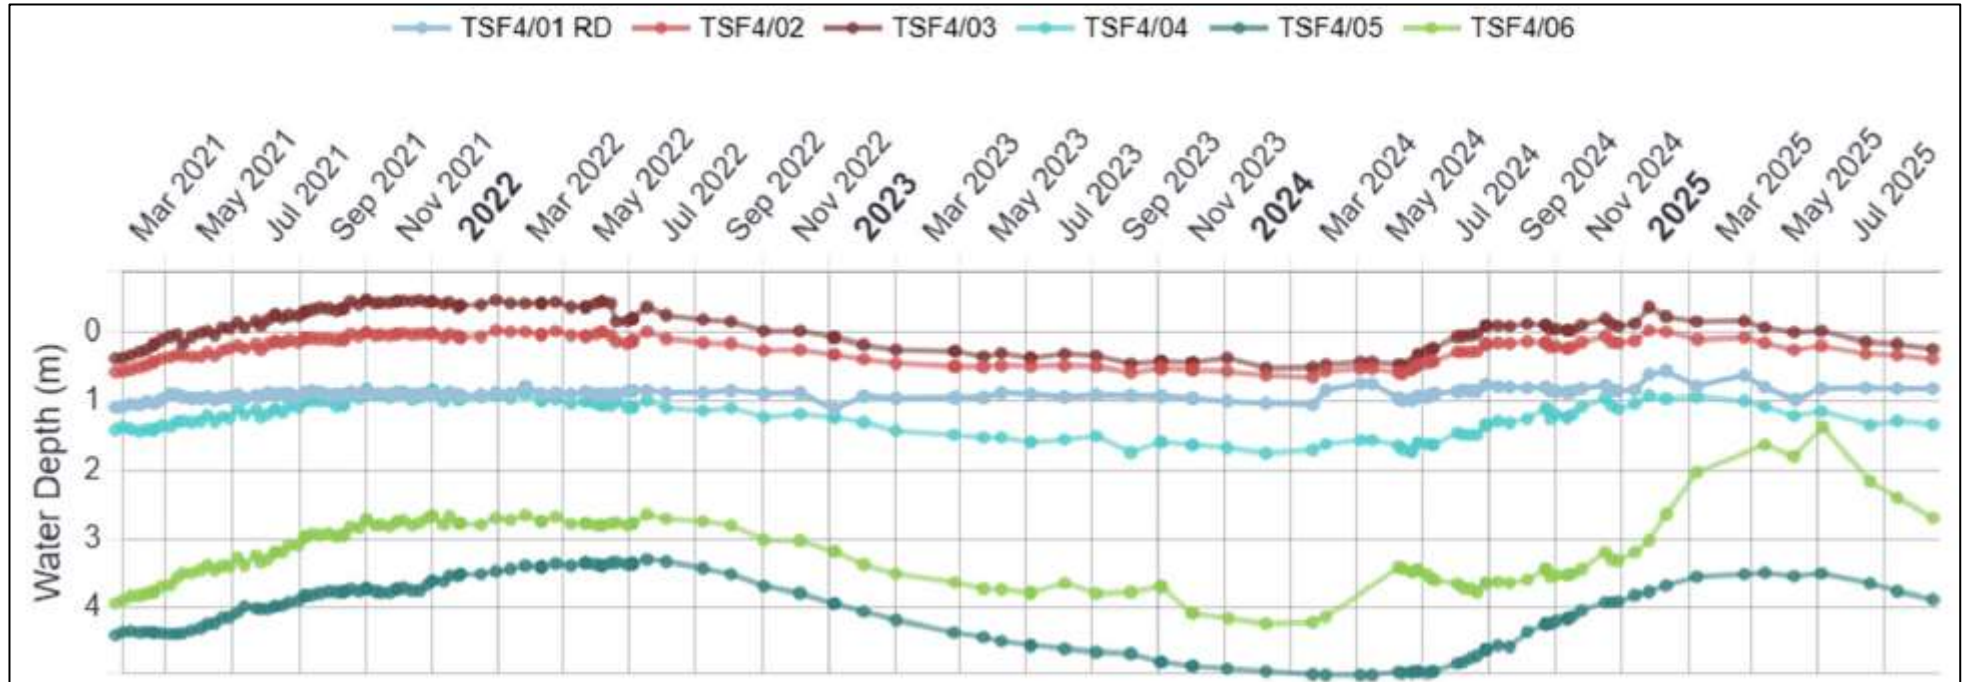
Groundwater surrounding TSF4 is saline due to regional geochemical conditions and is not considered suitable for domestic or agricultural use. Groundwater levels in the vicinity of TSF4 range from approximately ~0.5 to 2 mbgl and have remained within this range since 2020 (Figure 4). Monitoring data indicates that groundwater in the area has been influenced by long-term mining activities. Prior to mining, TDS concentrations ranged from approximately 1,500 to 12,500 mg/L, whereas current TDS concentrations surrounding TSF4 range between 35,000 and 80,000 mg/L. Consistent with typical hydrogeological behaviour in the region, TDS concentrations generally increase with groundwater depth.

Figure 4: Historical SWL measurements (Genesis 2025)

Previous deposition was taking place in excavation voids, excavated to the natural ground and, as a result, the hydraulic connection between tailings and the groundwater would have been more direct than it will be in the future as depicted in Figure 4 (WSP 2024). It is also mentioned that the TSF4 toe drain improvements completed in 2022 could start to take effect and begin to control groundwater levels.

Evidence of seepage and mounding has been recorded during the operational life of TSF4 (Section 9.3.2). Groundwater mounding has occurred historically (Figure 4), particularly within deeper groundwater areas on the eastern side of the facility (bores TSF4/05 and TSF4/06). For this reason, the department has assigned a **Possible** likelihood rating for this risk event.

Seepage and mounding has been recorded throughout the operational life of TSF4, and the shallow groundwater SWL (Figure 4) creates a potential pathway for seepage-affected groundwater to enter the drainage line and be transported towards Lake Raeside during stormwater runoff events. Although groundwater quality data from the TSF4 monitoring bores do not currently indicate significant concentrations of seepage identified within the aquifer (section 8.3.4), there remains a potential for increased seepage concentrations in the future if operational height of the supernatant pond increases and seepage recovery bores do not operate effectively. The department has assessed the likelihood of this risk event as **Possible**.

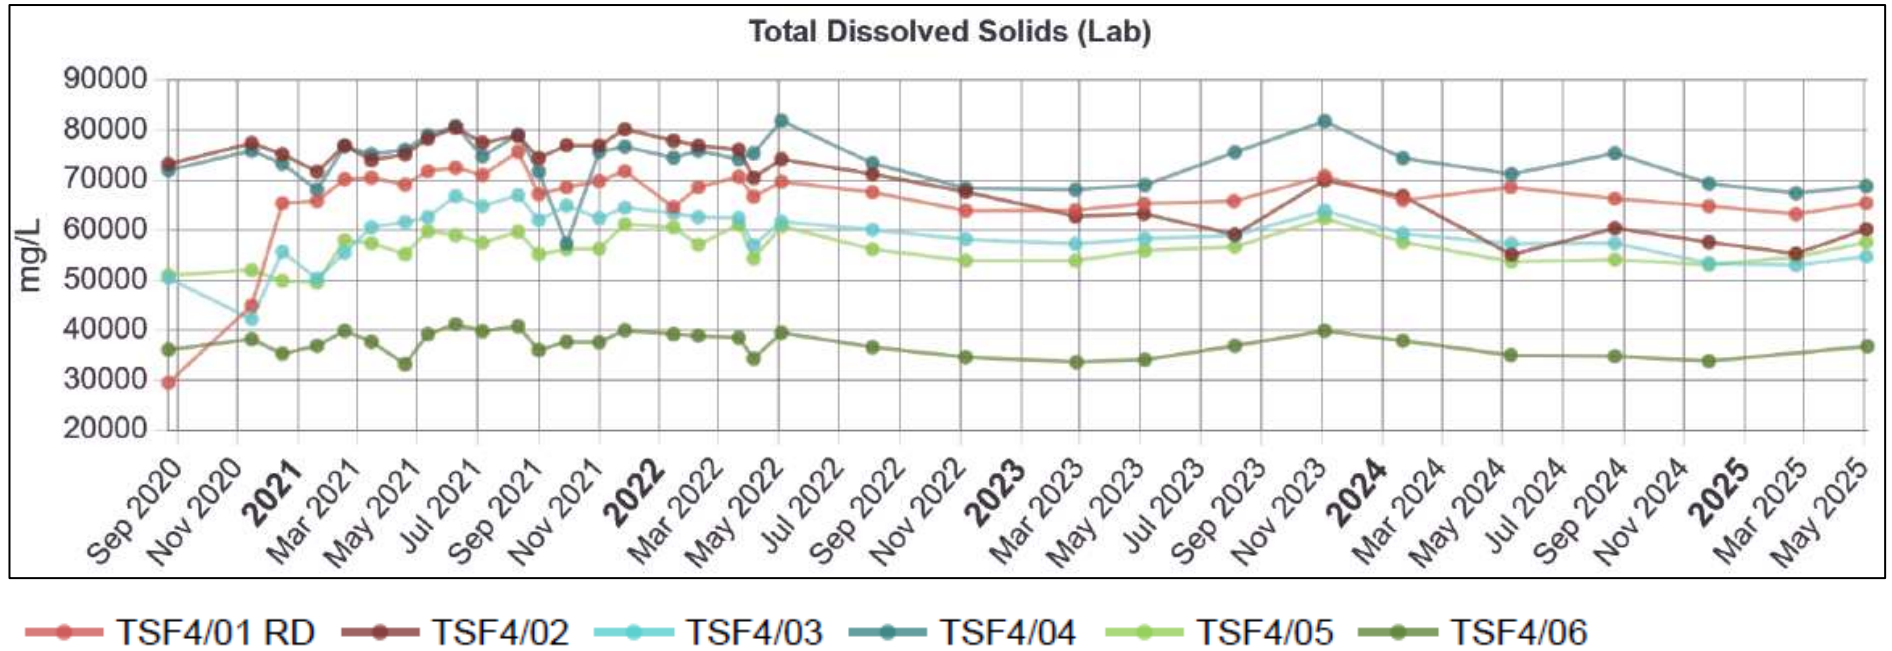
Groundwater TDS has not changed significantly since TSF4 commenced operations, with the exception of TSF4/01RD where TDS has increased from ~30,000 mg/L to ~65,000 mg/L.

Figure 5: TDS concentrations within TSF4 monitoring bores (Sourced from Genesis 2025).

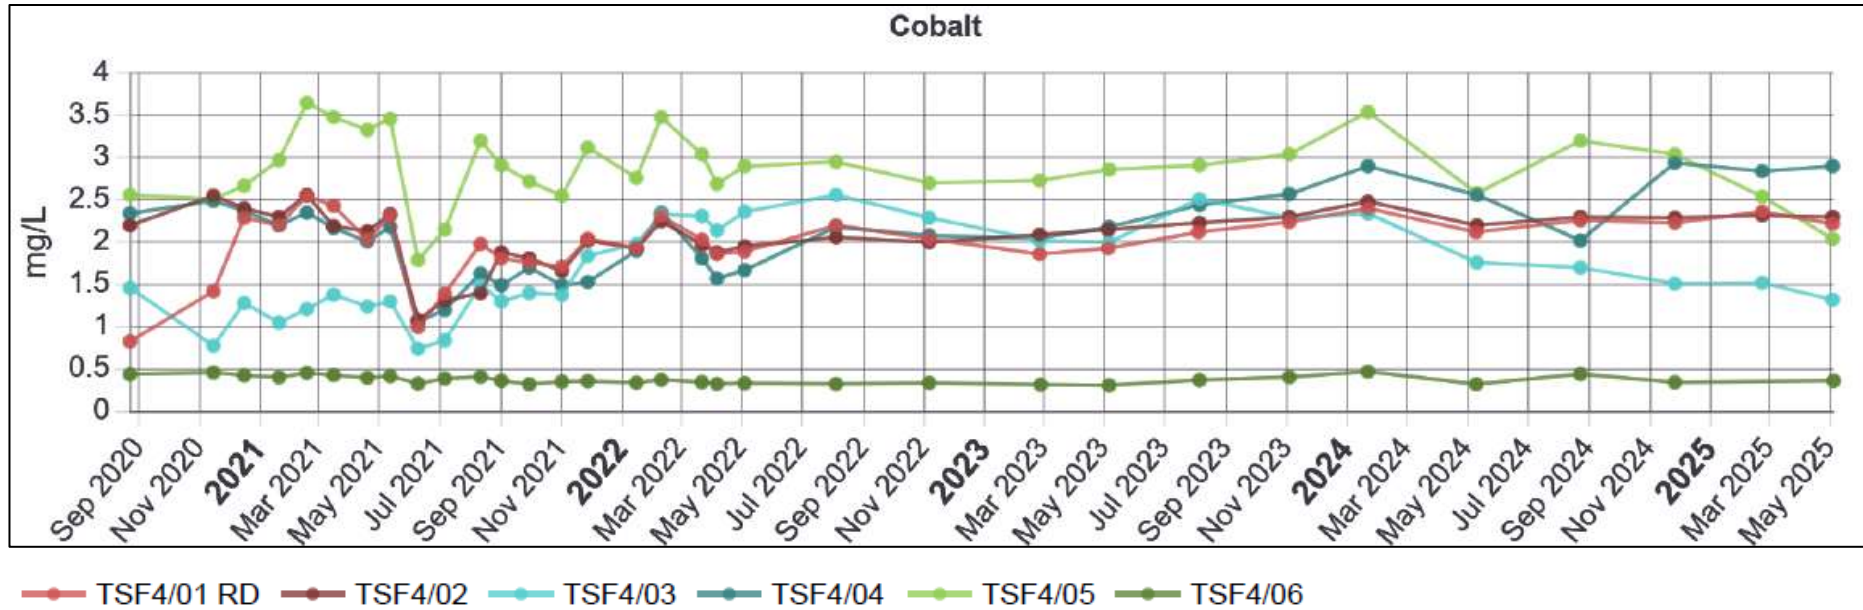
The department considers these concentrations to be overall low and not likely to result in consequential impacts to potential receptors, with the exception of cobalt. Historical cobalt concentrations (Figure 6) suggest that TSF4 has either not contributed, or has only minimally contributed to cobalt levels to the groundwater.

Figure 6: Cobalt concentrations within TSF4 monitoring bores (Sourced from Genesis 2025).

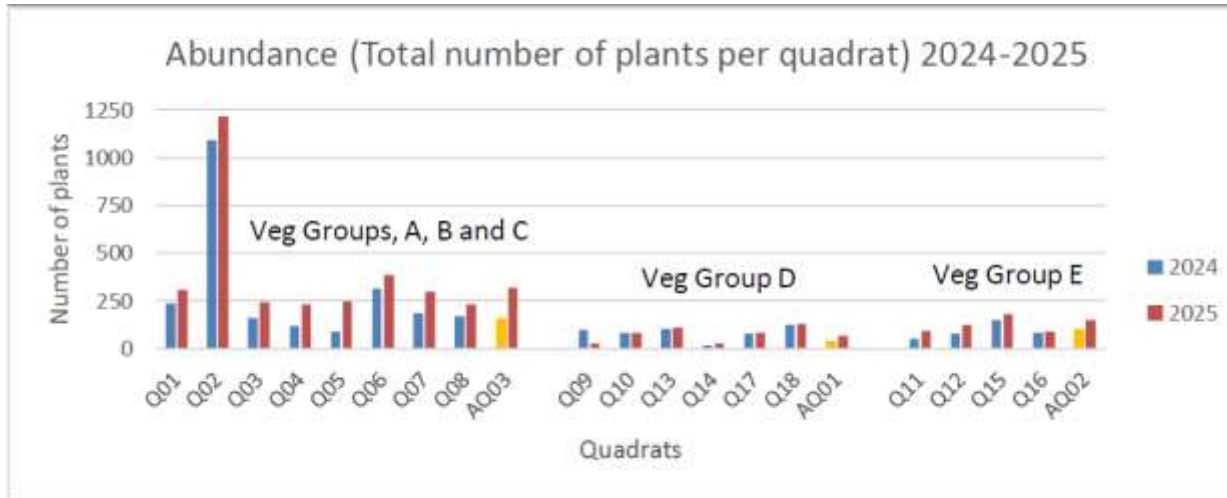
Figure 8: Total plant abundance within monitored quadrats (Sourced from NVS 2025)

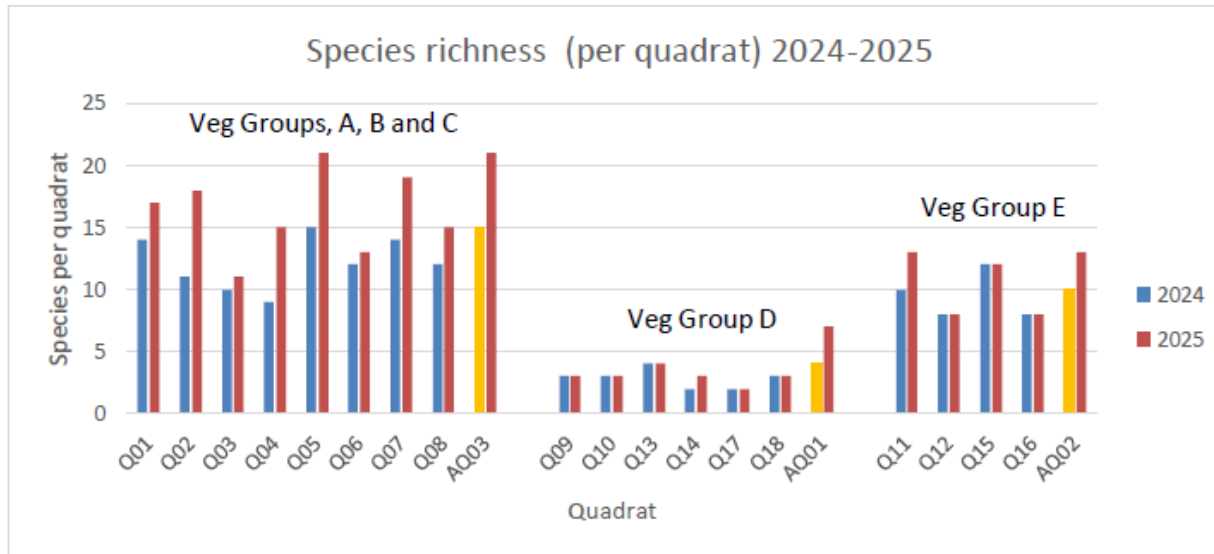
Figure 9: Species richness within monitored quadrats (Sourced from NVS 2025)
