## Application for Licence Amendment

### Part V Division 3 of the *Environmental Protection Act 1986*

<b>Licence Number</b>	L8457/2010/2
<b>Licence Holder</b>	Silver Lake (Integra) Pty Limited
<b>ACN</b>	093 278 436
<b>File Number</b>	APP-0030969
<b>Premises</b>	Randalls Gold Processing Facility  Mount Monger Road EMU FLAT WA 6431  Legal description  Mining Tenements M25/71, M25/125, M25/133, M25/307, M25/347 General Purpose Lease L25/27, L25/29, L25/31, L25/33, L25/41 Miscellaneous Licence G25/02  As depicted in Schedule 1.
<b>Date of Report</b>	3 February 2026
<b>Decision</b>	Revised licence granted

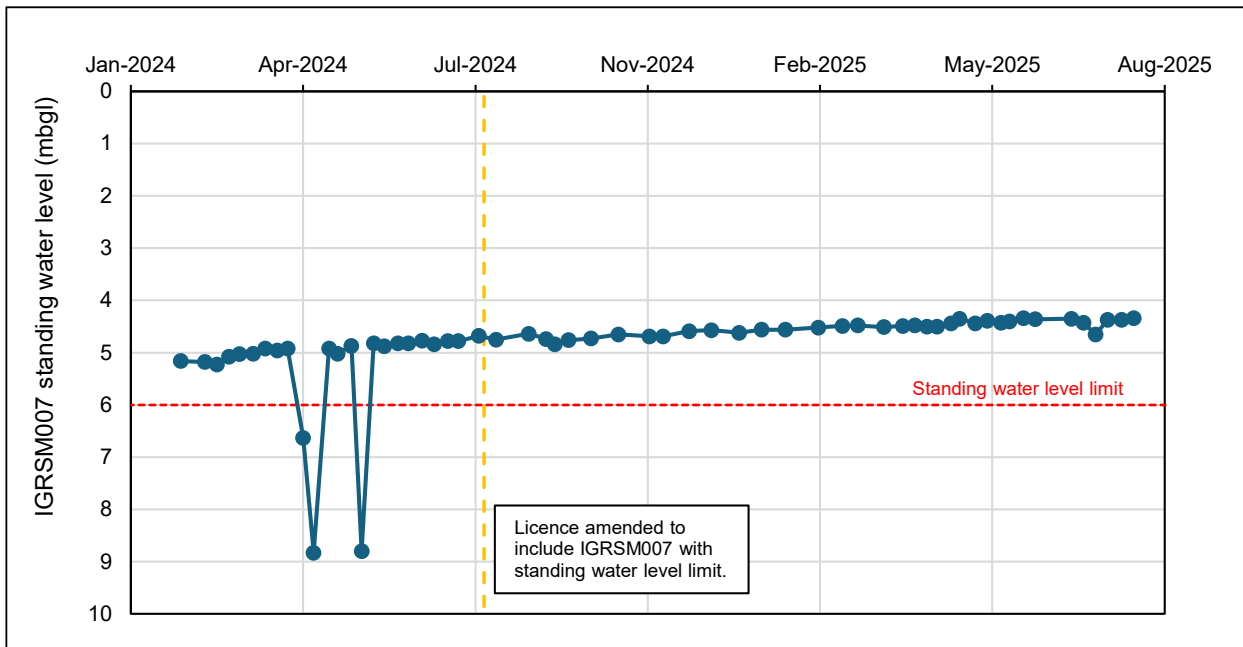
**Figure 2: Standing water level at monitoring bore IGRSM007**

The licence holder indicated that shallowing of groundwater may be observed at IGRSM007, as shown in monitoring results at the time of this assessment (Figure 2). However, groundwater level may stabilise or even deepen, following transition of tailings deposition to TSF1, as well as the implementation of further groundwater management strategies (e.g., groundwater recovery bores, etc.).

- Groundwater levels at this monitoring location were already shallower than 6.0 mbgl at the time when the limit was specified on the licence in August 2024. This was demonstrated with fortnightly monitoring data prior to and following the specification of the limit (Figure 2).

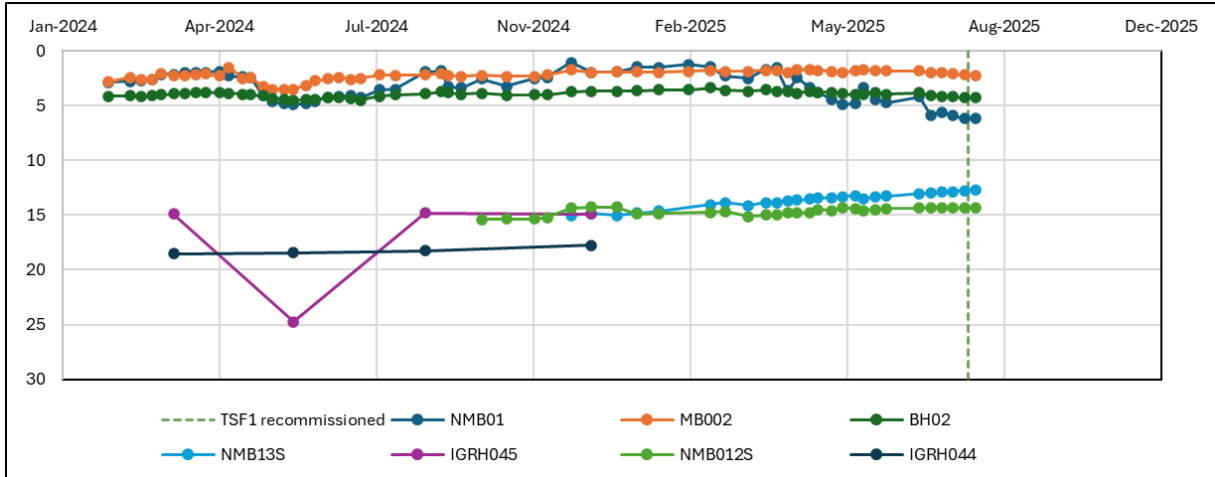
**Figure 3: Groundwater level at TSF1 monitoring bores**

Assessment of monitoring bores around TSF1 indicated the most significant locations of concern for groundwater mounding remained along the west and north-west of TSF1 (Figure 3). This was characterised by monitoring bores NMB01, MB002, and BH002. At the time TSF1 commenced time limited operation (under works approval W6927/2024/1), a declining trend had begun at these monitoring bores, perhaps due to intense groundwater recovery effort in this area.

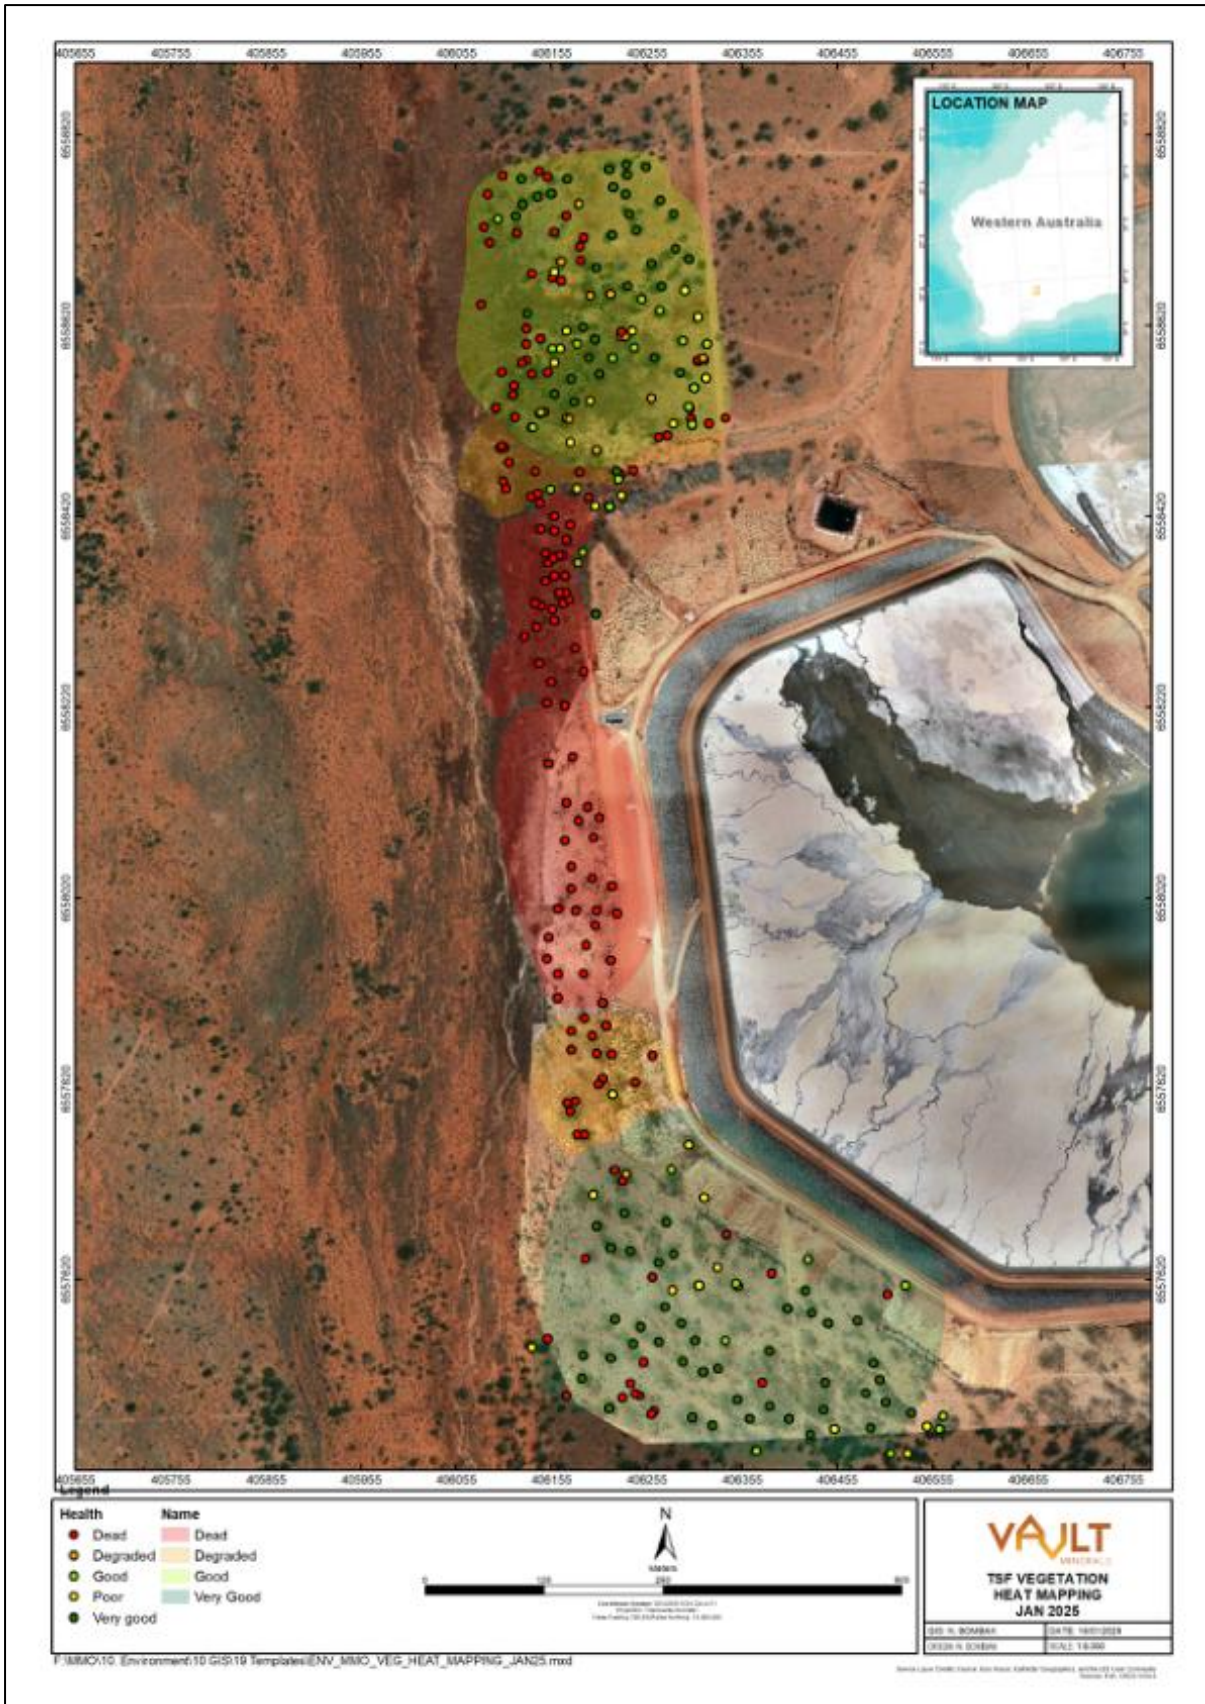
Figure 4: Vegetation condition heat mapping from January 2025

Since 2023, vegetation condition at SCQ1 has been classified as ‘Excellent’ and ‘Very Good’, while at SCQ9, vegetation condition has been classified as ‘Good’ and ‘Poor’ (Table 2). A more detailed survey in January 2025 around the SCQ1 quadrat revealed a varying degree of vegetation conditions, though overall still better than vegetation further south that was impacted by seepage from TSF2 (Figure 4). This is a noteworthy observation, as groundwater levels at MB002 is shallower than at BH02, yet the vegetation conditions at BH02 (SCQ9) are poorer than those at MB002 (SCQ1). This suggests other factors besides groundwater mounding are currently driving differences in vegetation condition.
