Application for Licence Amendment

Licence Number	L9010/2016/1
Licence Holder	Mount Morgans WA Mining Pty Ltd
ACN	612 053 291
Application Number	APP-0030200
Premises	<p>Mt Morgans Gold Project</p> <p>Legal Description - Mining tenements: M39/236, M39/395, M39/390, M39/272, M39/18, M39/228, M39/264, M39/304, M39/240, M39/248, L39/246, M39/441, M39/250, M39/504, M39/745, M39/403, M39/282, M39/36 and M39/1107 LAVERTON WA</p> <p>As defined by the premises maps attached to the revised licence</p>
Date of Report	05/02/2026
Decision	Revised licence granted

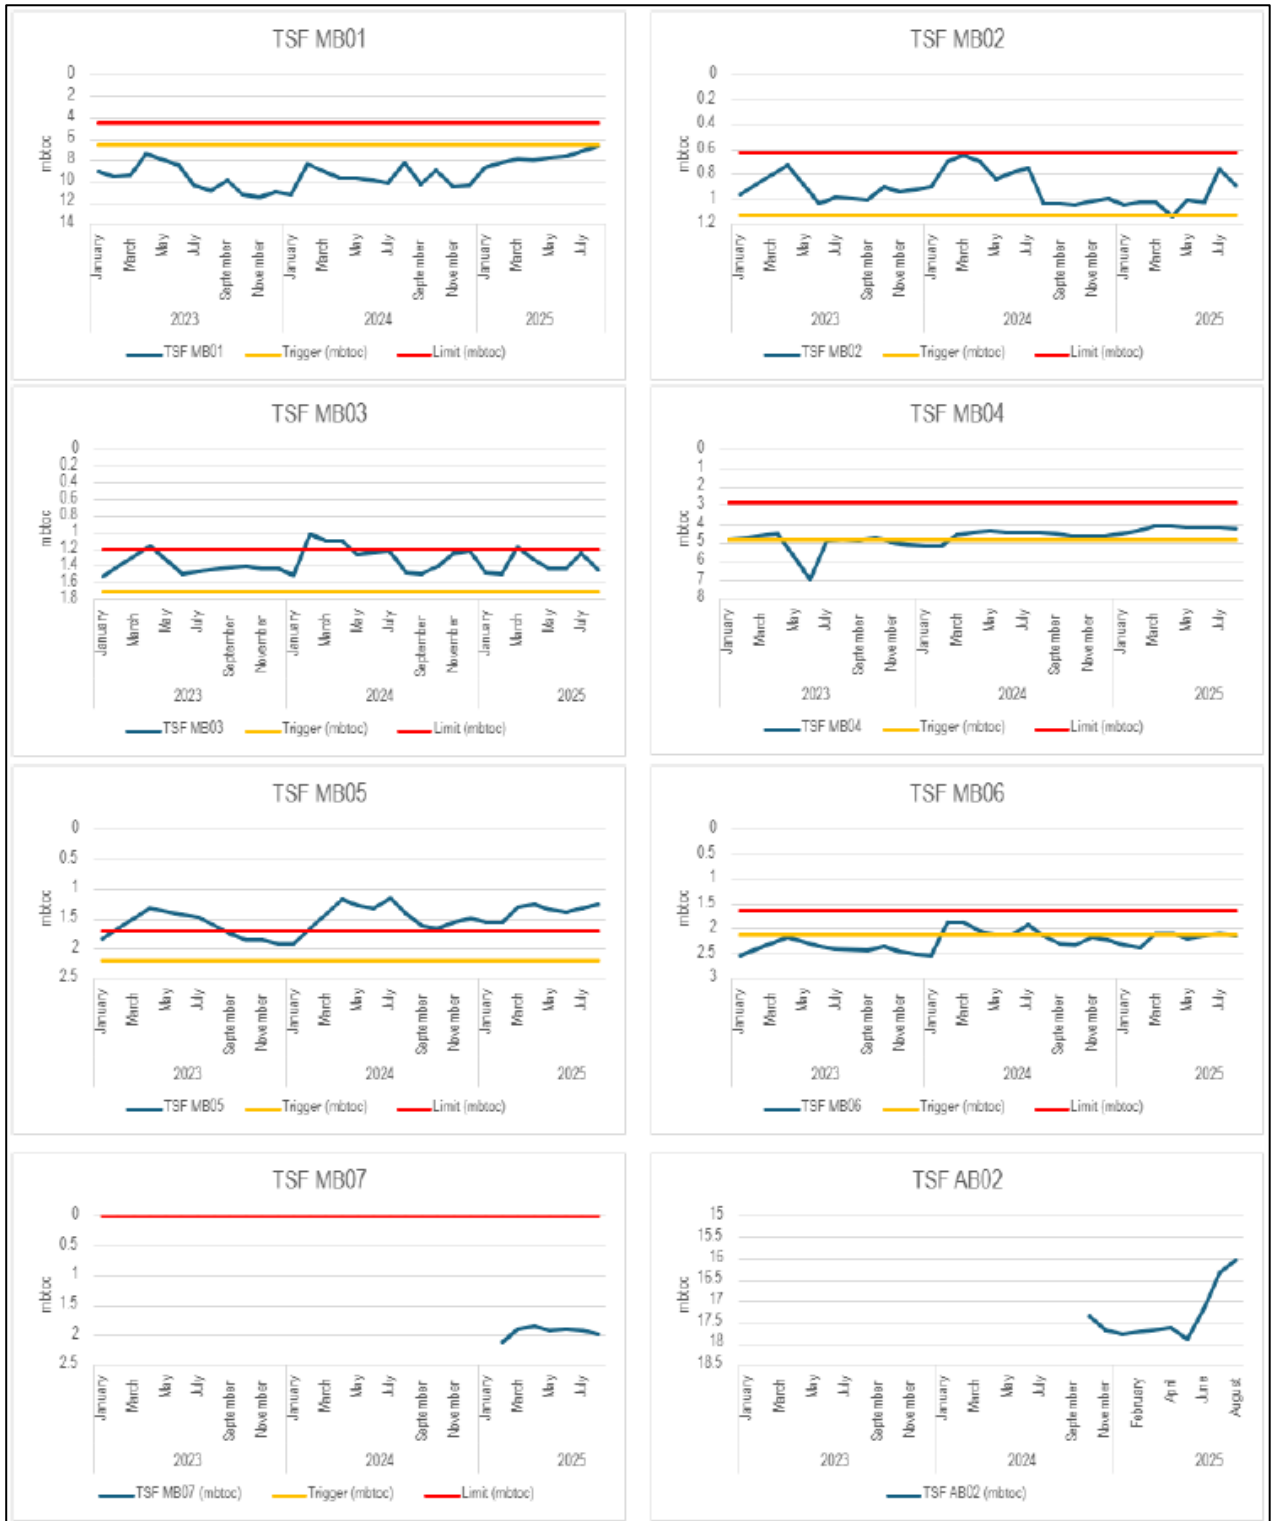
Figure 1: SWL in monitoring bores from January 2023 to August 2025 (Sourced from Mount Morgan 2025)

Groundwater SWLs around the TSF showed a slight increase in monitoring bores near Cell 1 (TSF MB1–TSF MB3) and a decline near Cell 2 (TSF MB4–TSF MB6) (Figure 1). The licence holder attributed these fluctuations to seasonal trends influenced by rainfall (Mount Morgan, 2025).

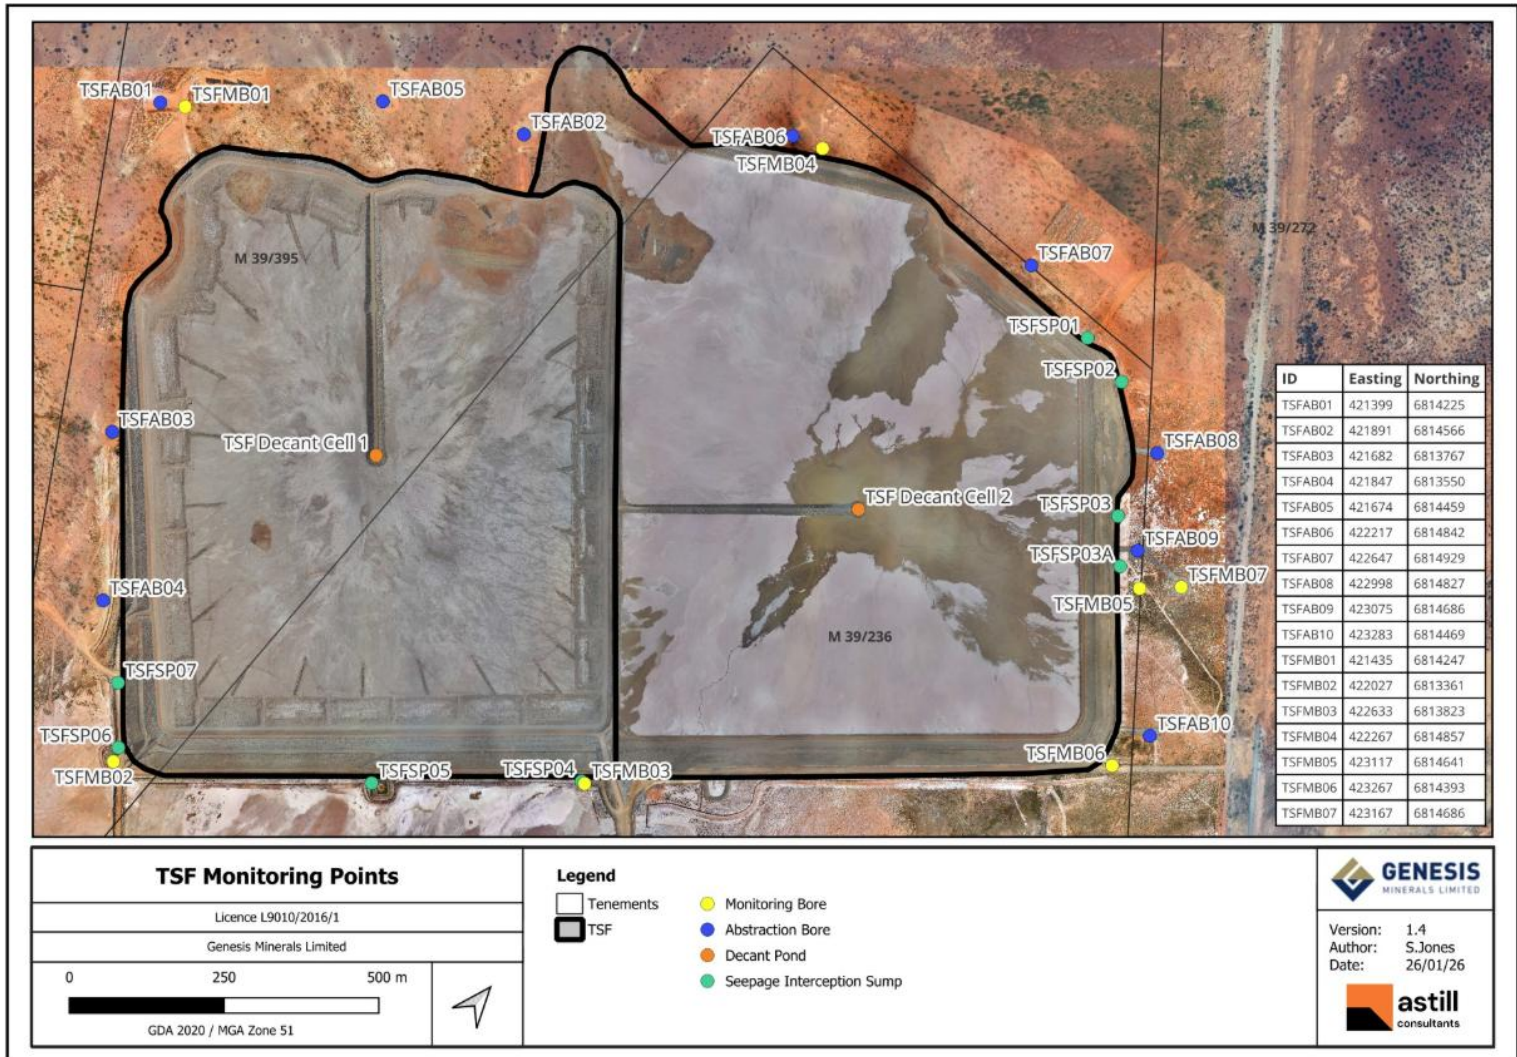
Figure 2: Monitoring bore, abstraction bore and seepage infrastructure locations (Sourced from Astill 2025)

The licence holder has proposed to continue annual vegetation monitoring in accordance with existing condition 1.2.6 (see below). Seepage and mounding from the TSF is managed through a variety of seepage recovery infrastructure (figure 2) involving recovery bores, seepage interception trenches and sumps. The seepage recovered is either returned to the TSF or is used in processing.

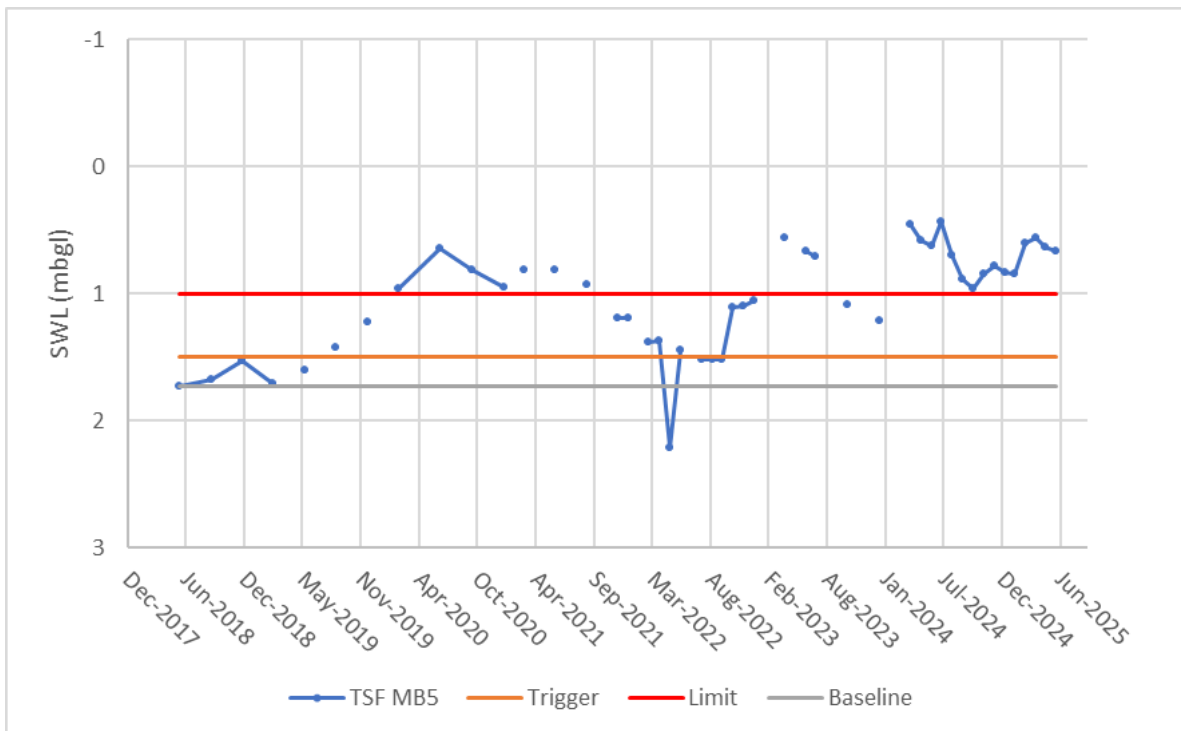
Figure 3: TSF MB05 SWL

TSF MB05 was installed in June 2018, with a recorded baseline SWL of 1.73 mbgl.

Since commencement of TSF operations, groundwater levels within TSF MB05 have risen from 1.73 mbgl to approximately 0.6–0.8 mbgl (Figure 3).

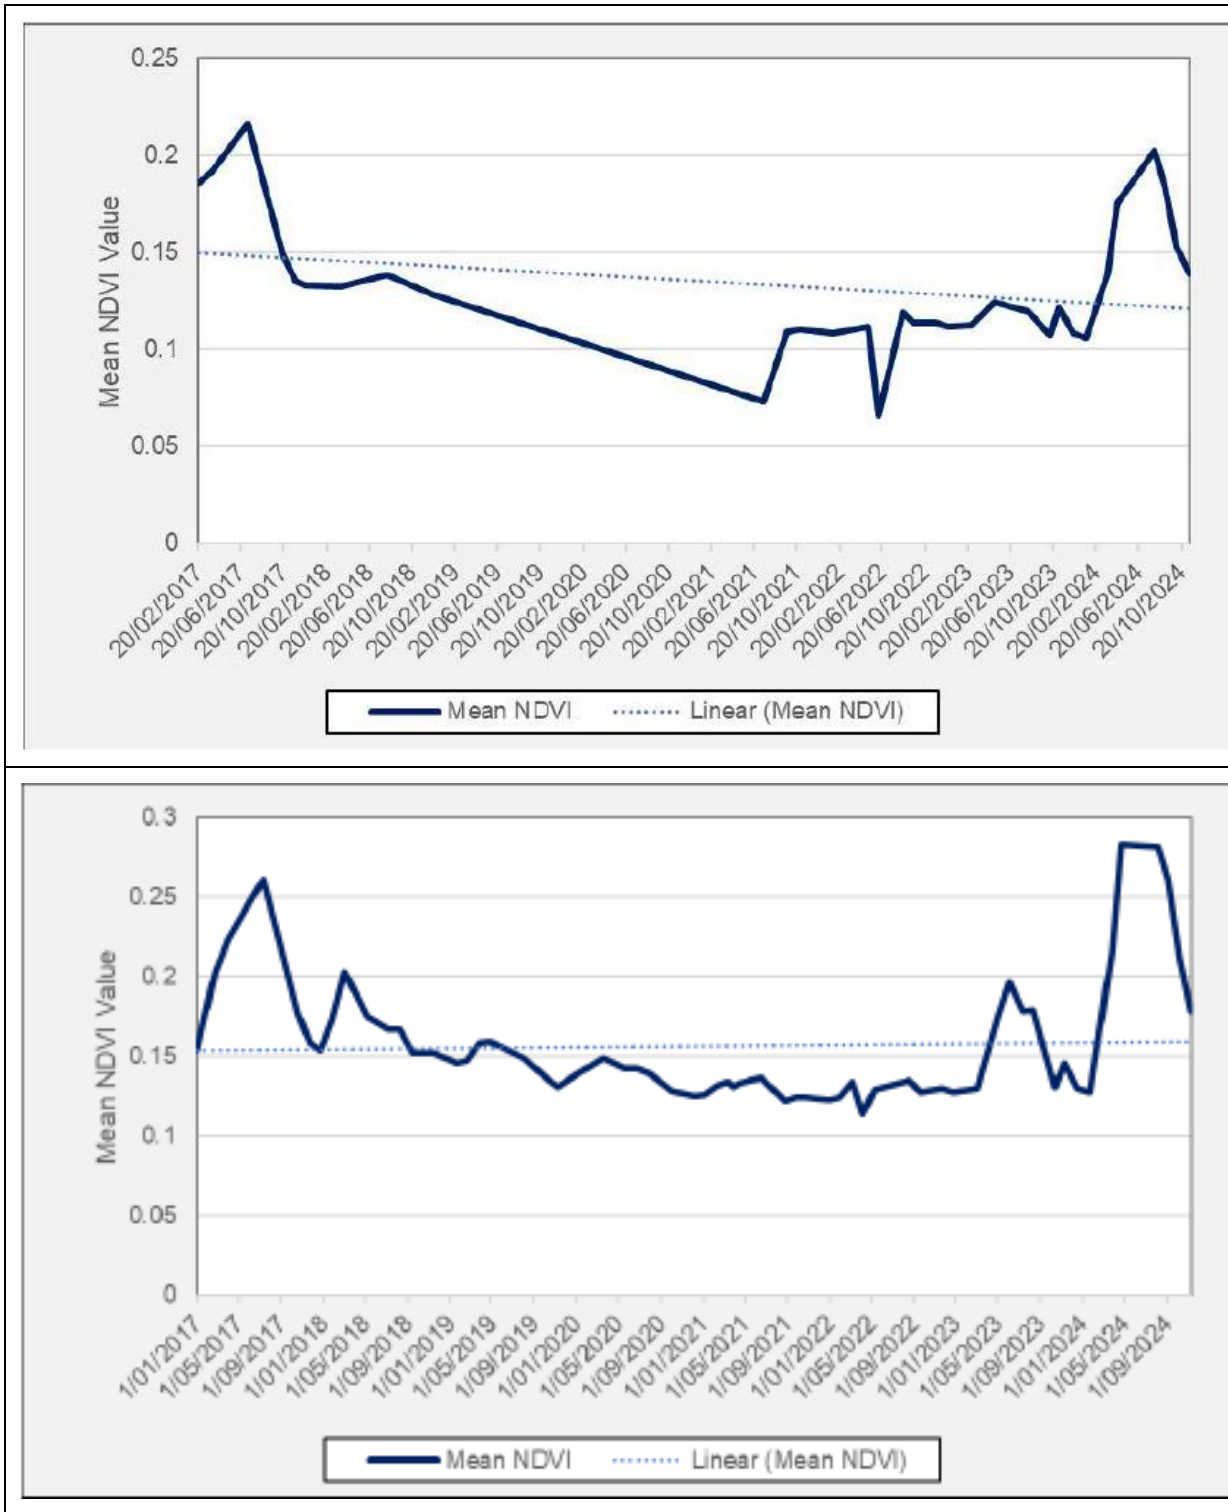
Figure 5: NDVI long term trend TSF Area (Top) Baseline Vegetation (Bottom) Sourced from RPM 2025).

<p>The NDVI graph shows a notable increase in vegetation density, likely associated with increased rainfall well above historic mean that occurred between January and July 2024, indicating negligible impact of high SWL on surrounding vegetation. This is further supported by the field assessment carried out in December 2024 (RPM 2025) which determined that there is no indication of a declining trend in vegetation density and/or condition around the TSF to suggest that groundwater mounding is impacting vegetation health (Astill 2025).</p>	<p>The department acknowledges that NDVI graphs show an increase in vegetation density around early 2024 at both the TSF area and the baseline vegetation location (Figure 5). However, this increase appears greater within the baseline area than at the TSF area, which may indicate reduced soil and vegetation health at the TSF area, limiting potential growth.</p> <p>Although RPS (2025) states that there has been negligible change in net vegetation health and density since 2018, Table 6 suggests a reduction in vegetation cover. This reduction is attributed to lower rainfall and potentially by the salt accumulation in the area (Figure 8). Soil salinisation may reduce opportunities for native vegetation to grow even for salt tolerant species.</p>

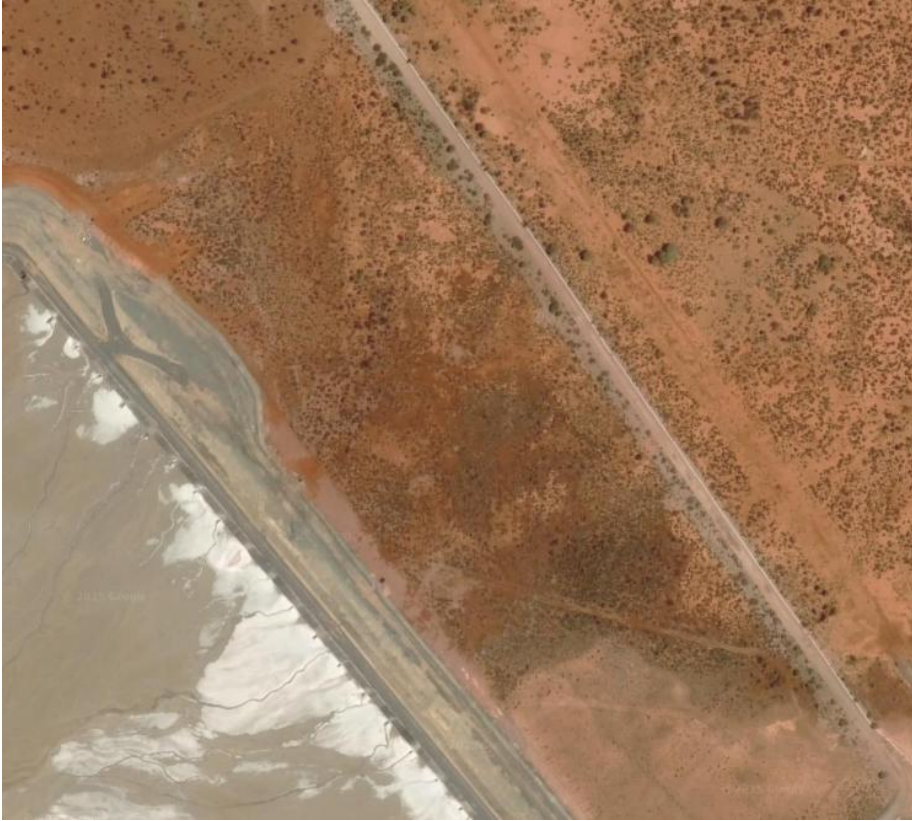
Figure 6: Historical aerial imagery of vegetation northeast of the TSF taken on 17 January 2021 (Sourced from Google Earth 2025).

On 24 September 2020 the licence holder notified the department of native vegetation loss associated with the TSF. Approximately 3.8 hectares of native vegetation on the eastern side of the TSF were impacted by salt deposits from receding surface water. Since 2020 additional salt accumulation appears to have occurred within the area and near TSF MB05 as presented in Figure 6, Figure 7 and within photographs taken during the vegetation monitoring events (Figure 8).

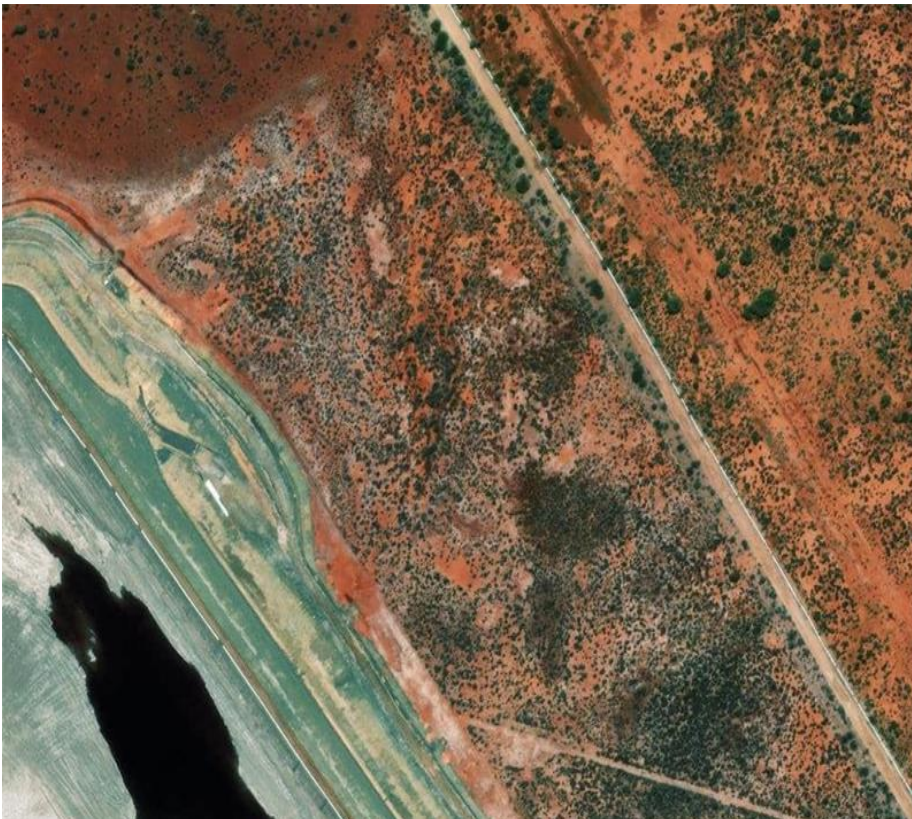
Figure 7: Historical aerial imagery of vegetation northeast of the TSF taken on 7 November 2024 (Sourced from Nearmaps 2025).

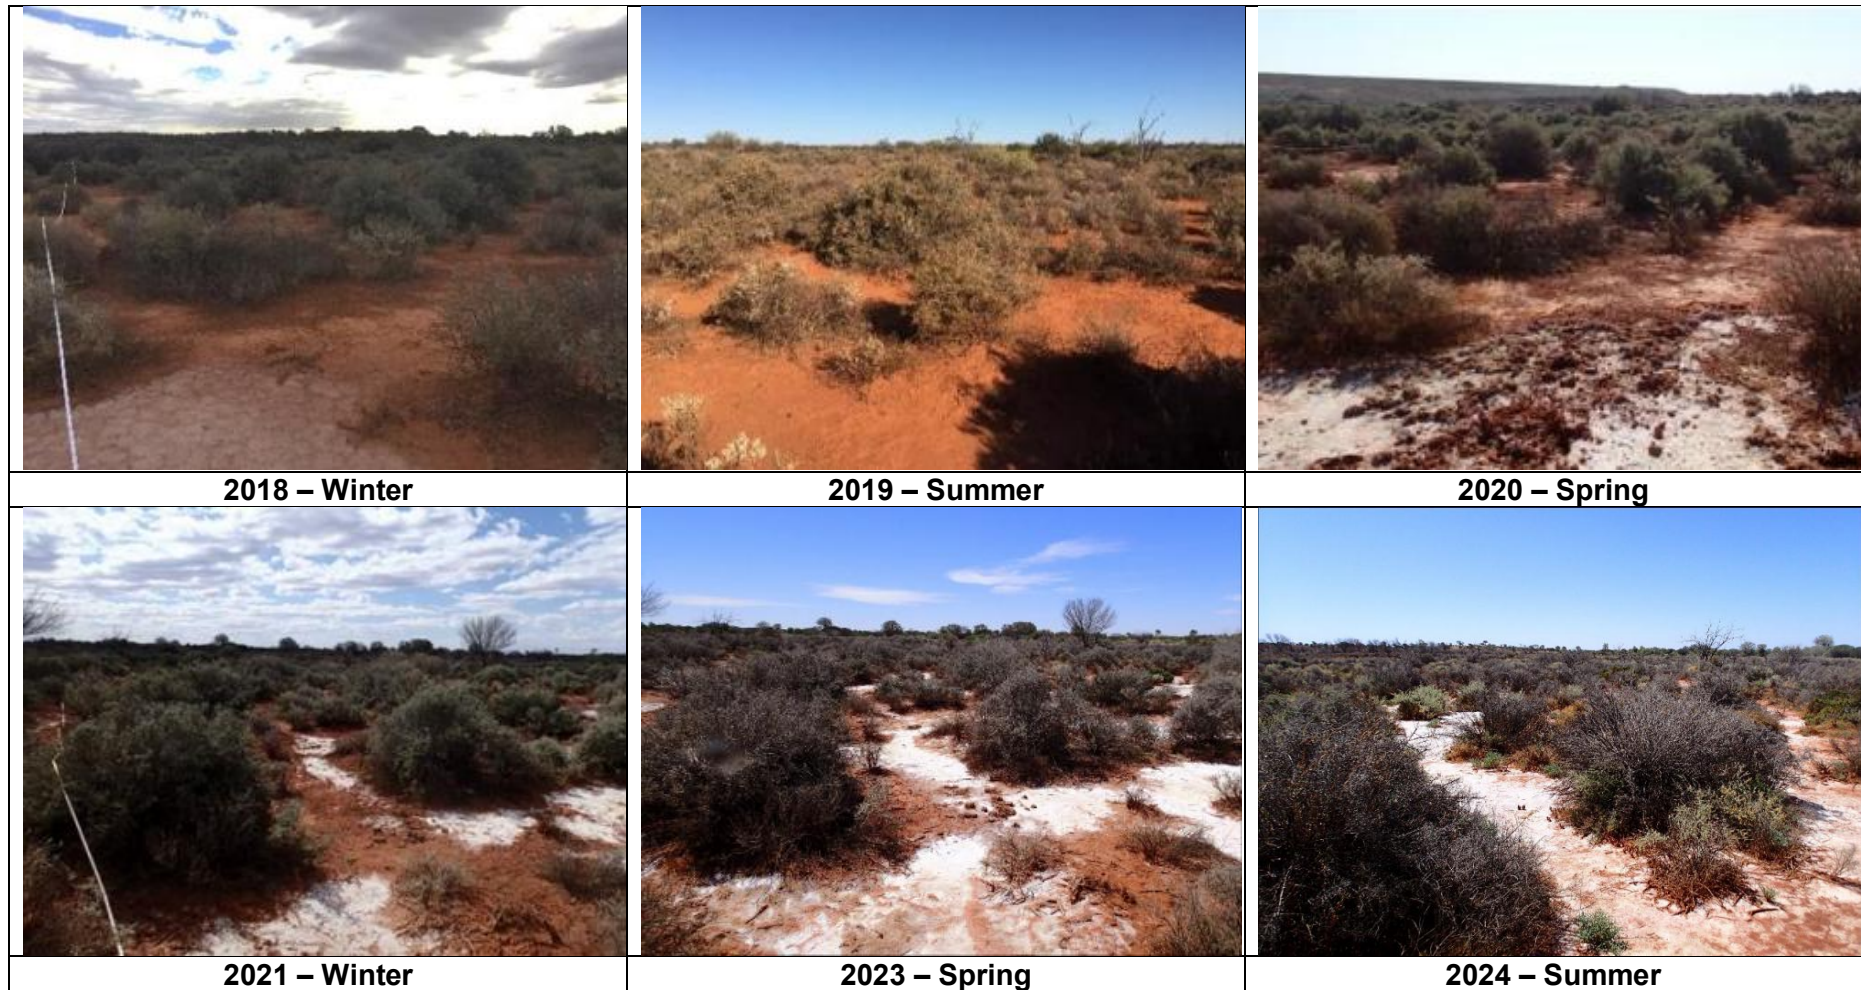
Figure 8: Photographs of NE quadrant during annual vegetation monitoring (Sourced from RPM 2022 and RPM 2025)
