Amendment Report

Application for Licence Amendment

Licence Number	L9155/2018/1
Licence Holder	Avoca Mining Pty Ltd
ACN	108 547 217
File Number	DER2018/001153
Premises	Higginsville Gold Project HIGGINSVILLE, WA, 6443
	M15/351, M15/289, M15/225, M15/642, M15/348, M15/31, M15/786, M15/506, M15/507, M15/620, M15/629, M15/639, M15/640, M15/580, M15/581, M15/597, L15/225, L15/288, L15/302, G15/19, G15/23, M15/528, M15/231, M15/748, M15/512, M15/352, M15/610, M15/375, M15/338, M15/1790, M15/1814, L15/282, L15/347, G15/26, G15/27, G15/29, L15/382, L15/389, M15/325, M15/681 and M15/817.
	As defined by the Premises maps attached to the Revised Licence
Date of Report	26 October 2020
Proposed Decision	Granted

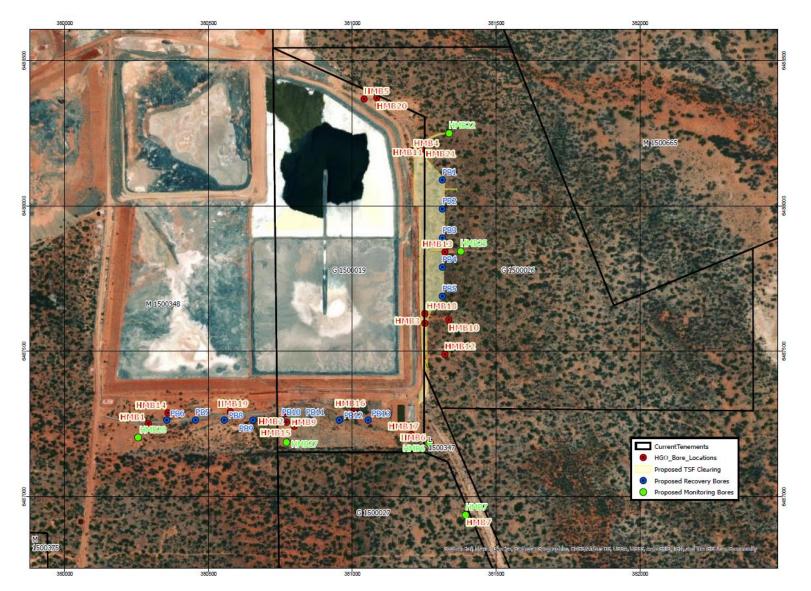
Figure 1 Location of existing monitoring bores, proposed seepage recovery and proposed compliance monitoring bores (Rockwater, 2020)

- Installation of a seepage recovery bore network (Figure 1), drilled at least 10m into fresh rock, 100mm or 155mm slotted PVC and gravel packed. Inclusion of pre-existing monitoring bores into recovery bore network if sufficiently high yielding;

- Use of new compliance monitoring bores HMB6, HMB7, HMB22, HMB25, HMB27, HMB28 (depicted in Figure 1 below) at a greater distance from the TSF (more reflective of risk to vegetation);

Environmental receptors	Distance from prescribed activity
Lake Cowan, associated aquatic biota and riparian vegetation (see description below)	 Current dewatering of 1,000,000kL/annum directly into Lake Cown from the Baloo pit (Figure 1) (see Appendix 2 for more detail)
	 Located 4.5km east (down hydraulic gradient) of TSF2-4 planned for recommissioning during this amendment (Figure 2)
Native vegetation	Directly adjacent to TSF and dewatering infrastructure (pipelines)
Groundwater	• Historical data from the Rockwater (2020) report indicates groundwater levels historically originally between approximately 15 and 22m bgl.
	 The most recent data collected by Rockwater in May 2020 indicates groundwater levels between 0.5 and 10.3m bgl;

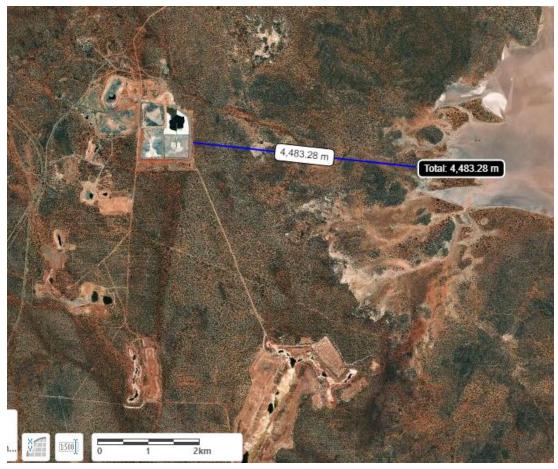
Figure 3 Distance of TSF 2 - 4 from Lake Cowan

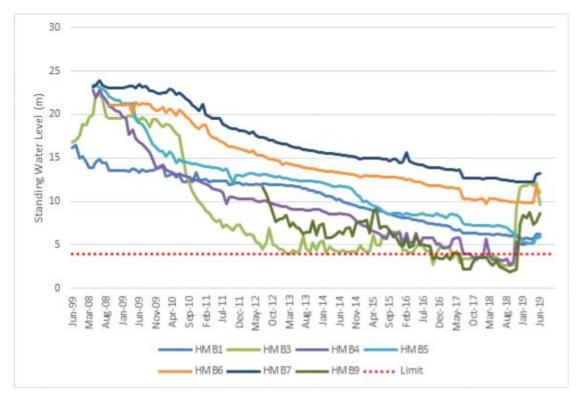
Figure 5 TSF 1-4 monitoring bore standing water level trends (AER 2018-2019)

Monitoring results for the 2018-2019 Annual Environmental Report (AER) provided under the current licence conditions, demonstrates groundwater mounding surrounding TSF1-4, whereby monitoring bores HBM3, HBM4 and HBM9 (Figure 4) breached the licence limit (groundwater to remain >4m bgl) on four instances in 2018 (Figure 5). Rockwater (2020) also indicated that HMB2, 13-16, 18, 19, 23, 24, 26 and 27 (which are not currently DWER compliance bores), had water levels shallower than the DWER trigger level of 4m bg when measured in May 2020. HMB26 was measured with the shallowest standing water level of 1.2mbgl.
