Application for Licence Amendment

Licence Number	L9247/2020/1
Licence Holder	Beacon Mining Pty Ltd
ACN	603 853 916
File Number	DER2020/000120
Premises	Jaurdi Gold Project Mining tenements: M16/115, M16/529, M16/34, L16/120, M16/365 and part of M16/204 SHIRE OF COOLGARDIE WA As defined by the Premises maps in Schedule 1 attached to the Revised Licence
Date of Report	19/10/2023
Decision	Revised licence granted

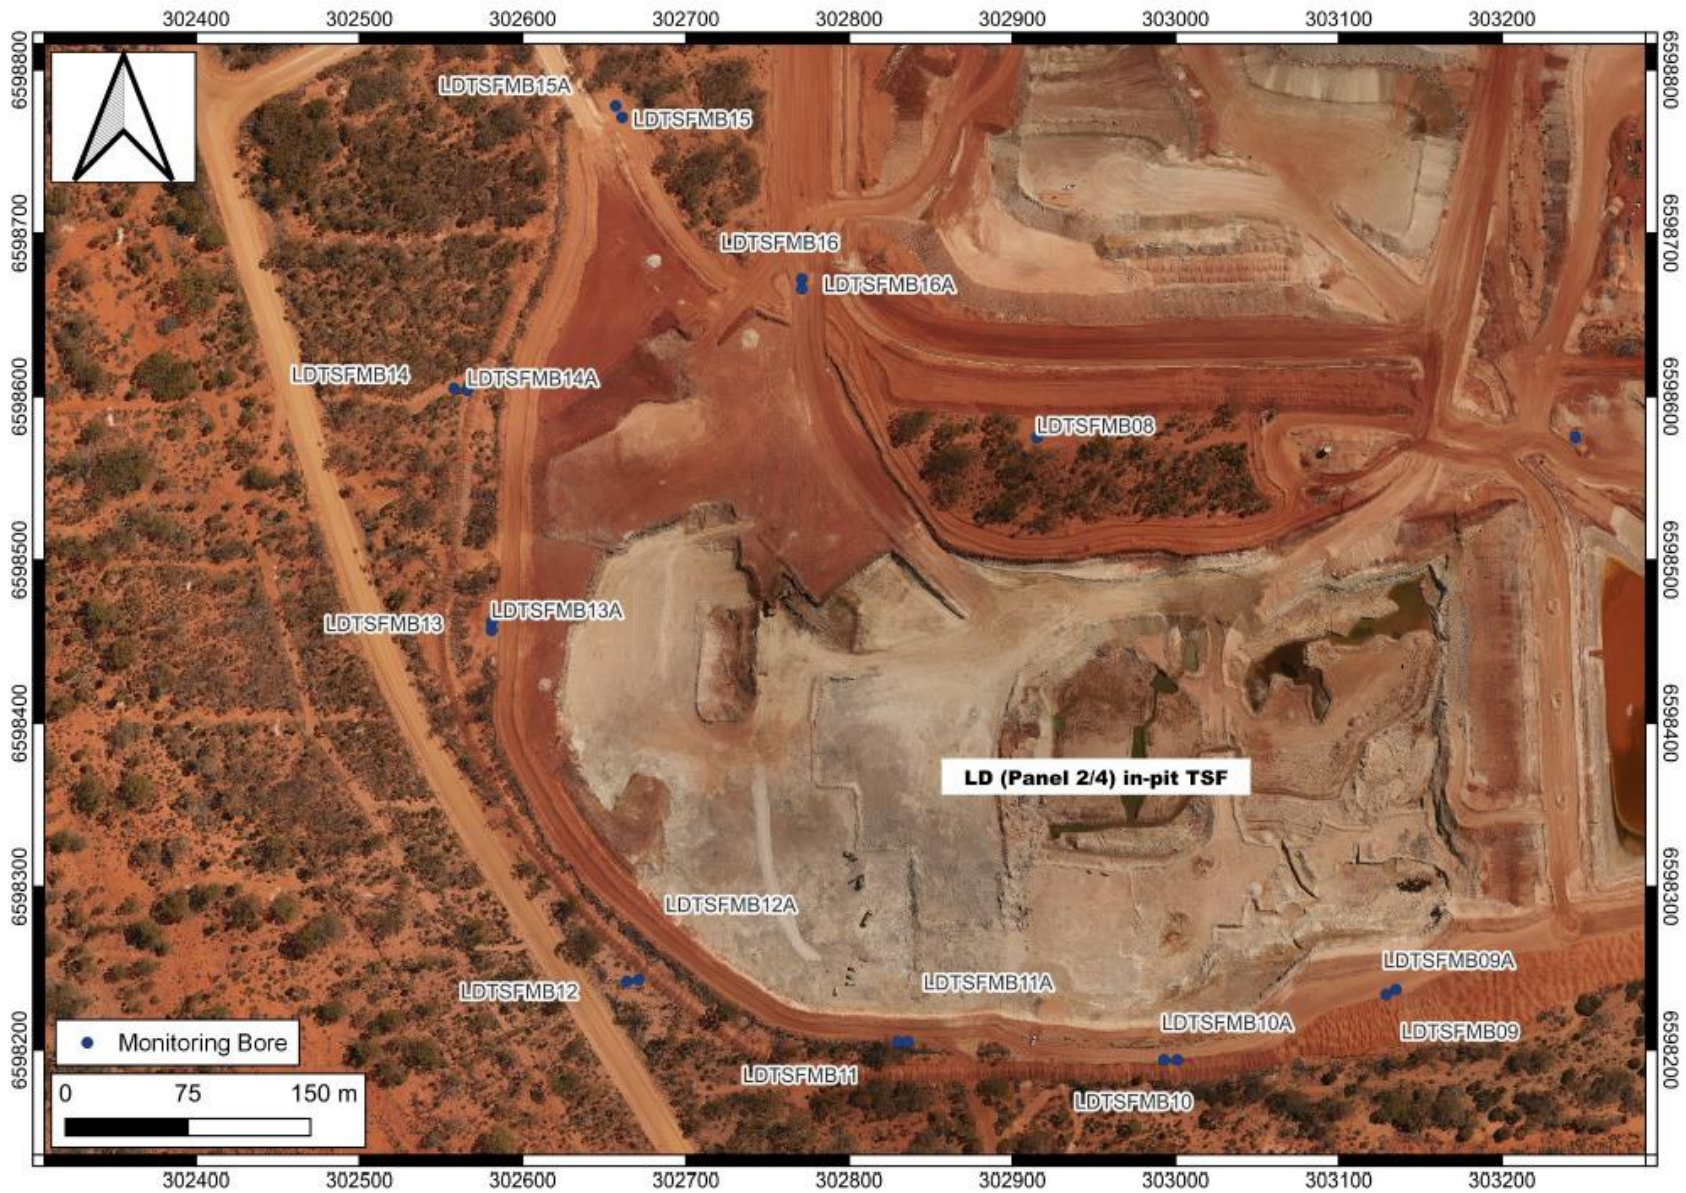
Figure 1: Lost Dog in-pit TSF (Panel 2/4) monitoring bore

A network of 8 monitoring bores is located along the perimeter of the TSF which also has the capacity to act as recovery bores if required. An additional 8 shallow monitoring bores also have been established to act as monitoring bores only (Figure 1).

A baseline groundwater analysis has been completed for the LDTSF24 monitoring bores which have been installed around the perimeter of the facility. Groundwater around the project area is considered saline. Underlying groundwater at the TSF area has recorded a total dissolved solids (TDS) concentration of between 43,000 and 68,000 mg/L. The main use of this groundwater is for mining purposes such as onsite processing activities and for dust suppression. Current groundwater standing water levels around the TSF range between 17.82 meters below ground level (mbgl) (bore LDTSFMB13) and 24.45mbgl (bore LDTSFMB13) (Figure 1).
