# **Amendment Report**

# **Application for Licence Amendment**

Licence Number L9259/2020/1

Premises Bellevue Gold Project

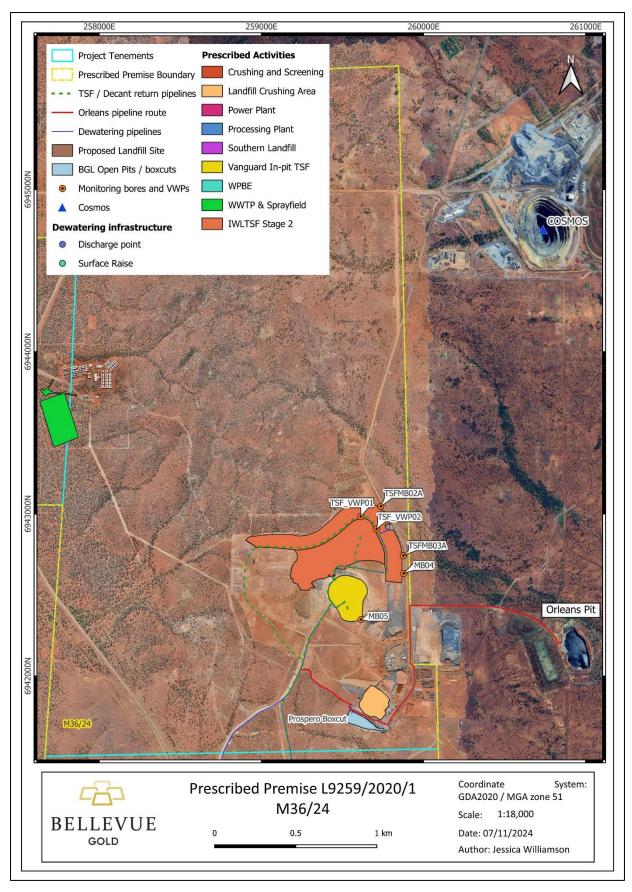
Figure 1: IWLTSF Stage 1 (Vanguard in-pit TSF) and Stage 2, as well as associated monitoring bores

- Dividing Stage 3 (RL 484.5 m) IWLTSF embankments (which involved combining both the Stage 1 in-pit TSF and Stage 2 WSD) into two halves: north and south. The northern half was now designated as Stage 2 (replacing the WSD and original Stage 2 TSF - RL 482.5 m) and the southern half as Stage 3 (Figure 1); and

Works approval W6724/2022/1 further requires the installation of additional groundwater monitoring bores MB06, MB07, MB08, MB09, and MB10 as part of the IWLTSF Stage 3 works (Figure 1). The monitoring bores have not been installed at the time of this assessment.

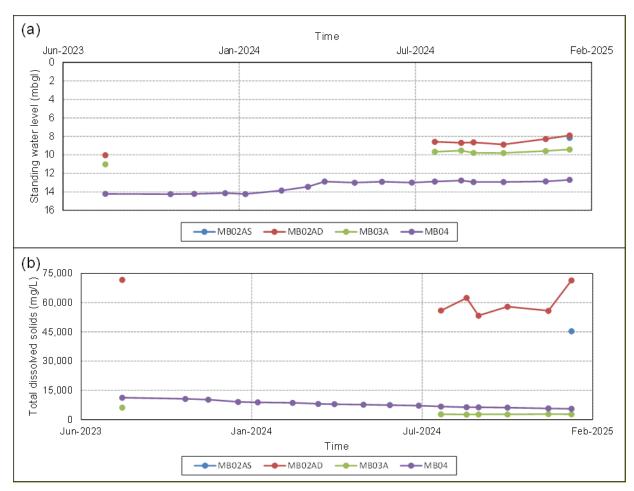
Figure 2: Ambient groundwater monitoring of (a) standing water level and (b) total dissolved solids during time limited operation of IWLTSF Stage 2

- Since August 2023, standing water levels have become shallower over time during time limited operation (Figure 2a). As of January 2025, standing water level in monitoring bore MB04 was the deepest, at 12.69 metres below ground level (mbgl), while the shallowest was measured in MB02A, at 7.9 mbgl.

- Notably, monitoring bore MB02AS was a shallow bore that remained dry throughout
  most of the monitoring period, until the latest monitoring event, where standing water
  level was measured at 8.16 mbgl in January 2025 (Figure 2a).

- Total dissolved solids (TDS) have varied significantly between monitoring locations (Figure 2b). Monitoring bore MB02D was highly saline, ranging between 53,300 mg/L and 71,700 mg/L, while MB04 was saline, ranging between 5,480 mg/L and 11,200 mg/L, and MB03A being brackish-saline, ranging between 2,570 mg/L and 6,130 mg/L. Notably, TDS levels were shown to decrease over time at both MB03A and MB04.

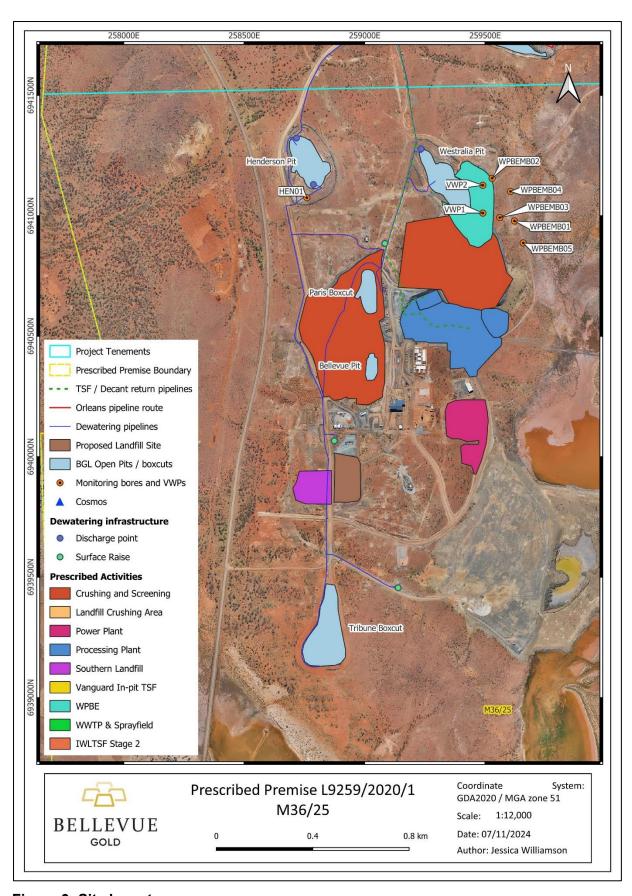
Figure 3: Site layout

Currently, the licence holder dewaters the Bellevue underground mine to maintain dry working conditions. The mine dewater is discharged into the Westralia and Henderson pit voids (which are authorised discharge points on the existing licence) (Figure 3).

To address future landfilling needs, the licence holder has proposed to construct a third landfill location at the premises (Figure 3). The proposed Tribune Landfill will be located across the road from the South Landfill was seen as a more favourable location due to being more discreet and less visible from both the premises entrance and the nearby highway.

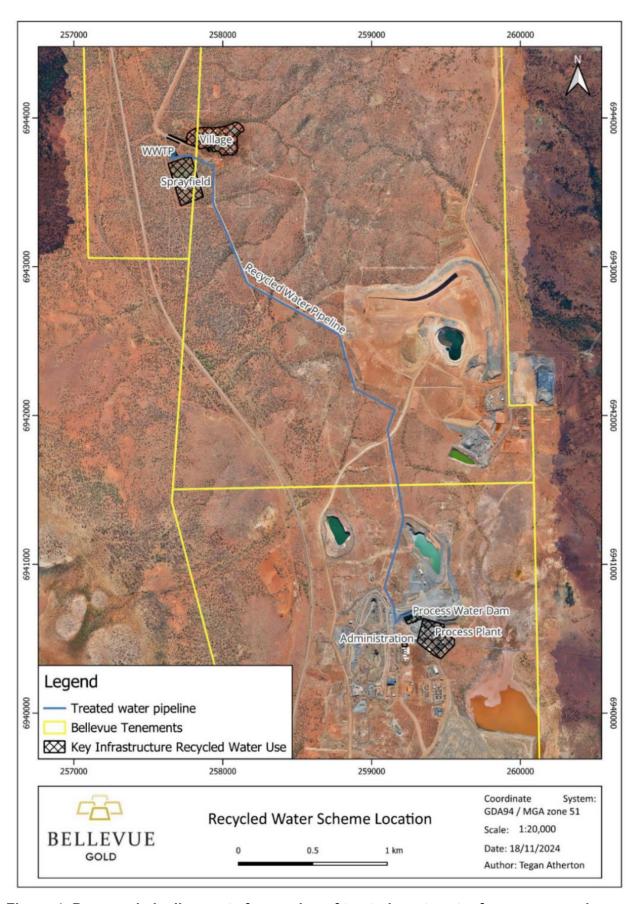
Figure 4: Proposed pipeline route for reusing of treated wastewater for ore processing

In addition, a 63 mm-diameter HDPE pipeline will be installed aboveground from the wastewater treatment plant to the processing plant, within an existing pipeline corridor (Figure 4). Once operational, the pipeline will send treated wastewater to the processing plant.

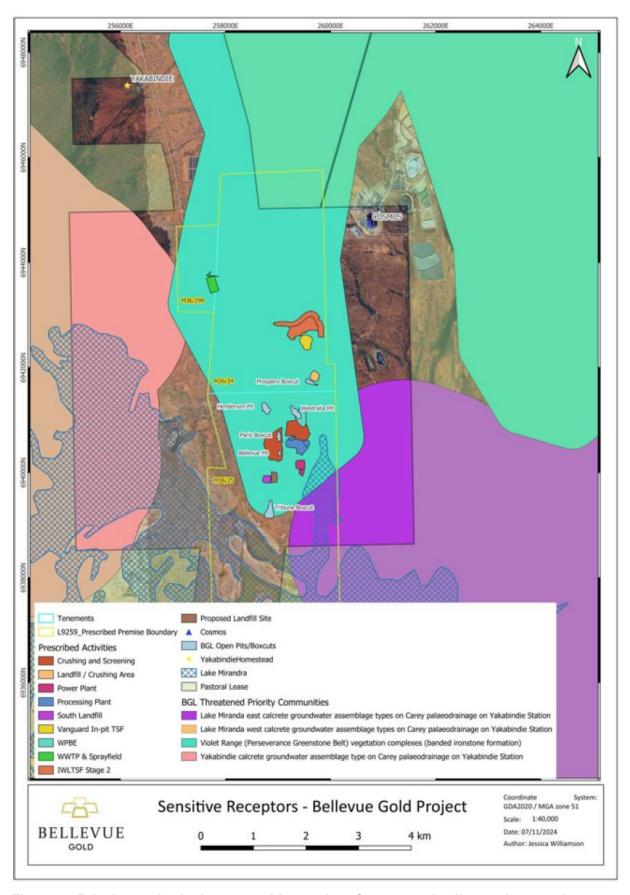
Figure 5: Priority ecological communities and surface water bodies at the premises

Human receptors	Distance from prescribed activity					
None	N/A					
Environmental receptors	Distance from prescribed activity					
Native vegetation	The premises is located within the Austin Botanical District, typified by Mulga ( <i>Acacia aneura</i> ) woodplains on the plains, scrub and shrublands on hills and rises, Mulga and <i>Eremophila</i> shrublands on stony plains, and chenopod communities on duplex soils.					
	Two detailed flora surveys undertaken across 2,428.4 hectares across the premises' surrounds identified a total of 345 vascular flora species across 19 vegetation communities.					
	Based on aerial imagery, native vegetation is present throughout the premises and abuts key infrastructure for the proposed activities, though their condition is likely degraded to some extent due to historic mining activities.					
Priority ecological communities	The premises is located within a Priority 1 'Violet Range (Perseverance Greenstone Belt) vegetation complexes (banded ironstone formation', which overlaps with the proposed activities (e.g., processing plant, IWLTSF Stage 2, Henderson Pit, Westralia Pit, treated wastewater pipeline, etc) (Figure 5).

Lake Miranda is a salt lake with periodic inundation driven by seasonal rainfall events. A portion of the Lake Miranda floodplain is overlaps with the south-eastern portion of the premises, primarily where the historic TSF is located.					
	Lake Miranda is located downstream of the premises at approximately (Figure 5):					
	350 m east of the processing plant;

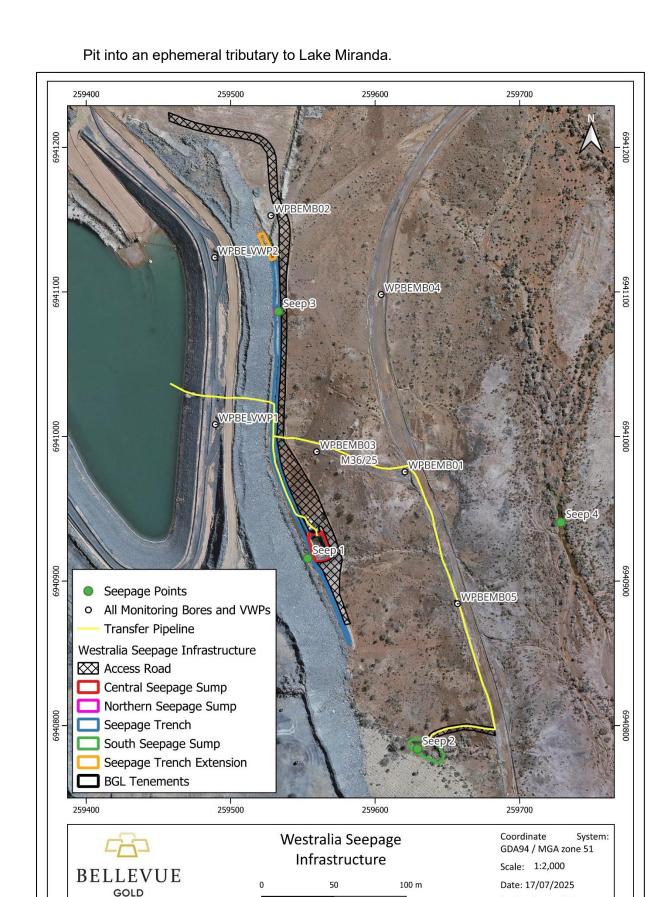
Figure 7: Location of seepage zones and seepage management infrastructure

In addition to the seepage zone identified in July 2024 (referred to as Seep 1), the licence holder has since identified three additional seepage zones along the eastern boundary of Westralia Pit (Figure 7), including:

- **Seep 2** Seepage originating from the base of the Westralia Waste Rock Dump, located south of the initial seepage zone (Seep 1);
- Seep 3 Seepage originating from the base of the WPBE wall, north of the initial seepage zone (Seep 1); and
- Seep 4 Surface expression of groundwater approximately 200 m east of the Westralia

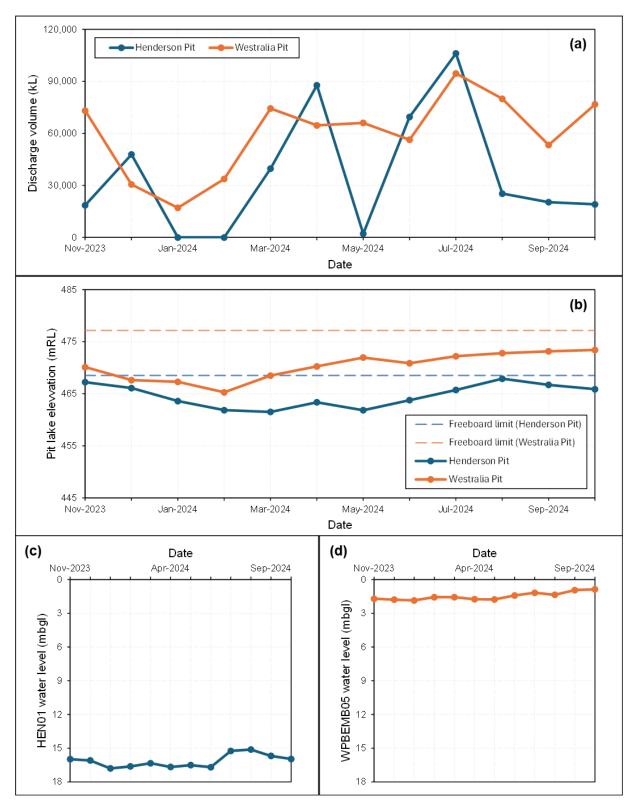
Figure 8: (a) Discharge volume, (b) Pit level elevation, (c) and (d) groundwater level at Henderson Pit and Westralia Pit for the 2023/2024 annual period

Pit fluctuates more significantly compared to Westralia Pit on a monthly basis (Figure 8a).

Typically, monthly discharge to Westralia Pit is higher compared to Henderson Pit, annual total discharge volume and monthly average discharge volume of the 2023/2024 annual period being higher at Westralia Pit. The highest monthly volume discharged to Westralia Pit was in July 2024 (i.e., 94,545 kL) (Figure 8a), which coincided with detection of seepage at the berm.

In order to ensure a minimum freeboard of 1.5 m is maintained, existing licence L9259/2020/1 specified a pit lake elevation limit of 468.5 mAHD and 477.15 mAHD for the Henderson pit and Westralia pit, respectively. Based on the most recent pit standing water level monitoring event in October 2024, neither of the pit lakes have exceeded this limit, with Henderson Pit lake level at 465.9 mAHD (i.e., 2.62 m allowance) and Westralia Pit lake level at 473.4 mAHD (i.e., 3.73 m allowance) (Figure 8b).

Groundwater monitoring bore associated with each pit showed that the standing water level at monitoring bore HEN01 near the Henderson pit fluctuated between 15 mbgl and 17 mbgl during the 2023/2024 annual period (Figure 8c). On the other hand, the monitoring bore associated with Westralia Pit (WPBEMB01) was had consistently remaining shallower than 2.0 mbgl for the entirety of the 2023/2024 annual period, with gradual signs of further shallowing towards the end of the annual period (Figure 8d). The shallowing effect was evident since June 2024, which corresponds to the increase in pit level observed. The licence holder has also indicated that the increase observed at monitoring bore WPBEMB01 was likely caused by rising pit water levels
