Application for Licence Amendment

Licence Number	L9273/2020/2
Licence Holder	Water Corporation
File Number	APP-0026949
Premises	Mount Barker Water Resource Recovery Facility and Mount Barker Woodlot Bunker Street and 47 Omrah Road MOUNT BARKER WA 6324

Date of Report	26/05/2026
Proposed Decision	Revised licence granted

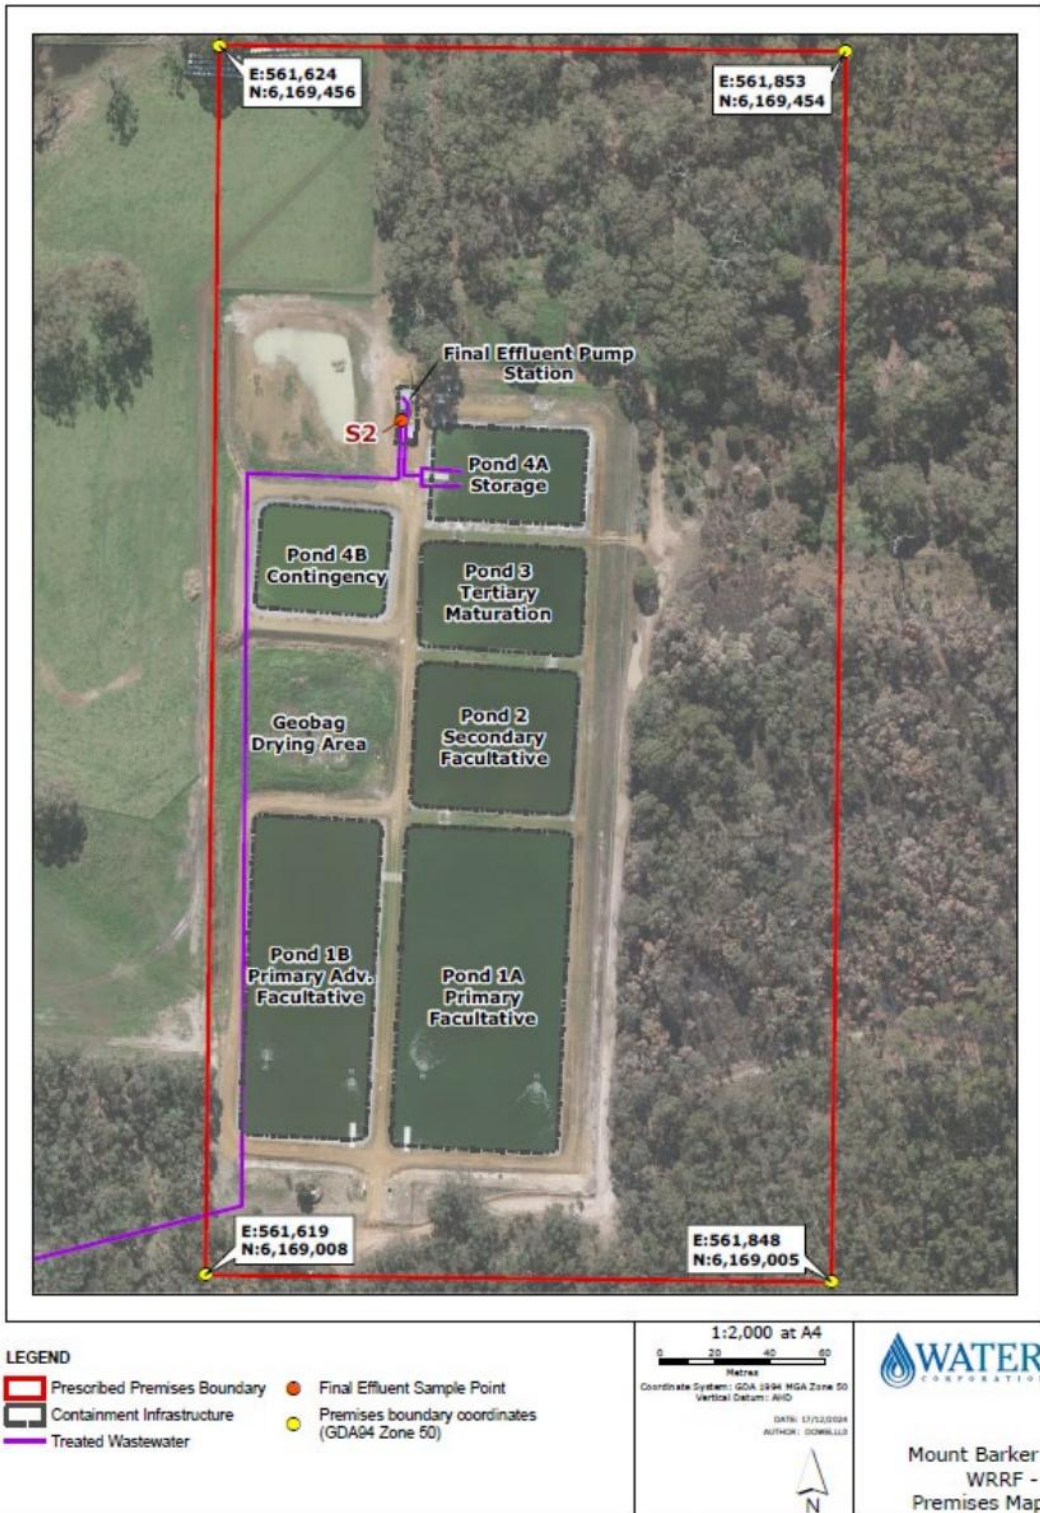
Figure 2: Current premises boundary of the WRRF

The WRRF operates to treat sewage from the local area, with an assessed design capacity of 1,280 cubic metres per day. The facility consists of several treatment ponds, and is depicted in Figure 2. Treated wastewater is pumped from the WRRF to the woodlot via a 5 km long main. The treated wastewater is stored in Dam 1 at the woodlot prior to irrigation via a surface drip irrigation system. Dam 1 has a storage capacity of 51.9 ML. Dam 2 at the woodlot is used for contingency storage, with a capacity of 34.7 ML. The dams were existing when Water Corporation purchased the woodlot, however Water Corporation have refurbished the dams, diverted the external catchments and upgraded the spillway for Dam 1. The dams are depicted in Figure 1. The location of the woodlot relative to the WRRF is depicted in Figure 3. Figure 3 depicts an unlined open channel, however the licence holder advised during assessment of works approval W6771/2023/1 that this channel is no longer in use, and treated wastewater is pumped directly from the WRRF to Dam 1 via a pressure main.

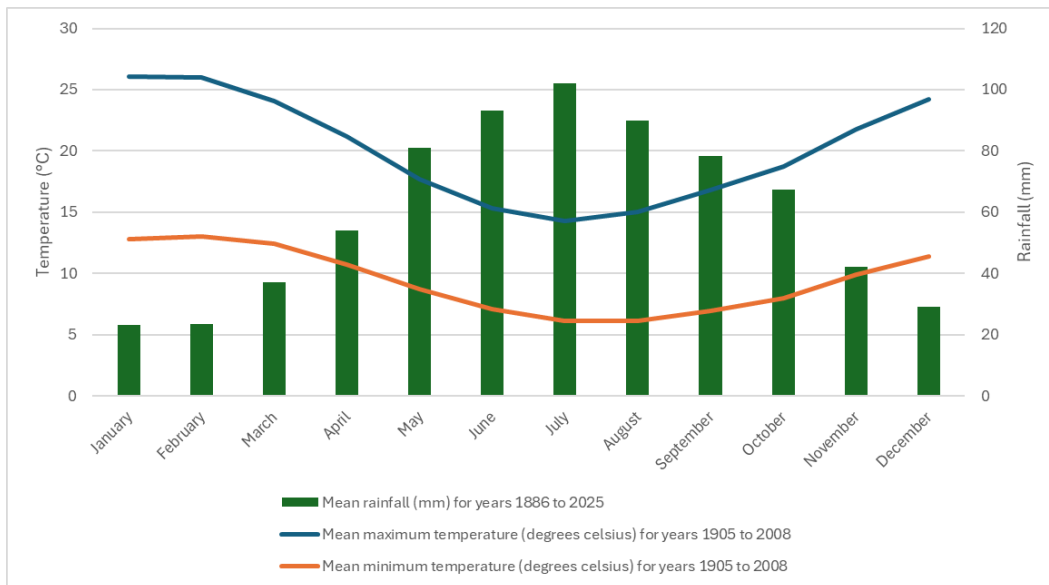
Figure 4: Average rainfall, minimum and maximum temperatures at Mount Barker (from data from the Bureau of Meteorology)

Mount Barker experiences warm, dry summers and cool, wet winters. Average annual rainfall is about 720 mm, with the wettest months being June to August. The driest months are January and February (BoM n.d.).

Average monthly maximum and minimum temperatures, as well as average rainfall for Mount Barker are shown below, and average monthly evaporation rates in Figure 5, using data from the Bureau of Meteorology’s website (BoM n.d.).

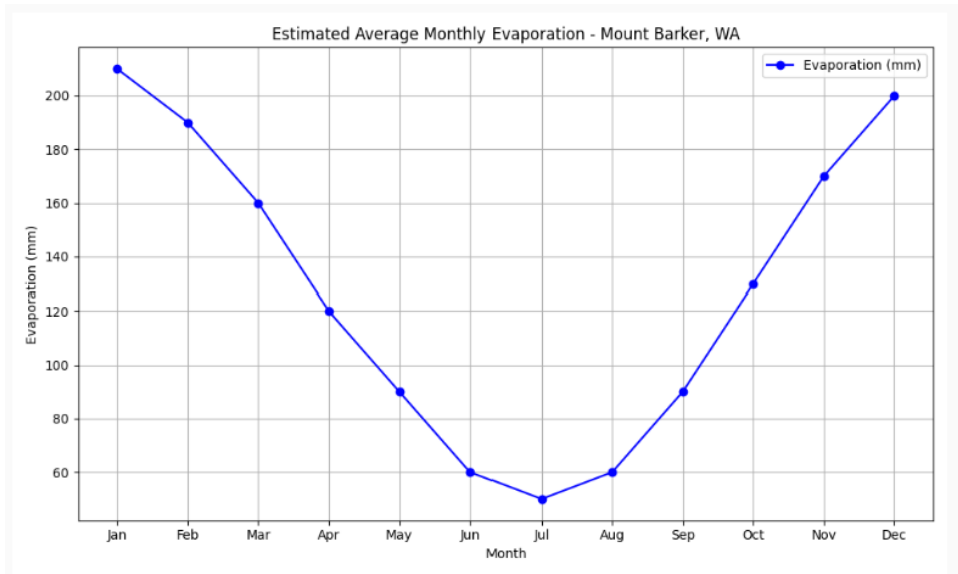
Figure 5: Average evaporation rates for Mount Barker (from data from the Bureau of Meteorology)

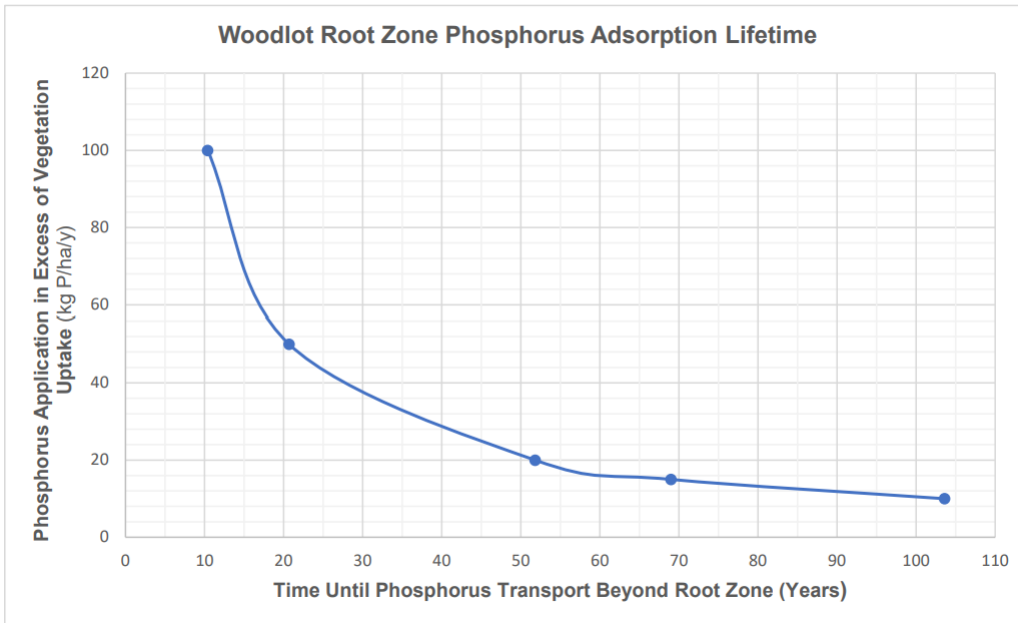
Figure 12: Indicative phosphorous adsorption lifetime for phosphorus applied in excess of vegetation uptake

A comprehensive soil assessment was undertaken by a consultant in 2017. Soil samples were reported to have high phosphorous retention ability. Predicted phosphorus retention was calculated for a 22-hectare area. Figure 12 demonstrates that an irrigation area of 22 hectares is anticipated to retain phosphorus continuously applied at a rate of 15 kg P/ha/y for approximately 70 years before there will be meaningful transport beyond the two-metre root zone of the woodlot.
