Application for Works Approval

Works Approval Number W2910/2025/1

Premises Mt Morgans Gold Project
Part of mining tenements: M39/236, M39/272, M39/282,
M39/395 and M39/1107
LAVERTON WA 6440
as depicted in Schedule 1 and the coordinates in Schedule 2
of the works approval.

Date of report 10 September 2025

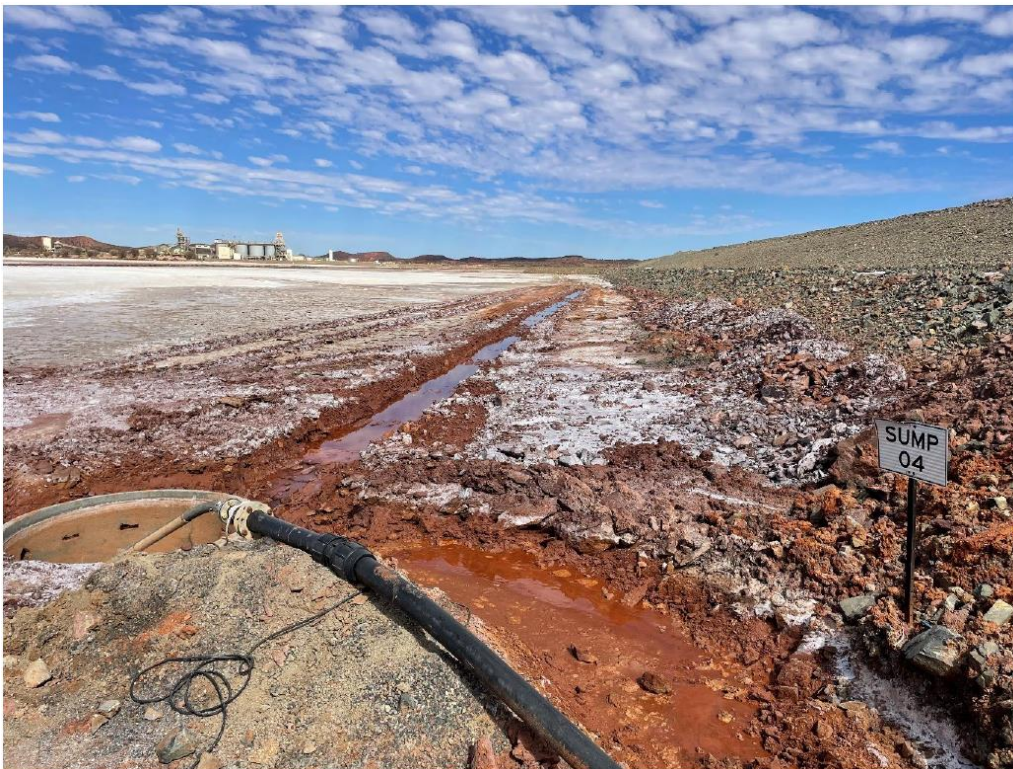
Figure 6: Interception trench and sump (SP4) (Sourced from GRM 2024)

Conditioned in licence L9010/2016/1 seepage recovered from the TSF is required to be either returned to the TSF or re-used in the processing plant. The TSF was designed to incorporate an underdrainage system within both cells 1 and 2. The underdrainage system involved a 1.5 mbgl (or until refusal on weather rock) cutoff lined trenches under the upstream toe to restrict potential seepage under the perimeter embankment. The trench led to seepage collection sumps (SP01-SP07) surrounding the TSF (Figure 6). The sumps consist of a 1.5 x 1.5 x 1.5 m lined concrete box (Dacian 2019) or a 1.8 m x 1.8 m diameter concrete well with a 0.15 m precast concrete slab (CMW 2024).

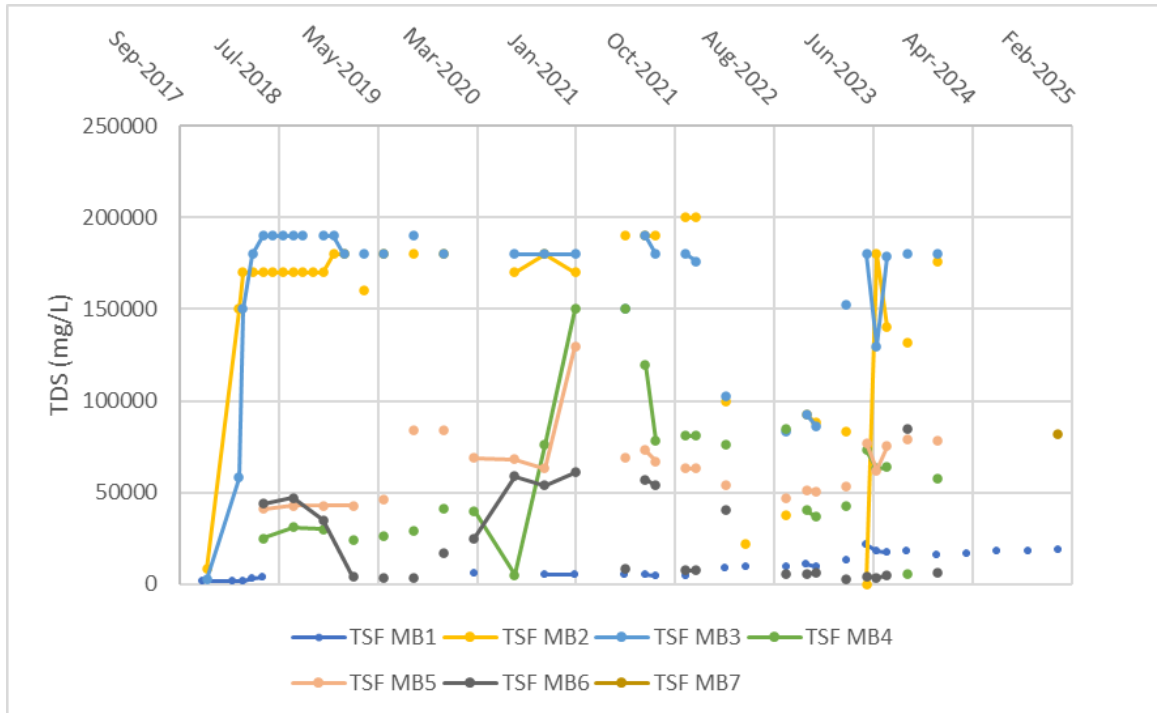
Figure 8: Historical TDS concentrations within monitoring bores surrounding the TSF

Groundwater surrounding the TSF is brackish to hypersaline water with total dissolved solids (TDS) concentrations ranging from 1,360 to 190,000 mg/L. The large variation is due to groundwater density effects where hypersaline playa water infiltrates the ground with a fresh groundwater lens situated on top of the hypersaline water (GML 2024). Figure 8 presents the historical TDS concentrations recorded within monitoring bores surrounding the TSF. Results indicate that most monitoring bores have shown an increase in TDS concentrations over the life of the TSF with the highest concentrations reported in monitoring bores TSF MB2 and TSF MB3 located at the southwest and southern side of the TSF respectively. It's noted that these are located close to or within the playa and generally has the shallowest groundwater and is where groundwater expression occurs the most often when compared to other areas of the TSF.

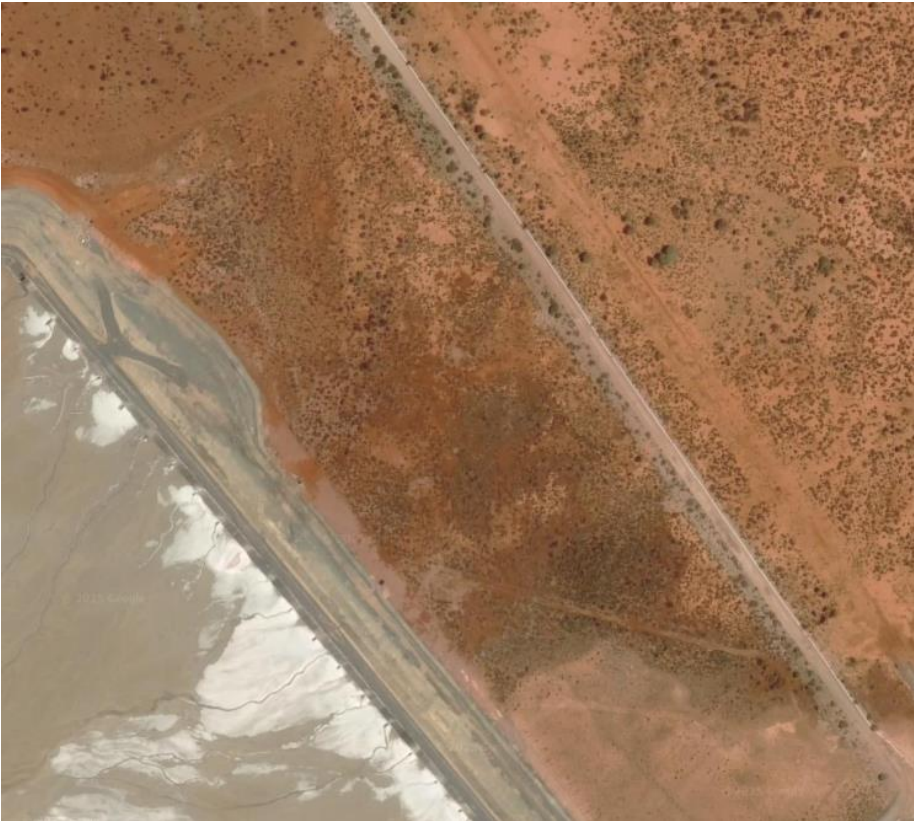
Figure 14: Historical aerial imagery of vegetation northeast of the TSF taken on 17 January 2021 (Sourced from Google Earth 2025).

The department reviewed satellite imagery in the same quadrant (QNE) and historical imagery (Figure 14 and Figure 15) indicates further salt deposition may have taken place after 2020 resulting in potential further vegetation loss. Estimated total vegetation cover in the area has decreased further from 2020 (Table 3) and identified the decrease in NDVI between 2023 to 2024 (east of the TSF) appears to occur where potential further salt deposition locations are located (Figure 12). Section 2.5.2 mentions that the recently installed seepage recovery bores may be able to prevent further vegetation loss in this area.

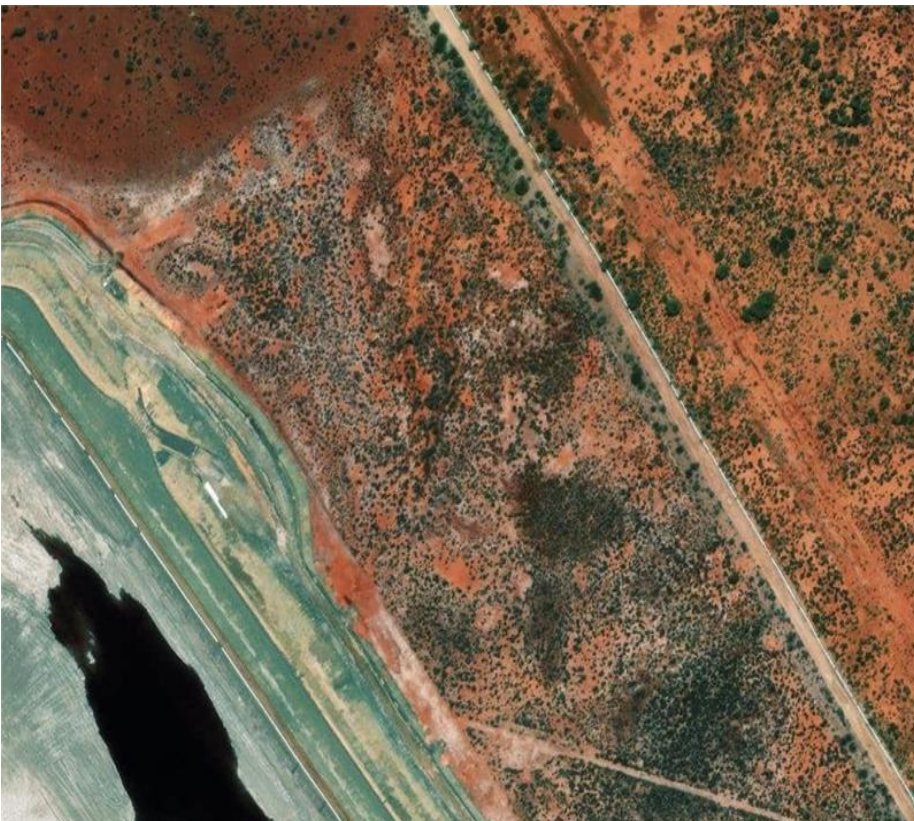
Figure 15: Historical aerial imagery of vegetation northeast of the TSF taken on 7 November 2024 (Sourced from Nearmaps 2025).
