## Application for works approval

**Works approval number** W6342/2020/1

**Applicant** Mt Magnet Gold Pty Ltd

**Premises** Mt Magnet Gold  
Mining tenements M58/121, M58/193 and M58/205  
MOUNT MAGNET WA 6638

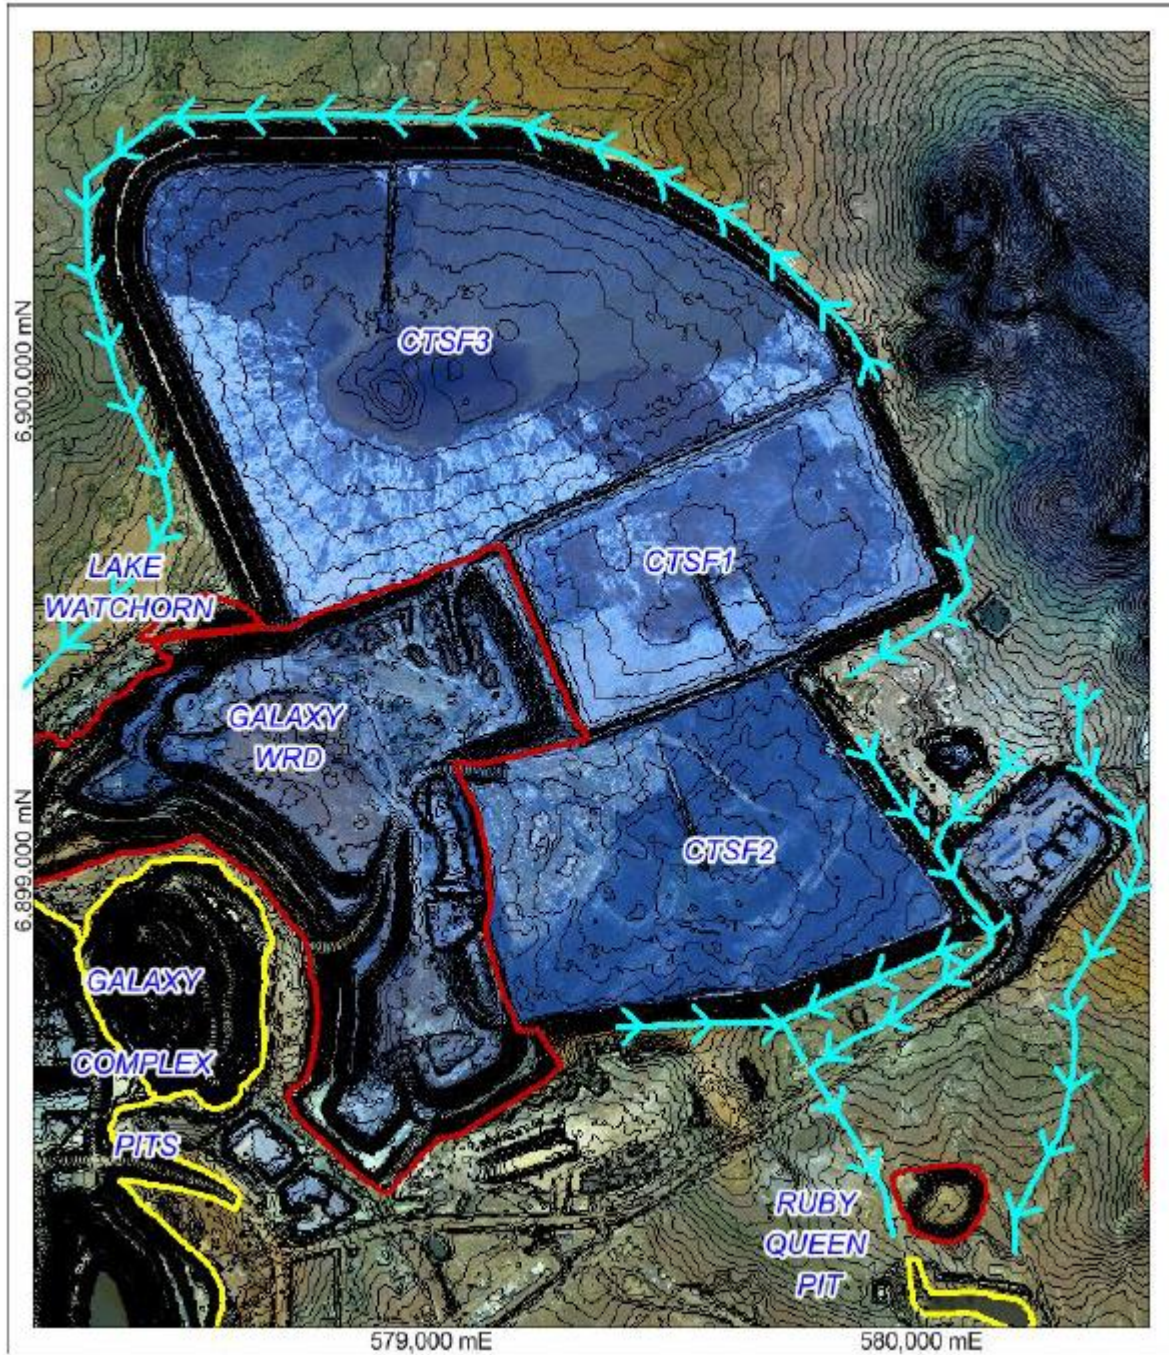
Figure 4 Stormwater drainage and topography

It is also noted in application documents that flow paths are contained by the Galaxy complex pits (Figure 4). A review of the application documentation by the department's Principal Hydrogeologist suggested not all seepage may be captured by pits, and that there is potential for dense, saline groundwater staying near the base of the regolith, flowing along an inclined bedrock surface by gravity.

Embankment raising will use dried tailings and mine waste (for downstream capping) sourced from the Galaxy mining area (Figure 4). Dried tailings are borrowed from within each CTSFs and are free of organic matter and other deleterious material, non-dispersive, with a fines content (passing 0.075 mm sieve) in excess of 33%. Waste rock used for embankment raises is geochemical and physical benign with no acid drainage or heavy metal contamination potential (MP83570, 2019).

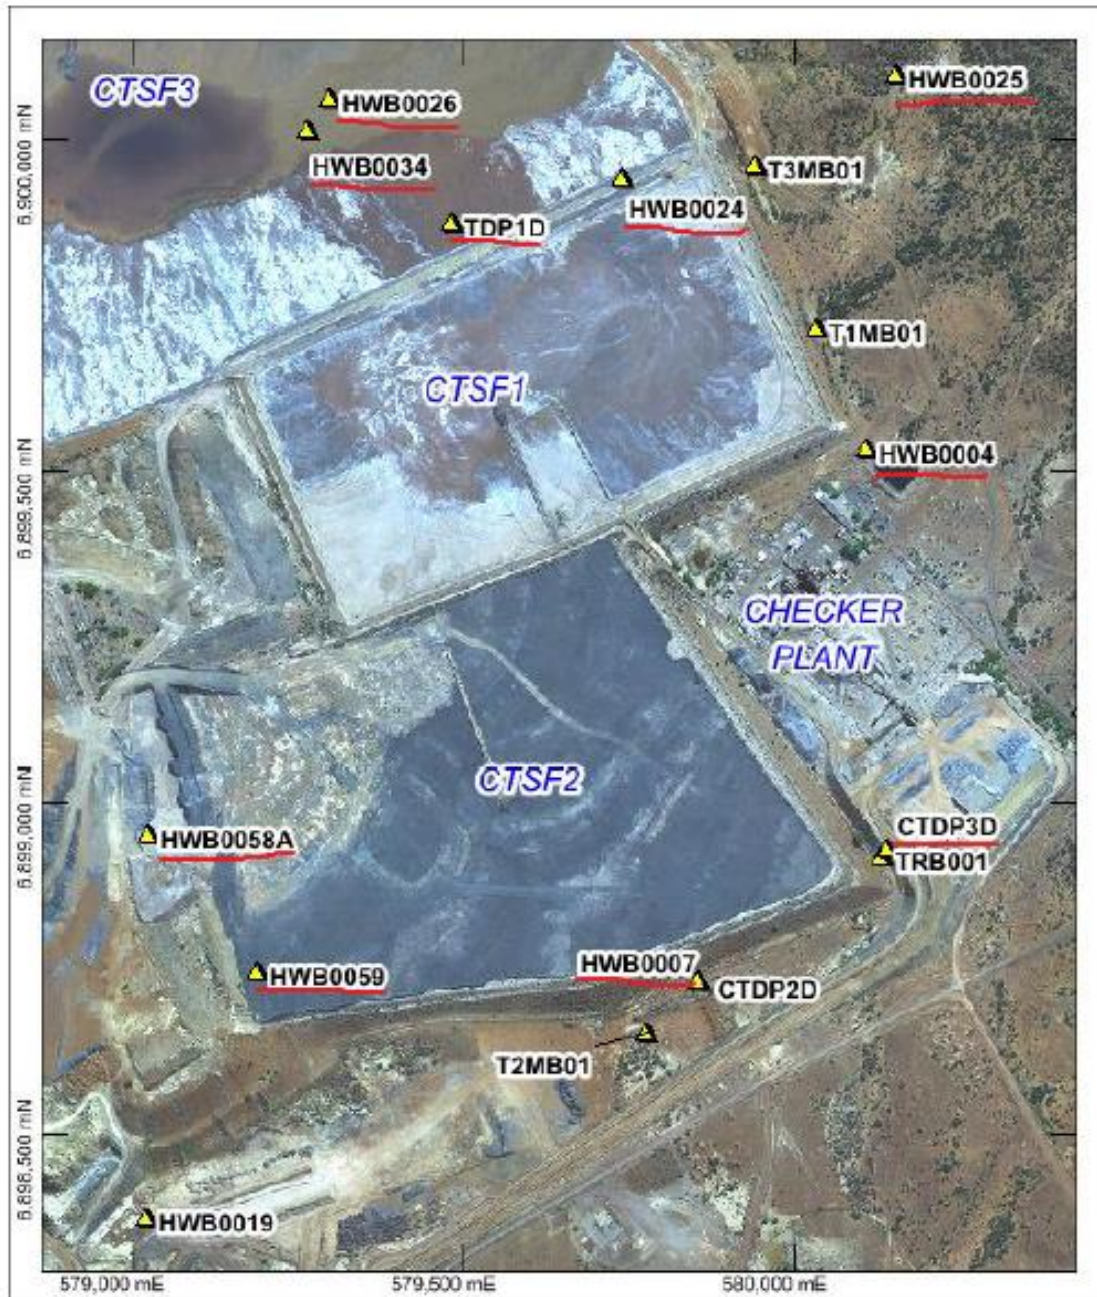
Current groundwater monitoring is focused on capturing impacts of operational CTSF3, and is less comprehensive for seepage impacts from historical use of CTSF1 and CTSF2. The applicant provided a map showing groundwater bores with relevant historic monitoring data available (Figure 5). Further correspondence (Correspondence 22 April 2020) confirmed the majority of these bores have been destroyed or are not operational anymore (Table 5), limiting the extent of the existing borefield for all CTSF's onsite.

Figure 5 Groundwater bores with relevant historical data available. Red underlined monitoring bores have been destroyed or are not operational anymore.

The applicant proposes to use 3 existing monitoring bores (HWB0019, T1MB01, T2MB01), which are not listed on the current licence (L5529/1998/12), to monitor for characteristics of tailings that may occur in seepage of TSF's. These monitoring bores were reinstated in October 2019 (Figure 5). Monitoring bore HWB007 was suggested by the applicant to have been reinstated (RFI 9 April 2020), however it appears this bore has been replaced with monitoring bore CTDP2D which is listed on the existing licence. Details about the monitoring bores which are not yet licensed under L5529/1998/12 are shown in Table 7.

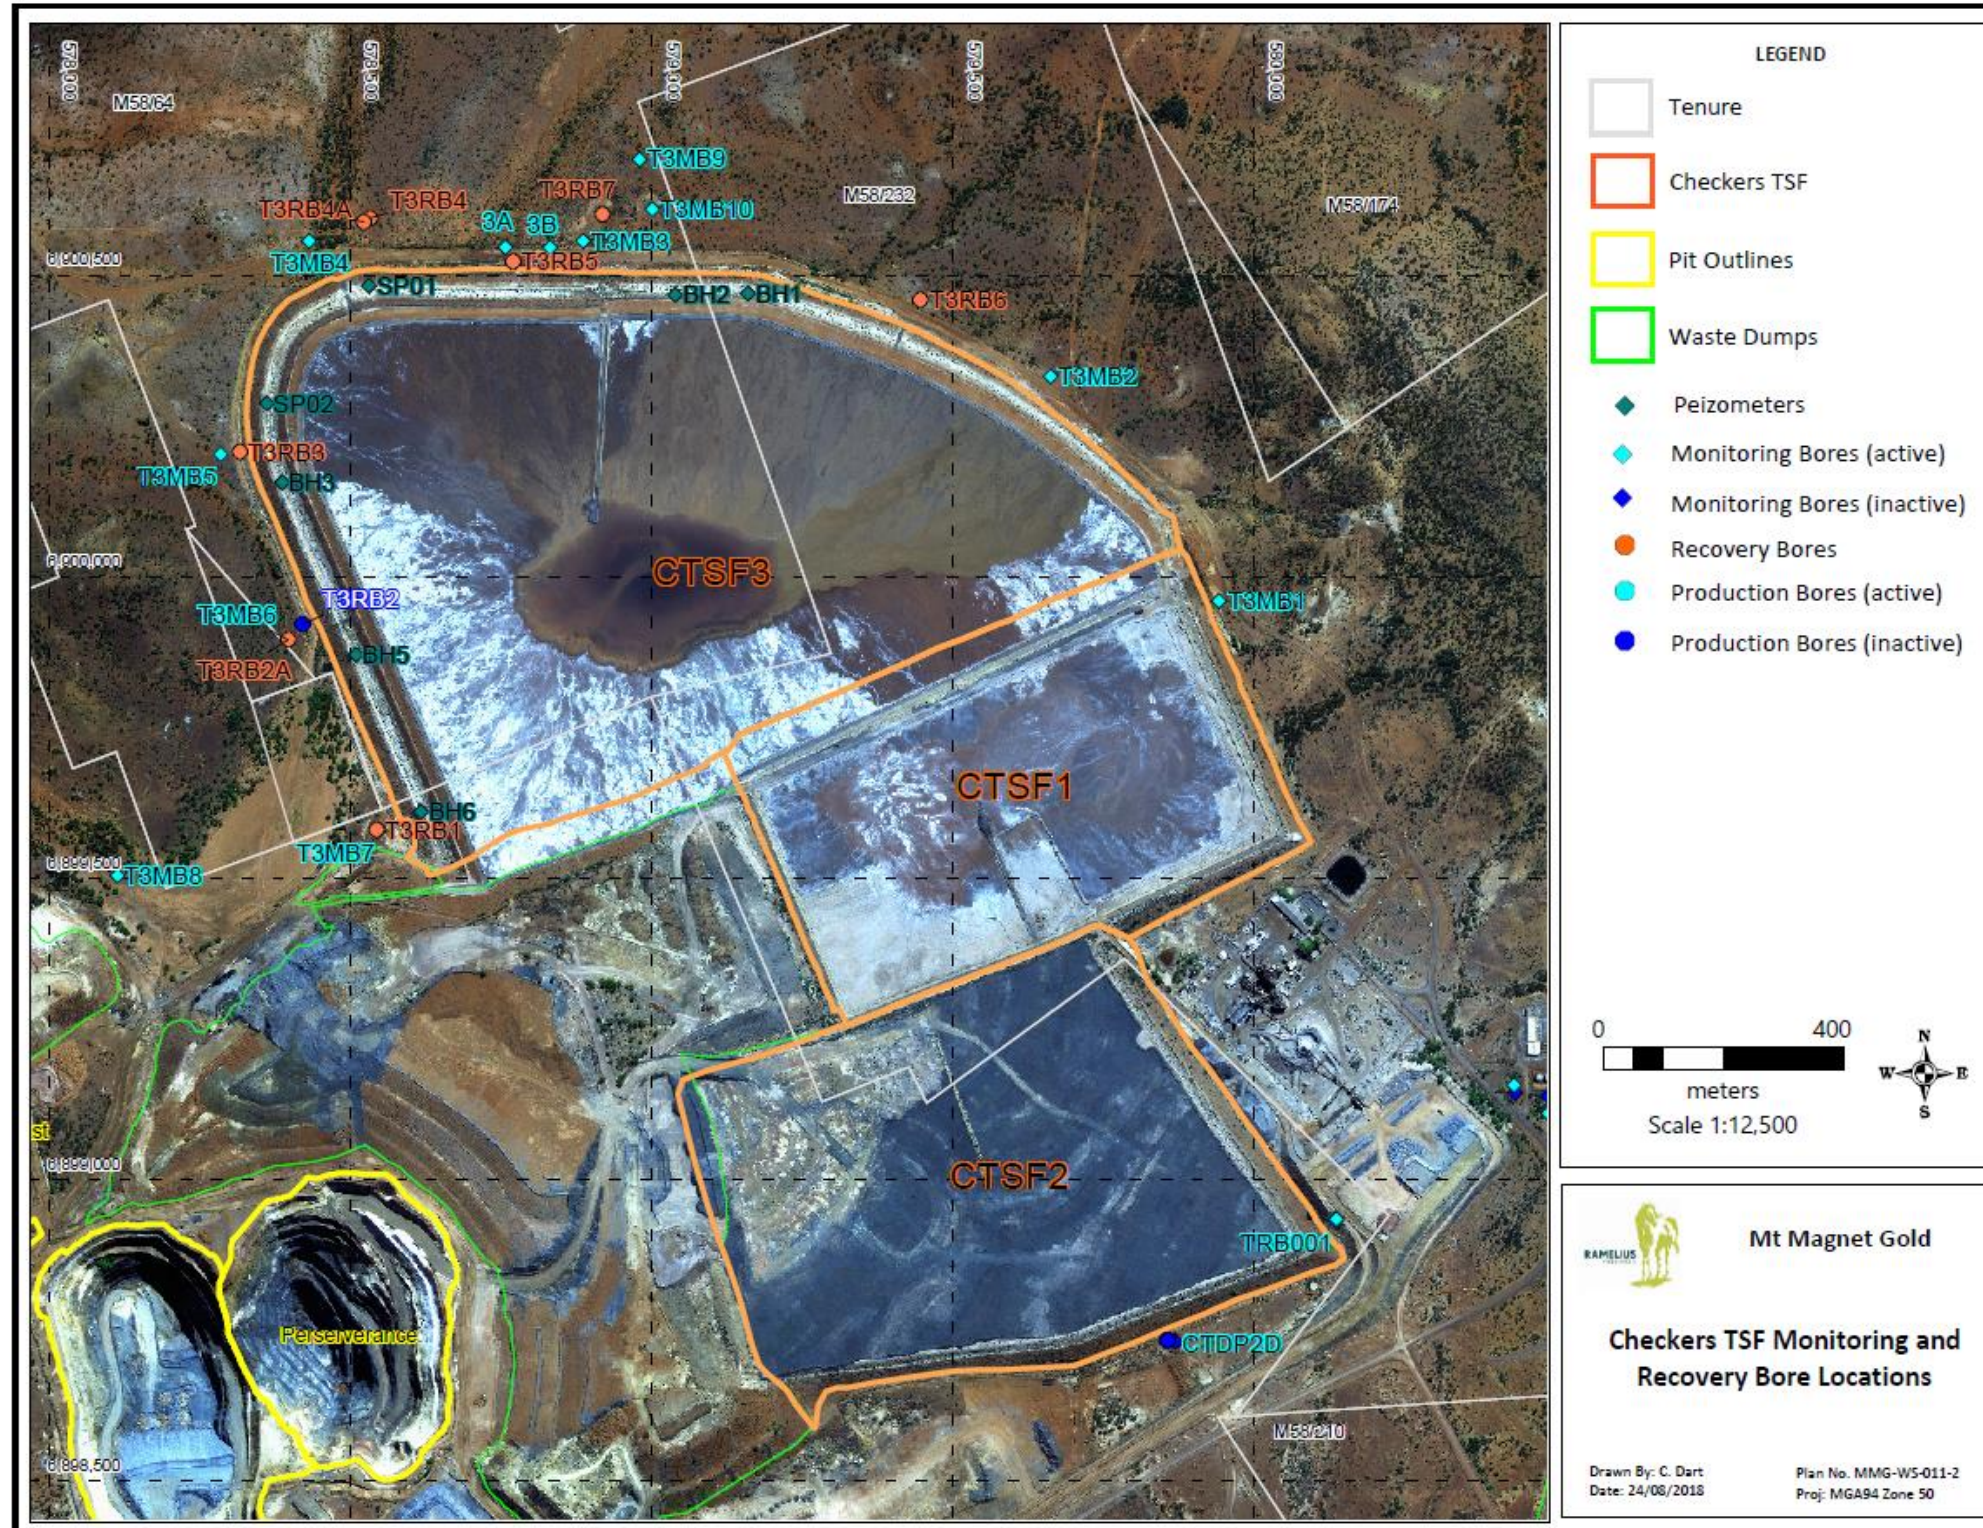
Figure 7 Monitoring and recovery bores at the premises

Other seepage management infrastructure consists of recovery bores, which are located on the western and northern side of CTSF3 (Figure 7). It should be noted that no record of recovery bore labelled on Figure 7 as T3RB5 is available and appears to not exist.

The Annual Environmental Report (AER, 2019) covering operations from 2018 - 2019 submitted to the department as required by the current licence L5529/1988/12, showed cyanide present in most CTSF3 monitoring bores (Figure 7). Any detectable cyanide, and TDS concentrations >10 000 mg/L in the groundwater is considered by the applicant to be from seepage, as set out in Table 6.

It should be noted that only two of the CTSF3 monitoring bores are located at the southern side, below the adjacent to CTSF3 located CTSF2. Therefore limited groundwater quality concentrations are available. The groundwater monitoring bores CTP2D and TRB001 south of CTSF2 both indicate impacts of seepage (Table 8), agreeing with findings in the Electromagnetic Survey discussed below. Findings from the Electromagnetic Survey were made available to the department during the assessment, which indicates extensive seepage at the southern side as described below.

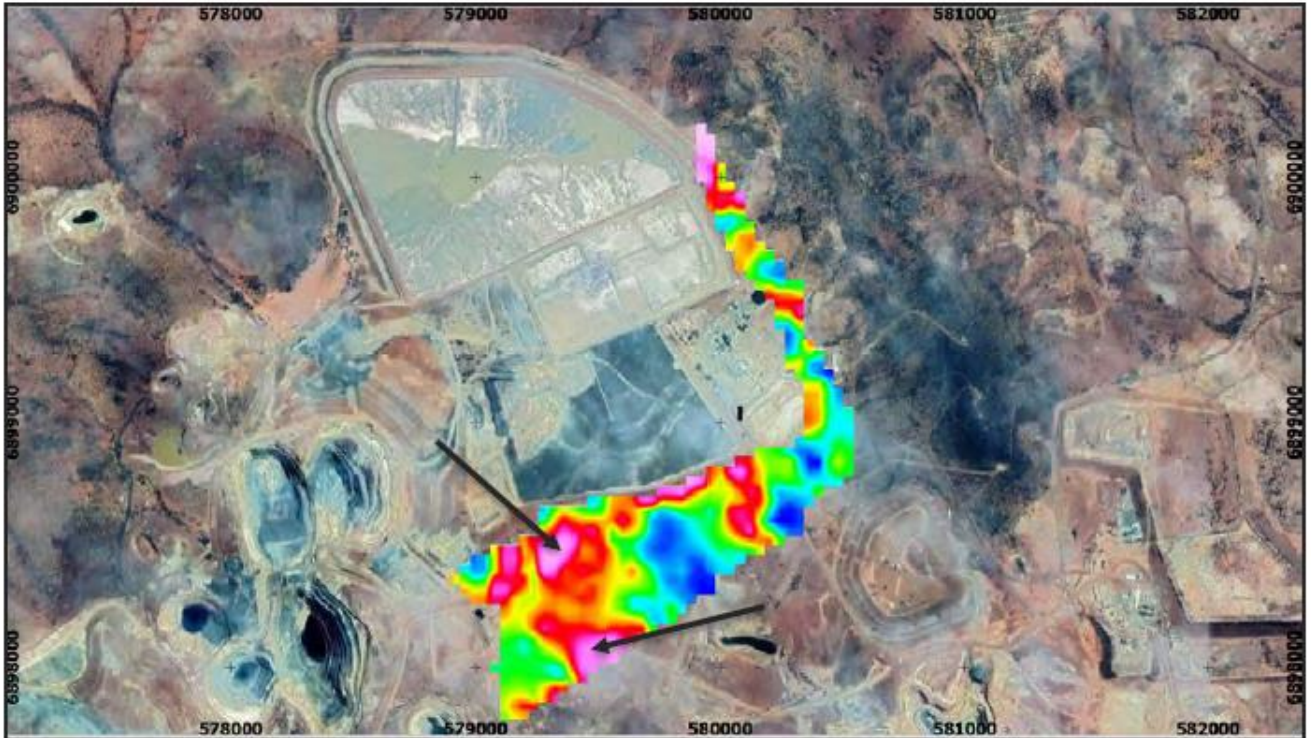
**Figure 8 Anomalous zones indicating seepage (NEWEXCO 2019)**

As part of further information requested by the department from the applicant, findings from an Electromagnetic Survey which was carried out 2019, were provided (NEWEXCO 2019). The study identified anomalies at the southern side of CTSF2 associated with increased salinity which appears to be sourced from tailings seepage as suggested in the report (Figure 8). The report compared findings to a survey undertaken in 2012 and concluded that the anomalies have formed in the past 7 years. The installation of recovery bores in those locations of suspected seepage were recommended by NEWEXCO. It should be noted that the applicant does not accept the interpretations and recommendations in the report as stated in further correspondence with the department (RFI 9 April 2020). However no evidence has been provided to the department to suggest otherwise and therefore the Delegated Officer considers the findings of the NEWEXCO report to be valid.

Data from the few groundwater monitoring bores (T3MB1, CTP2D and TRB001) located within the area identified in the NEWEXCO report (Figure 8), agree with suggestions of seepage occurring. A review of the provided data by the department's Principal Hydrogeologist confirmed the necessity of seepage recovery and further investigation of the saline groundwater plumes discharging from the southern wall of CTSF2.
