Licence Amendment Application

Proposed Solid Waste Depot

Lot 821 and Aprt of Lot 802(501) Alexander Drive, Mirrabooka WA 6061

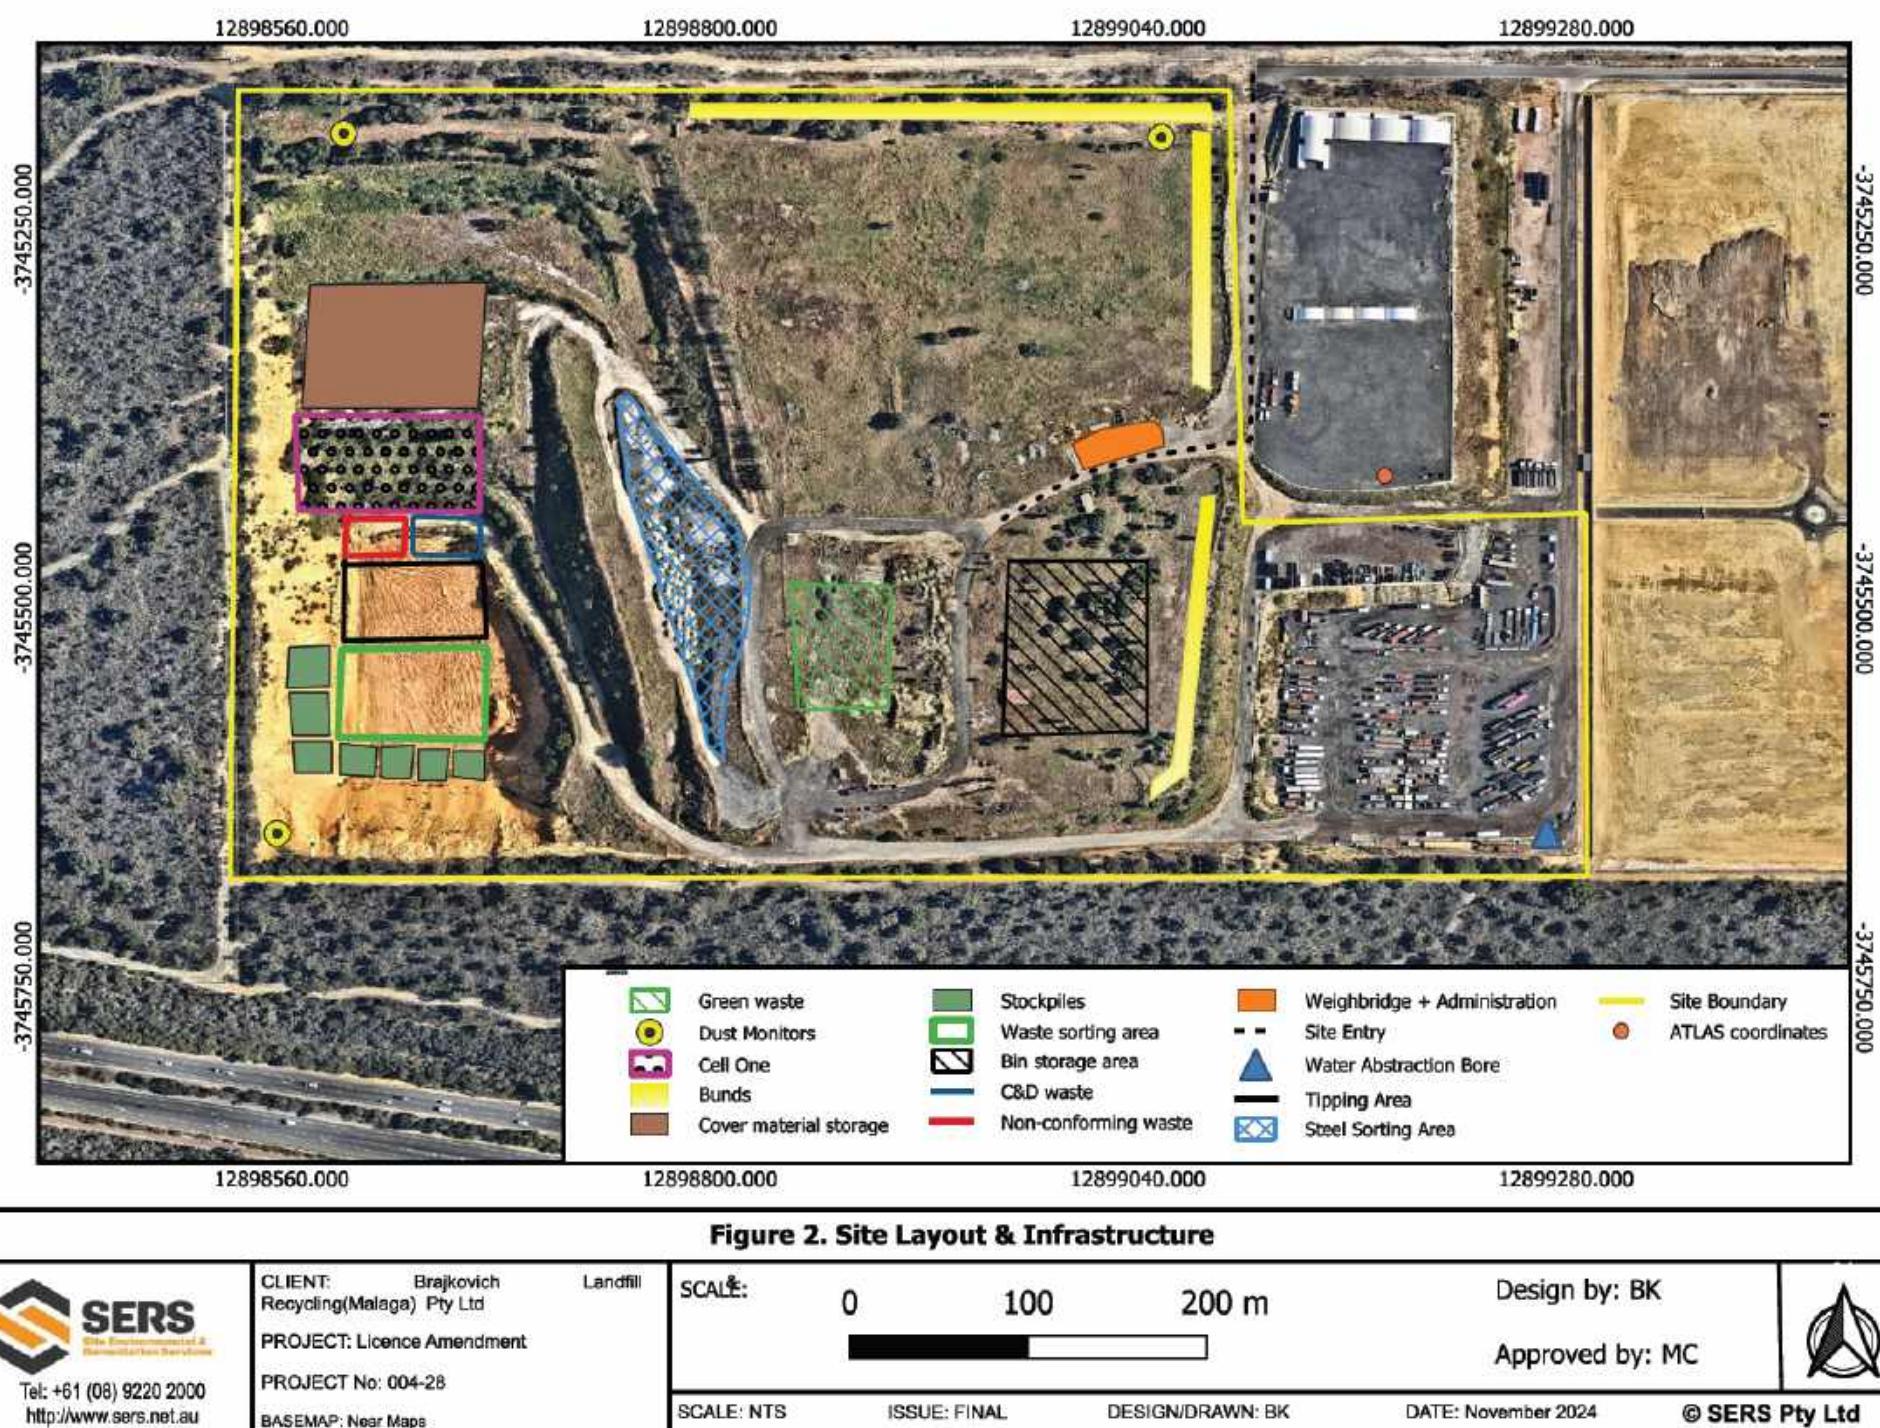
Figure 2- Site Layout & Infrastructure

Operation of proposed Solid Waste Depot will be restricted to area as outlined within **Figure 2**- **Site Layout & Infrastructure**. Site entry is proposed off Victoria Road, northeast corner of the Site. There is currently an accessible driveway suitable for Vehicles, which will be utilised in Site access and egress. All vehicles carrying waste will be required to go through an installed weighbridge. Vehicles will use designated roads on site for ingress and egress.

Vehicles carrying waste will be directed to the waste sorting area on the central western portion of the site, where waste will be deposited into tipping area (*refer* Figure 2 Site Layout & Infrastructure for details). Waste deposited into the tipping area will be taken to southwest area of the site for further processing such as mechanical sorting. The Southwest area has been proposed for sorting and storage of waste material due to its depth in comparison to other parts of the site. This area will be filled to a level of approximately 70mAHD on expiration or early termination of current lease.

The Middle portion of the site will be utilised as a steel sorting area. The structure on the central-east portion of the site is intended to be utilised as an administration office and amenity block for site staff. Equipment to be utilised as part of the site operations are inclusive of the following:

Site operation and layout have been displayed within Figure 2 Site Layout & Infrastructure.

Operations are proposed to take place in locations as outlined within Figure 2- Site Layout and Infrastructure.

The proposed operations are to be contained within the Site boundary (Figure 2. Site Layout and Infrastructure). A summary of the Site details is listed below in Table 3-3.

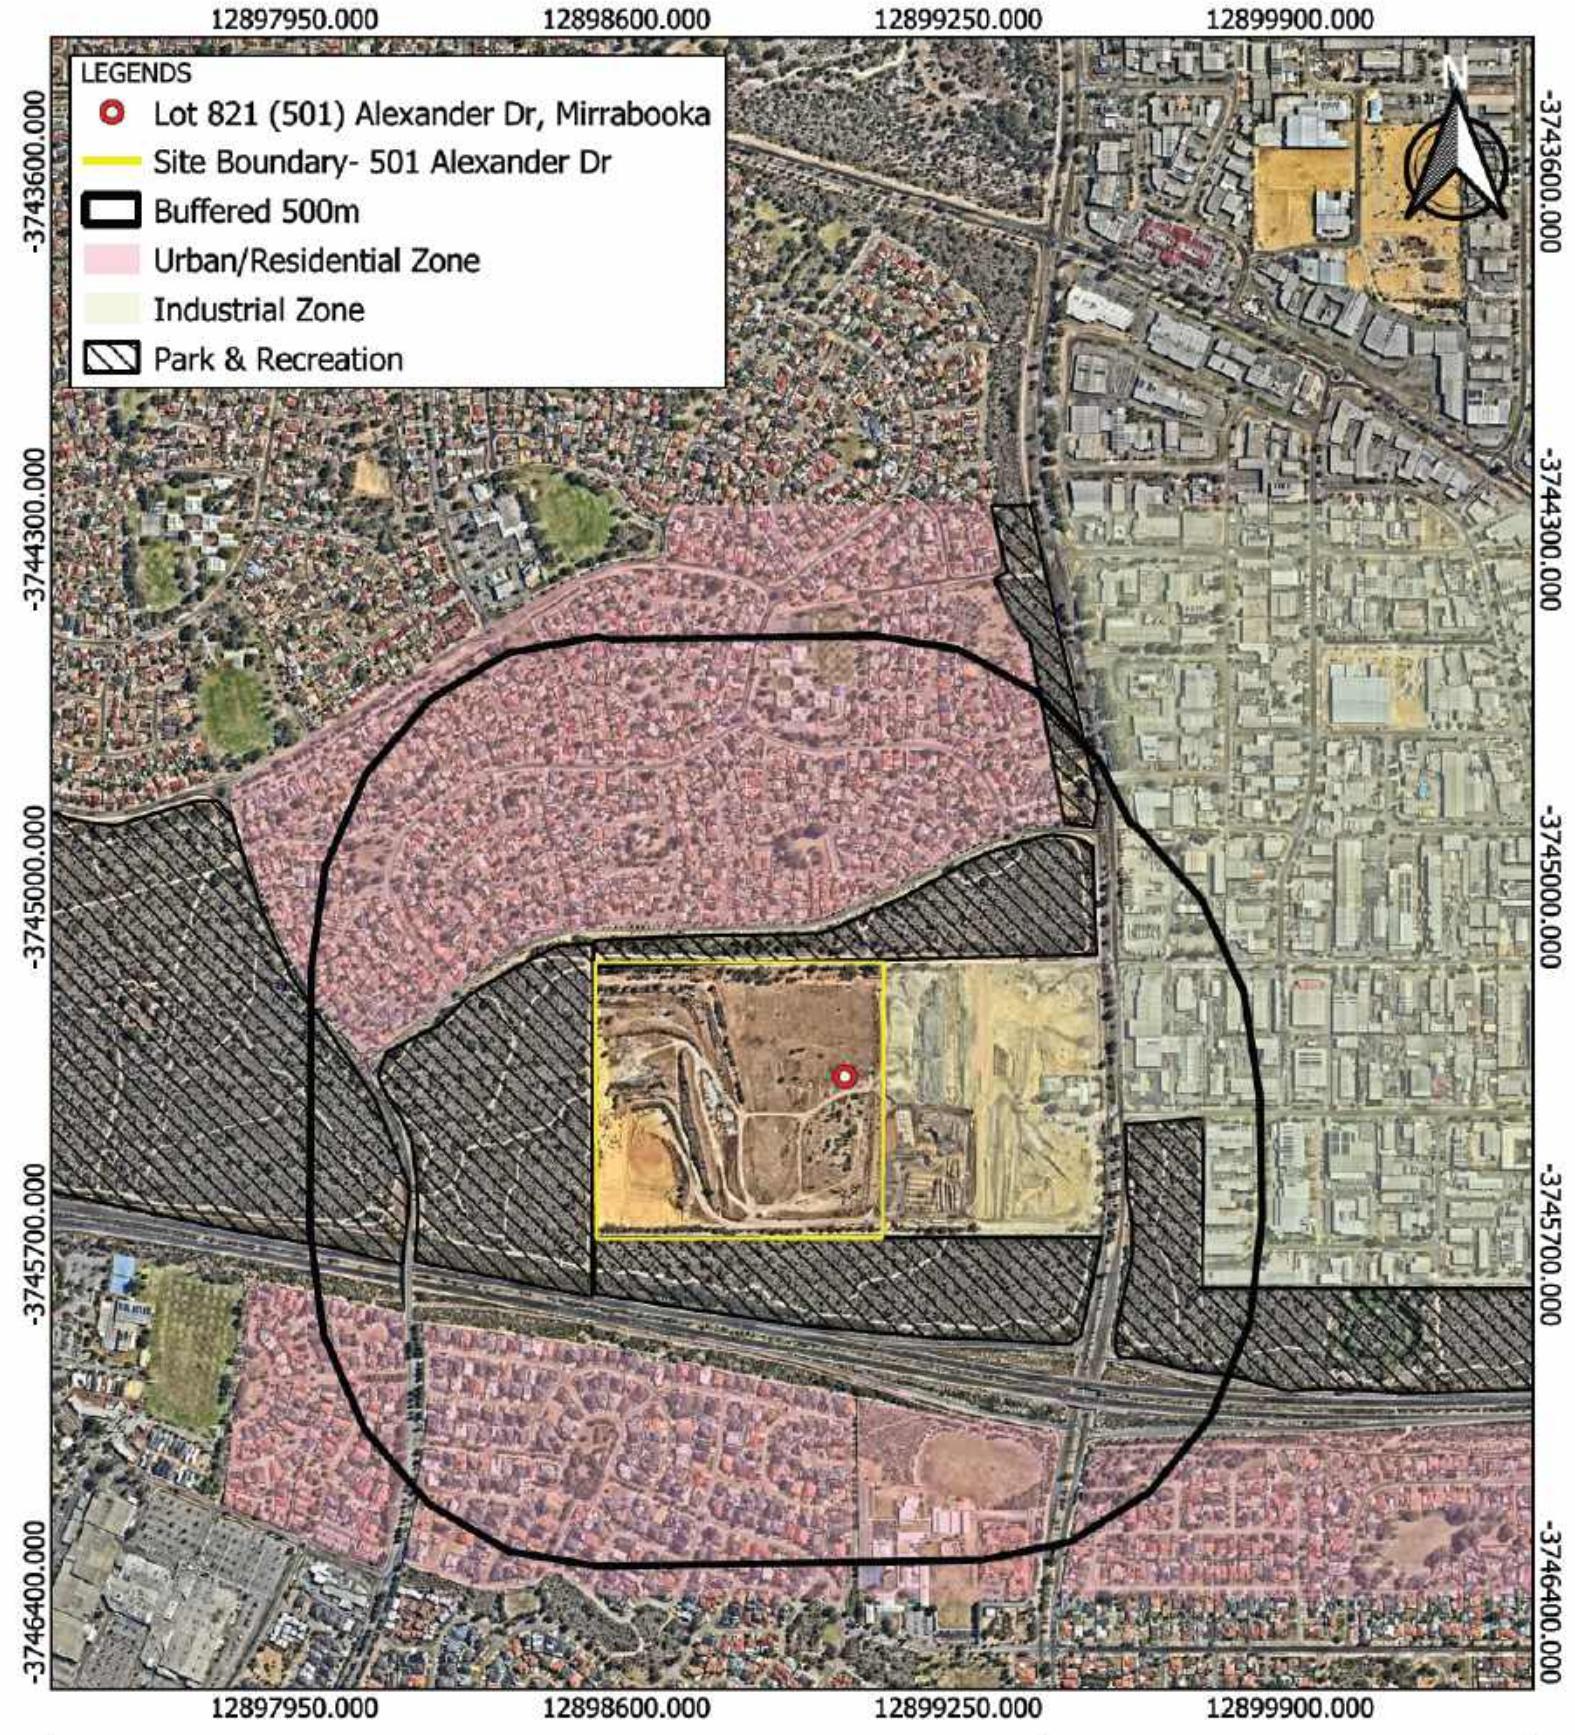
Figure 3- Surrounding Land Uses

The Metropolitan Region Scheme (MRS) is a legal land plan administered by the Western Australian Planning Commission outlining urban planning objectives and zoning throughout the Perth Metropolitan Area. Under the provisions of the MRS, the subject site is zoned Parks and recreation (Reserve) and Industrial zone. Surrounding MRS land zoning is displayed in **Figure 3 Surrounding Land Use**.

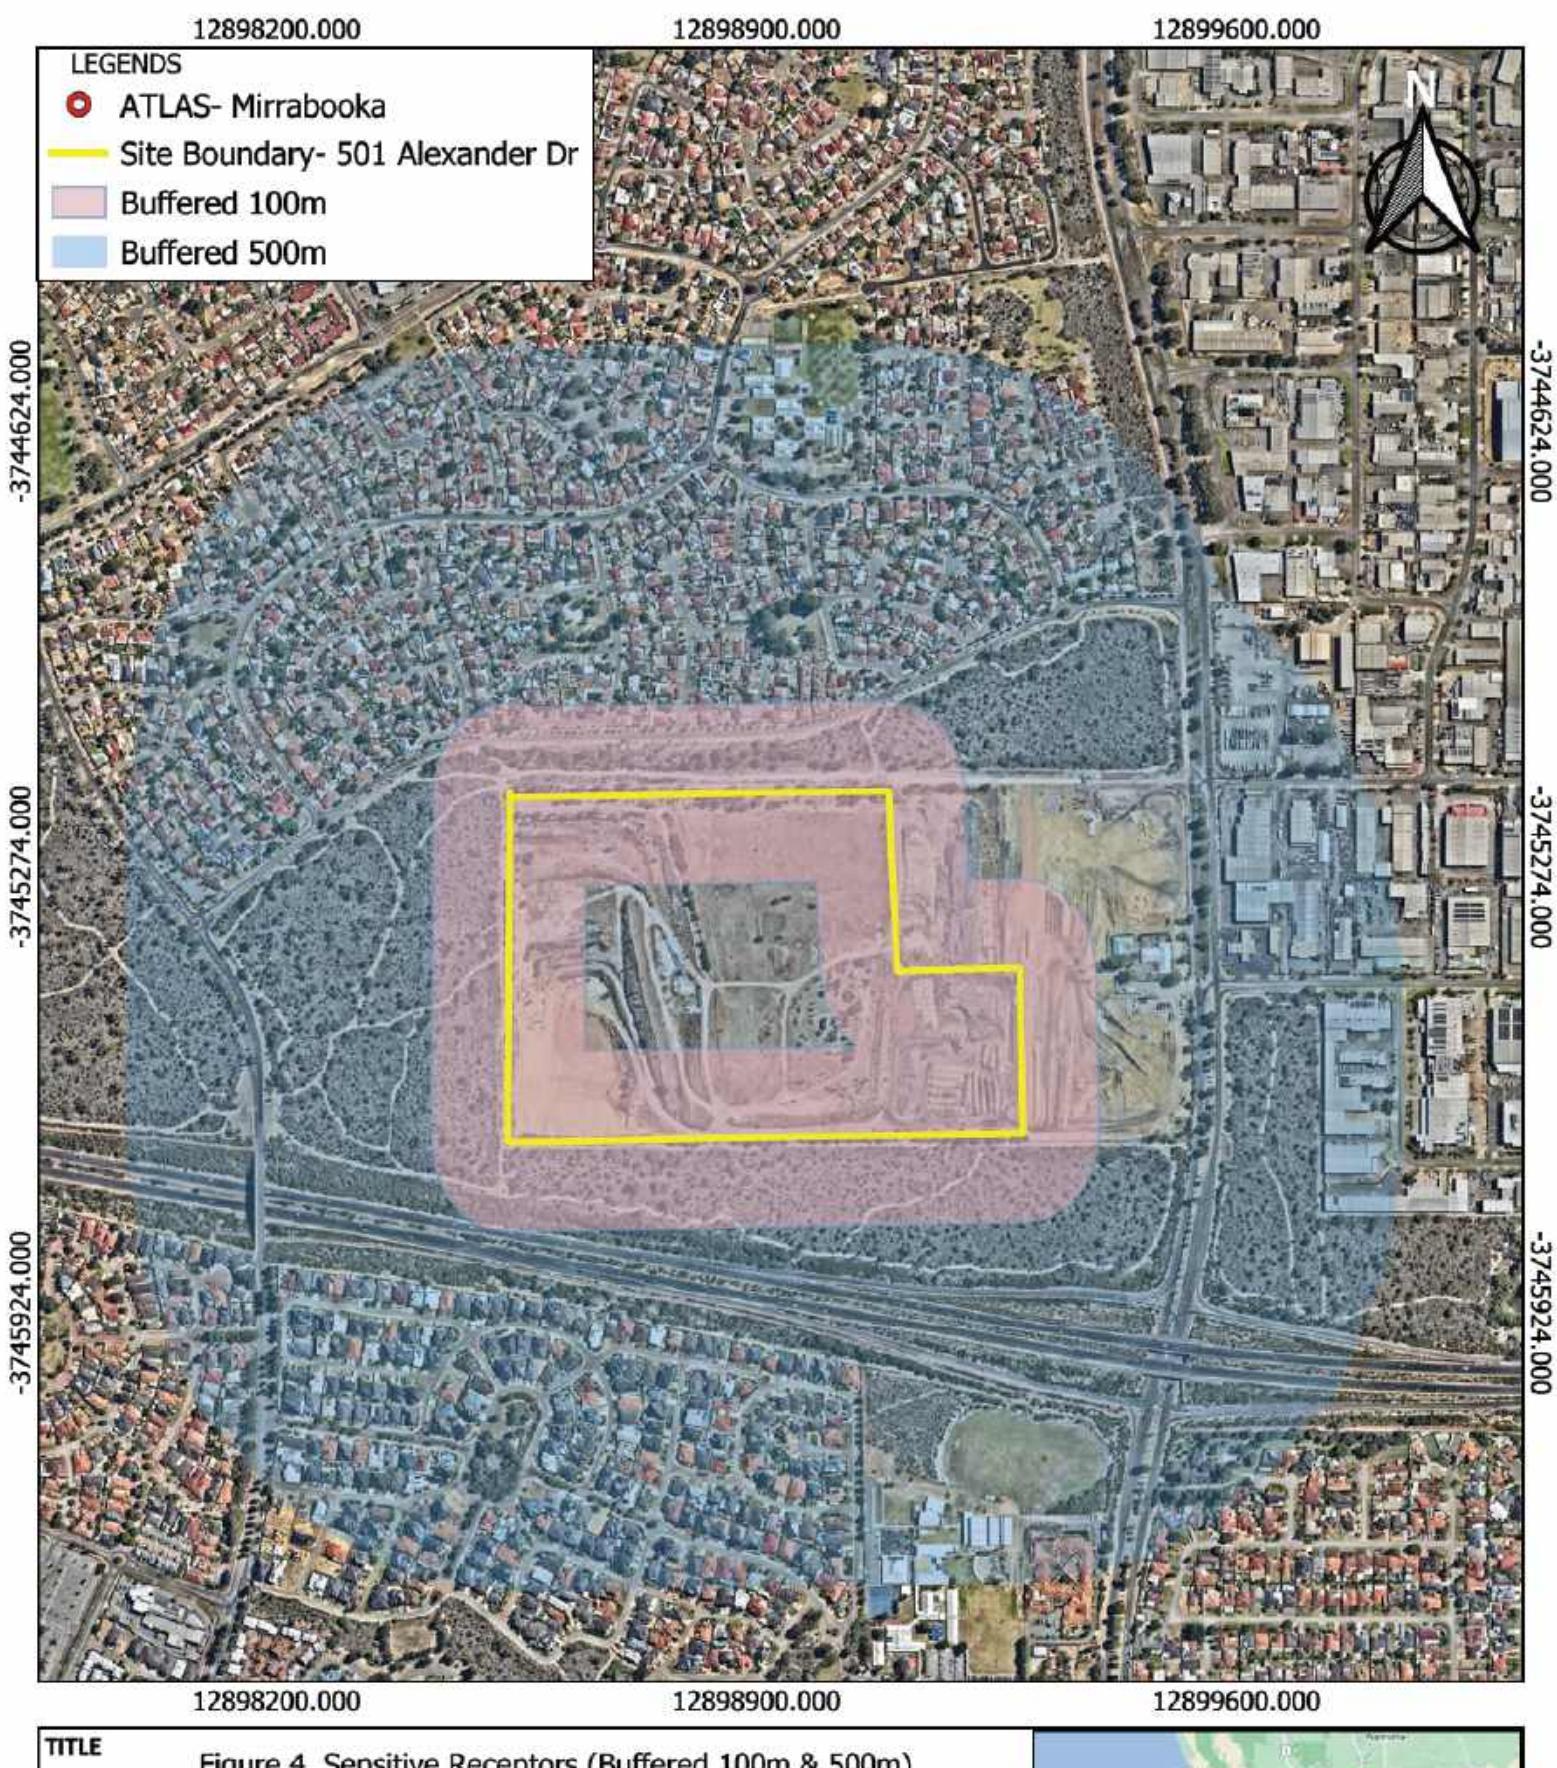
Figure 4- Buffer Zones and Surrounding Sensitive Receptors

The site is located within the area zoned as Industrial and Park & recreation (Reserve) according to Metropolitan Regional Scheme, however the surrounding area to the north and south of site has been zoned as Urban (Figure 3. Surrounding Land Use). The nearest sensitive receptor is an industrial receptor located adjacent to eastern boundary of the site. There are industrial and urban receptors located within 100m and 500m of the site boundary (Figure 4. Sensitive Receptors). Measurements have been taken conservatively from the closest boundary of the site to the boundary of the receptor. It should be noted that operation areas will have additional buffer distances due to their location onsite and strategic positioning. Table 3-2 below lists sensitive receptors within 100m buffer of the site boundary.

Table 3--2 Sensitive Receptors within 100m buffer around the Site Boundary
