REVEGETATION PLAN
AGGREGATE DUMP SITES
PANNAWONICA ROAD
30.5 & 39.18 SLK

Prepared by Matthew Oswald
Gascoyne Region
May 2007

REVEGETATION PLAN

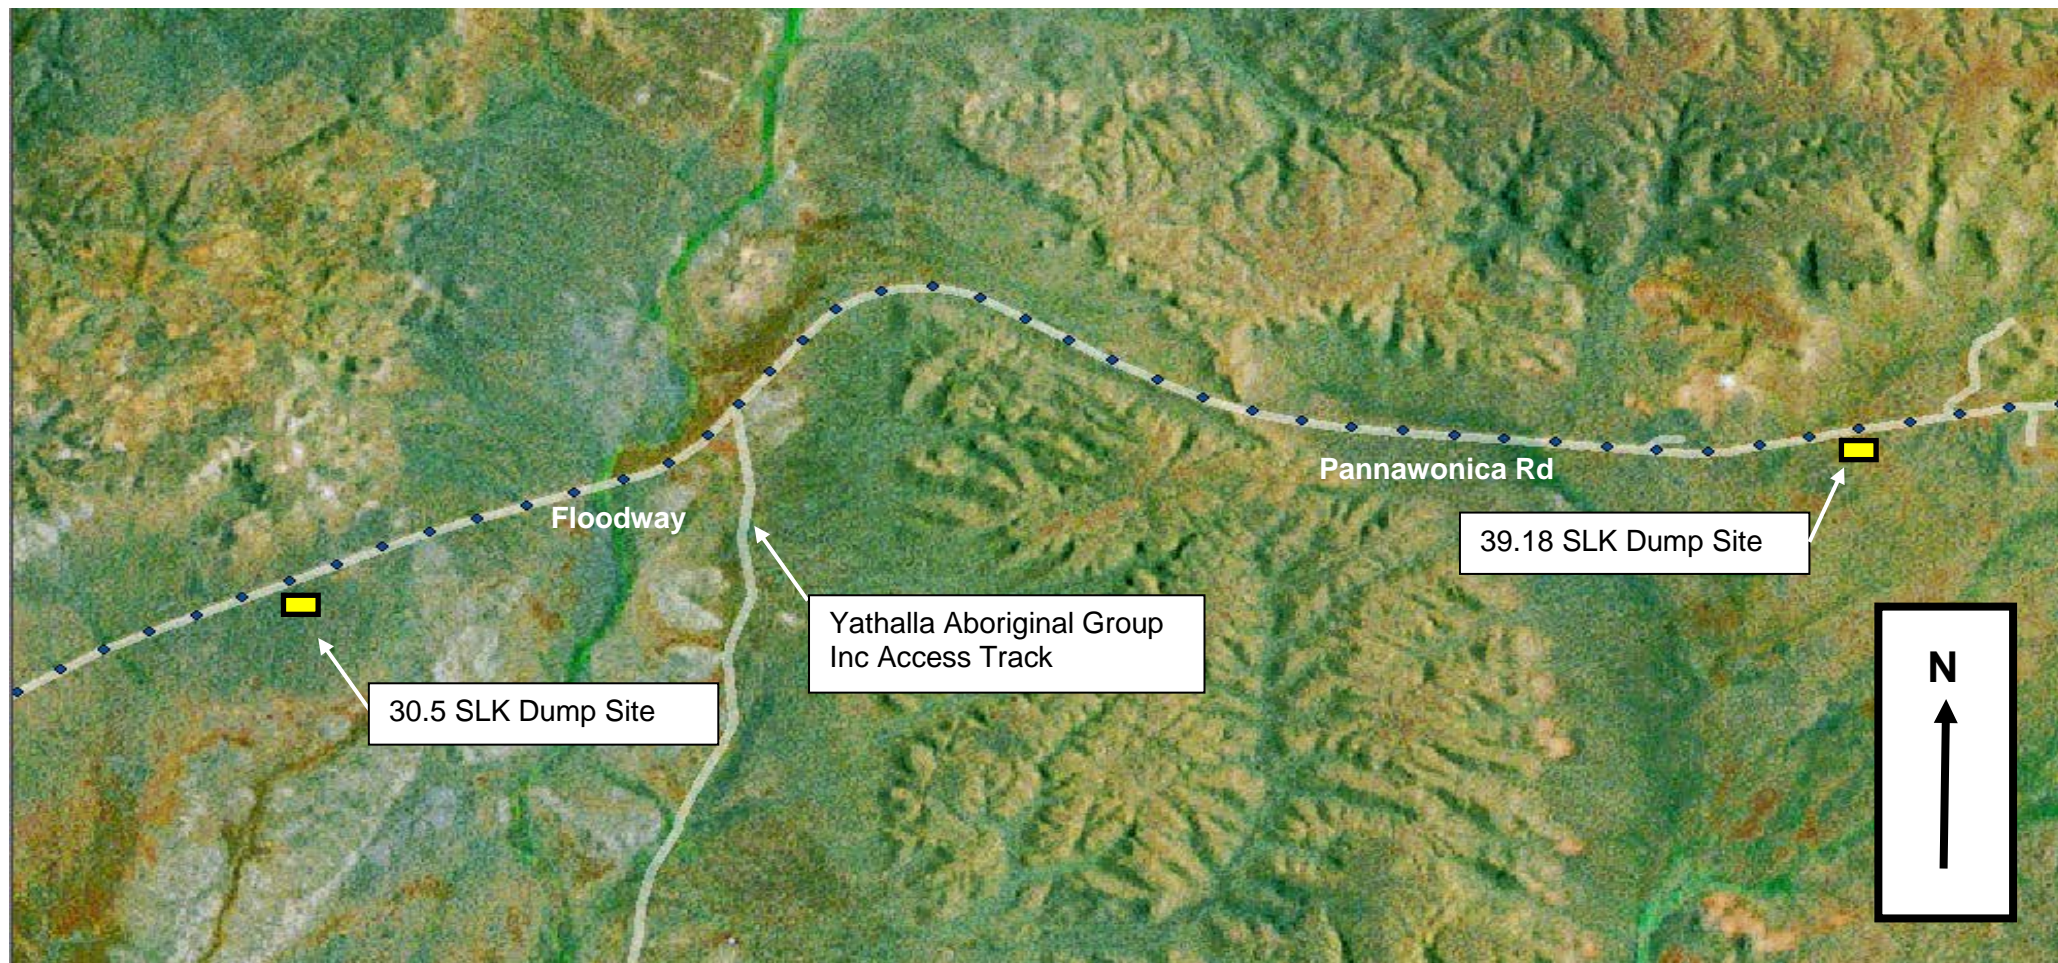
Figure 2 – Location of Aggregate Dump Sites

Aggregate Dump 30.5 SLK is located approximately 50 meters off Pannawonica Road on the right hand side. The dimensions of the site are approximately 100m long by 100m wide.

Aggregate Dump 39.18 SLK is located approximately 50 meters off Pannawonica Road on the right hand side. The dimensions of the site are approximately 100m long by 100m wide.

The location and boundaries of the revegetation area(s) are shown in Figures 1-2 below.
